## MEMORANDUM FOR CESPL-PM-N

SUBJECT: 2023 Redondo Beach King Harbor Structure Condition Inspections

Redondo Beach King Harbor  
2023 Condition Inspection  
Field Notes

### Redondo Beach King Harbor June 2023 Condition Inspection Structure Photographs

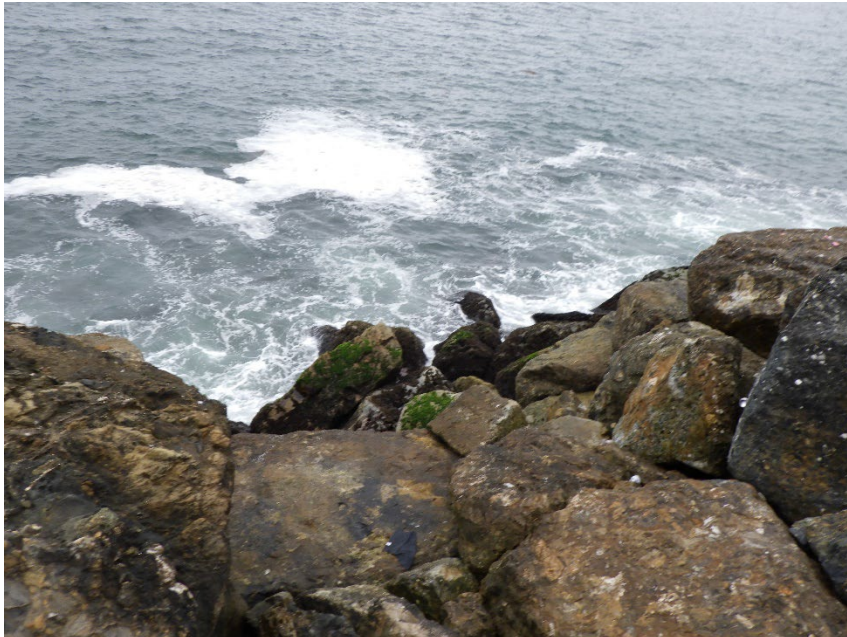
North Breakwater	
Station (s)	Description
15+50 – 16+00	Condition 3. Oversteepened slope on seaward side as seaward slope is failing, armor stones are separating from seaward shoulder, bridging of slope stones above voids. Damage extends from waterline into central crest.
16+10 – 16+40	Condition 3. Oversteepened seaward slope, missing and separated stones at waterline causing loss of interlock on slope up to seaward shoulder. Several missing stones at seaward waterline, outer layer of stones on the seaward slope are missing creating an oversteepened slope and loss of interlock. Damage is approximately 30 feet wide extending from waterline up to crest, additional damage visible on either side of Condition 3 area.
17+00 – 17+50	Condition 4, near breach centered at 17+25. Seaward face of slope has failed, remaining stones are losing interlock revealing underlayer. Multiple stones upturned on structure crest. Damage extends from waterline through central crest. Harbor side shoulder is still intact.

Figure 2: Condition 3 damage area, loss of armor stone on seaward slope at approx. station 15+75.

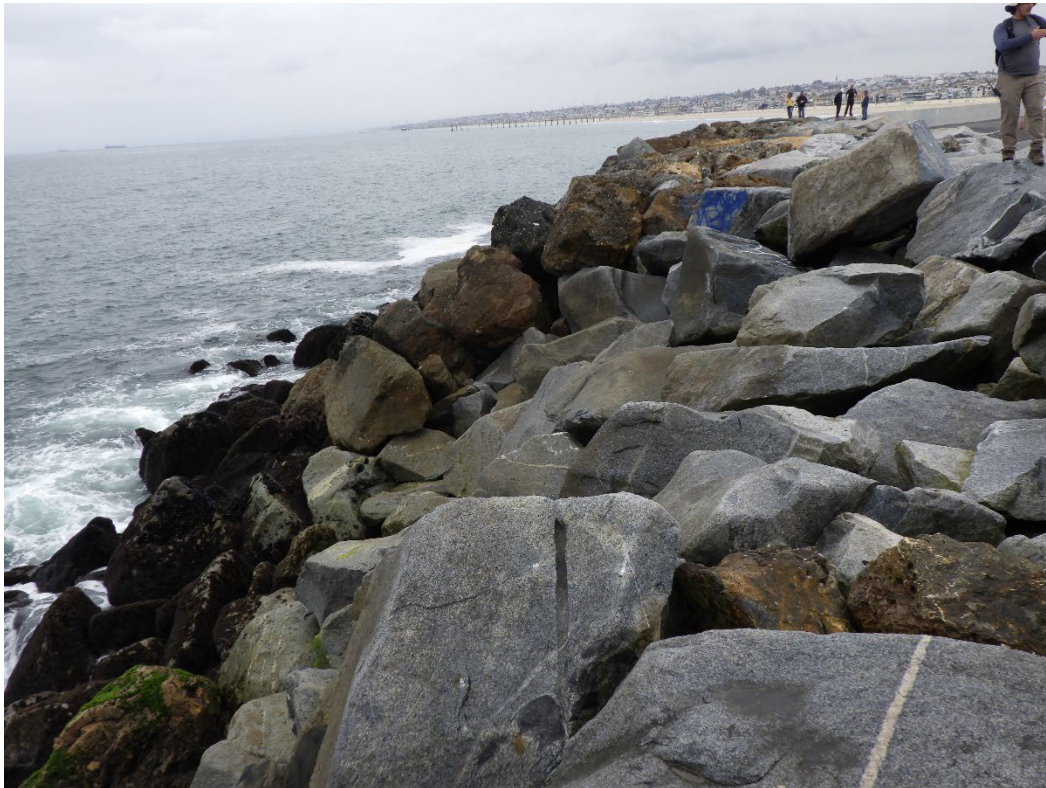
*Figure 4: Loss of interlock and armor stone on seaward slope 17+50*

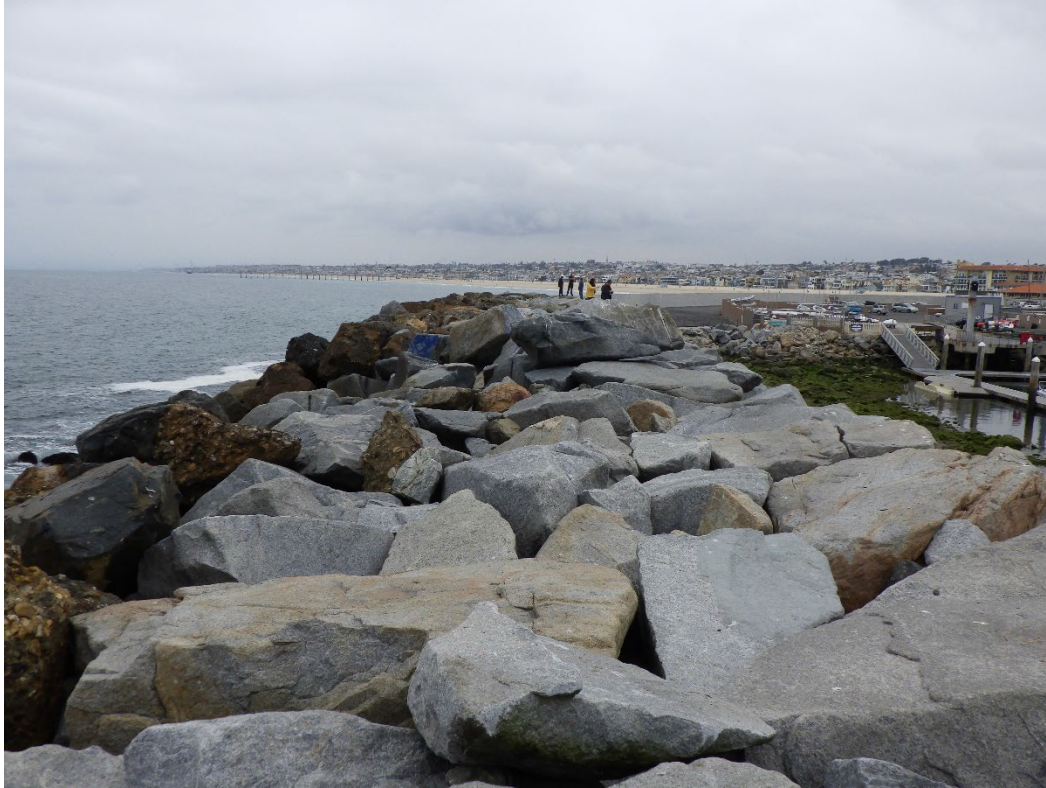
*Figure 5: Photo from 18+00 looking north, condition 4 damage area at 17+50 visible (center-left).*

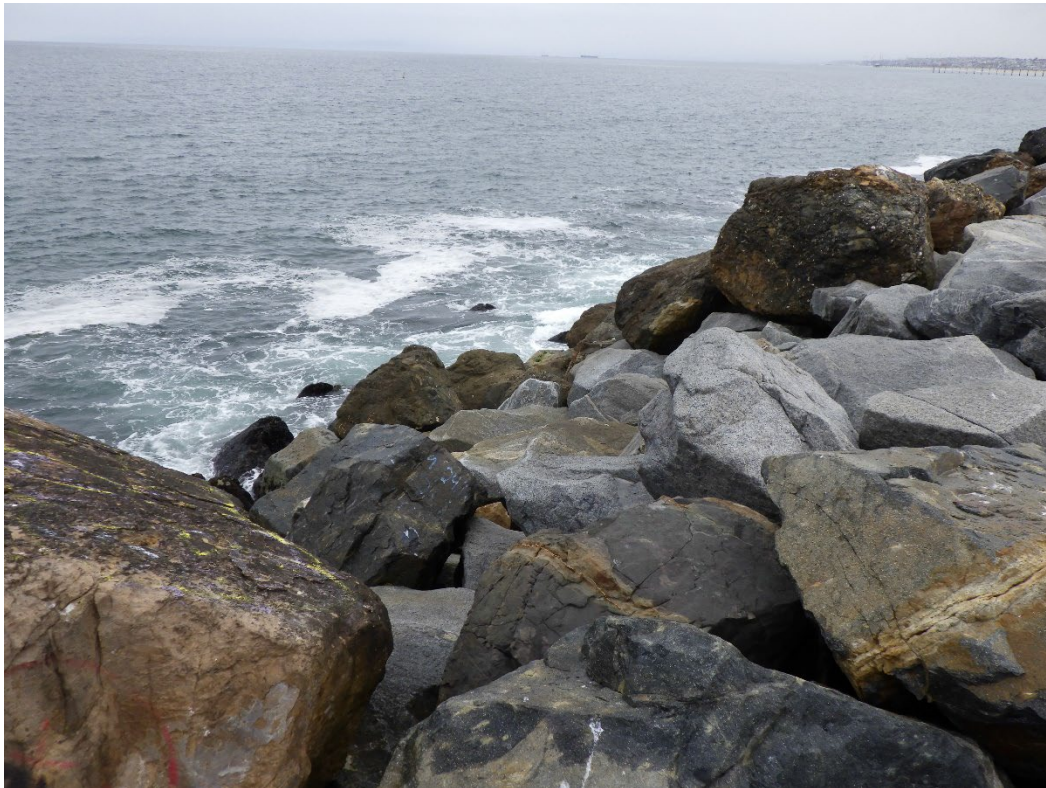
17+75 - 18+00	Condition 2. Loss of interlock along seaward slope resulting in loss of crest elevation on seaward shoulder, damage is progression from Condition 4 area centered at 17+25.
18+00 – 18+20	Condition 3. Several stones missing at waterline of seaward side causing slope stones to slide down the slope and loss of interlock throughout. Upturned stone at waterline and bridged/perched stone at 18+30. Damage appears to have progressed from previous inspection.
18+50	Condition 3. Missing armor stone on seaward slope from waterline up to seaward shoulder. Damage area is roughly 15 feet (approx. 1 stone width) wide. Stones on either side of damage area beginning to separate from structure resulting in 2 perched stones. Damage is newly formed based on comparison of previous 2 inspection reports.
18+75 – 19+00	Condition 2. Missing stones at waterline of seaward side causing slope stones to slide down and some bridging of stones on the upper slope. Loss of crest elevation on seaward shoulder.

*Figure 6: Missing stones on seaward slope, Station 18+20.*

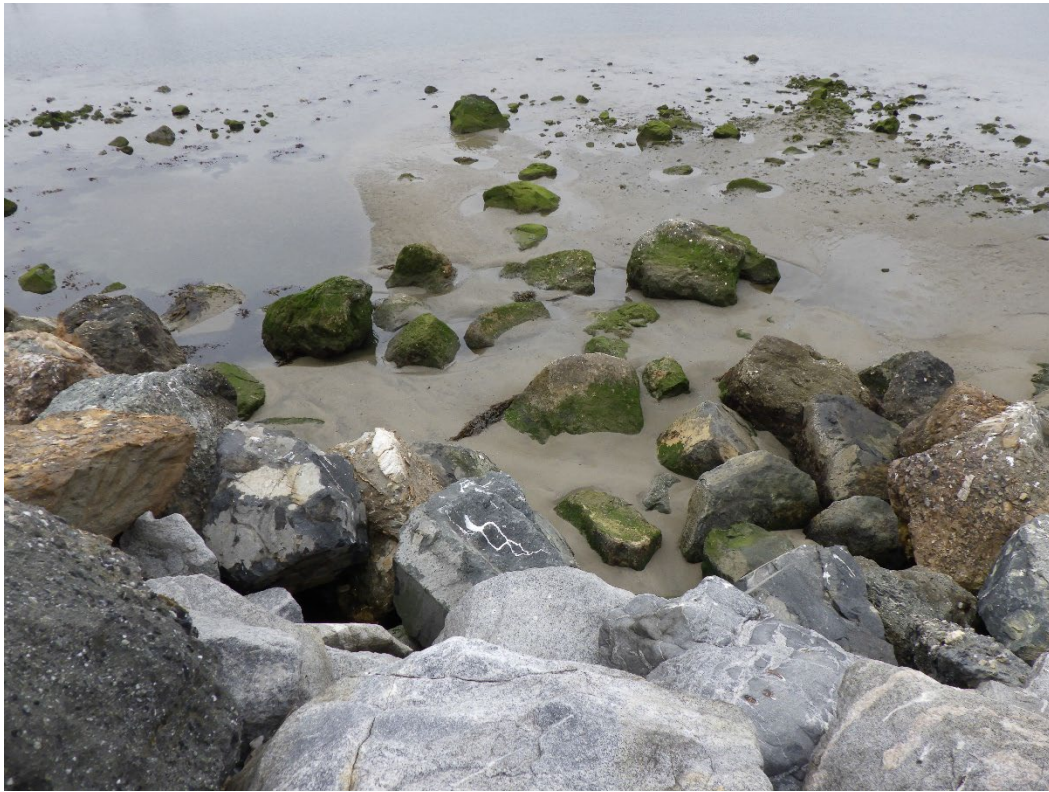
*Figure 8: Damage to harbor side bench Station 19+80*

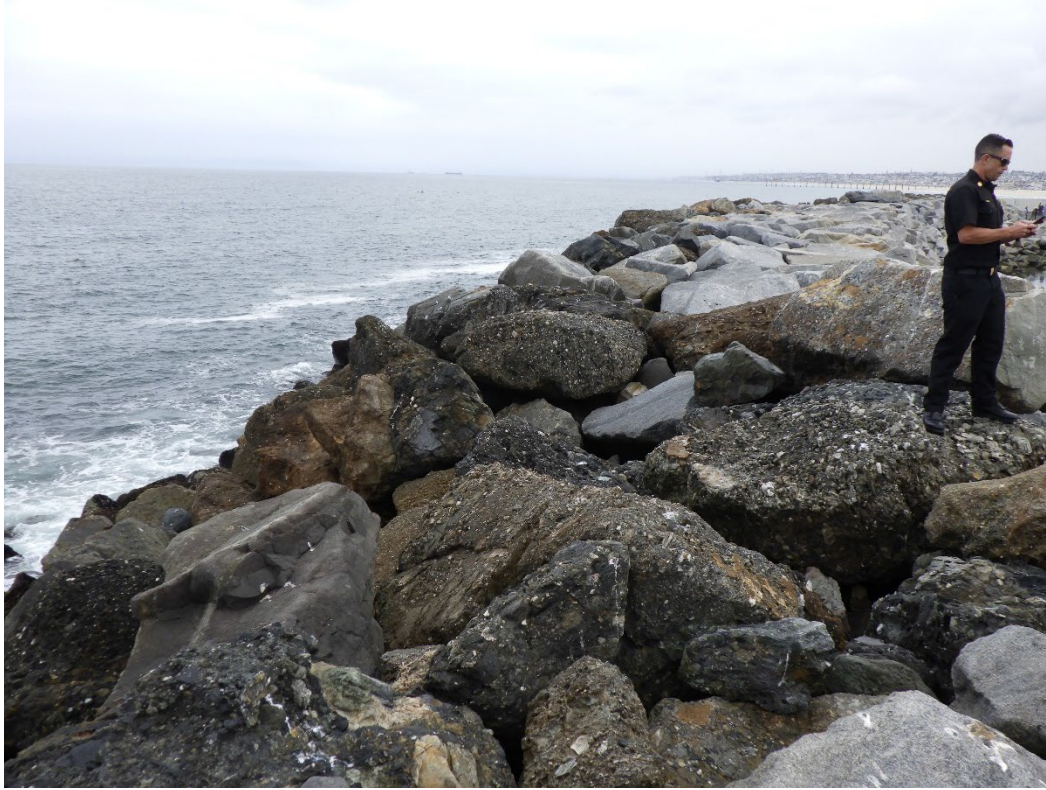
*Figure 9: Loss of crest elevation and oversteepened slope along seaward shoulder from 20+00.*

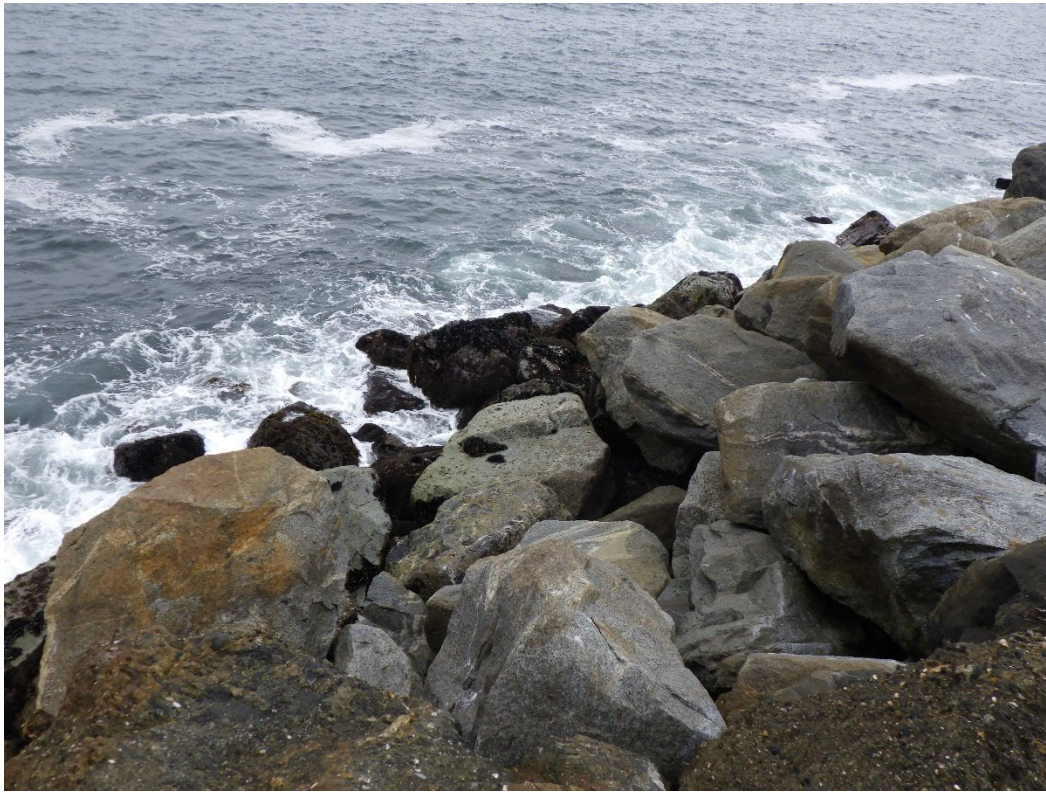
20+60	Condition 3. Missing several armor stones on seaward slope in 20-30 foot wide area centered at 20+60, shoulder stones slumping down caused by damage at waterline. Damage extends from waterline to seaward shoulder.
21+05	Condition 3. Several stones from seaward slope have become dislodged and have fallen away from structure, visible in water just off the structure. Damage is 20 feet wide (2 stones wide). Armor stones on seaward slope have completely fallen away revealing underlayer, stones on either side are perched. Damage extends up to seaward shoulder.
21+30	Condition 2. Shoulder stone sliding down seaward slope, loss of interlock and missing armor stone at waterline, 2 armor stones visible in water separated from structure. One shoulder stone is upturned. Damage is approximately 20 feet wide, repairs to consist of mostly resets.
21+75 – 22+00	Condition 2. Missing stone at waterline on seaward side resulting in an oversteepened slope and a loss of crest elevation, stones on seaward shoulder beginning to separate from central crest. Repairs to consist of mostly resets.

*Figure 10: Missing stones at waterline causing instability and loss of interlock up slope, Station 20+60.*

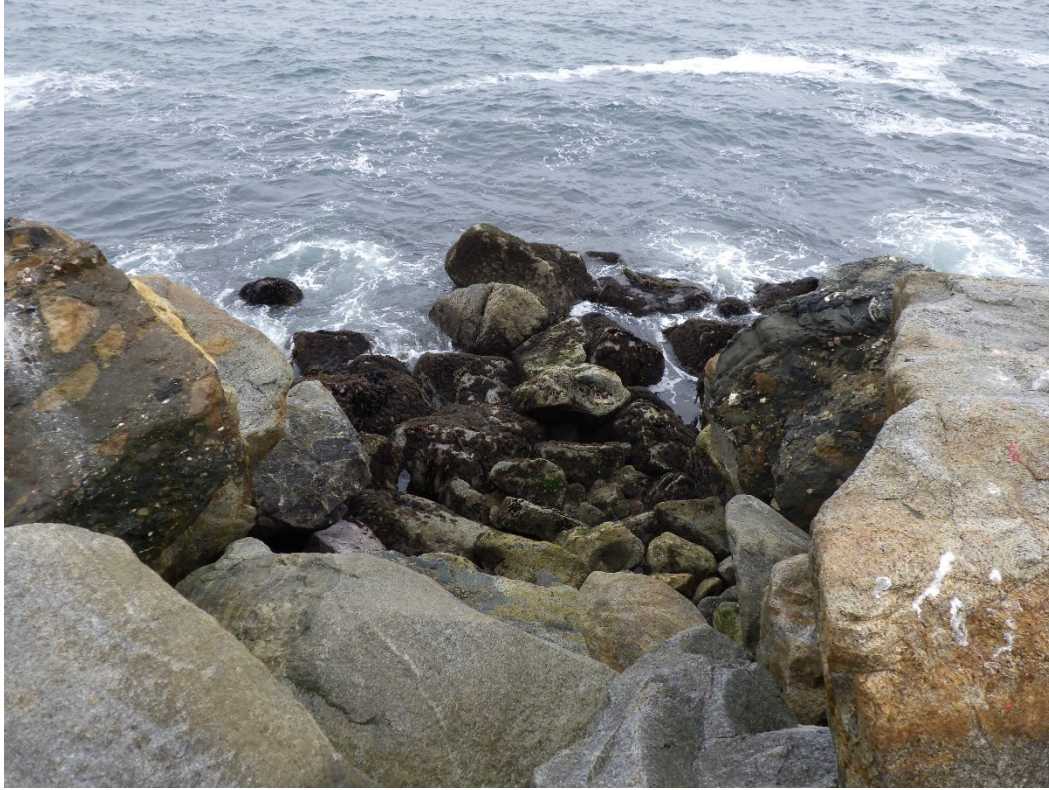
*Figure 11: Loss of armor stone from seaward slope, Station 21+05.*

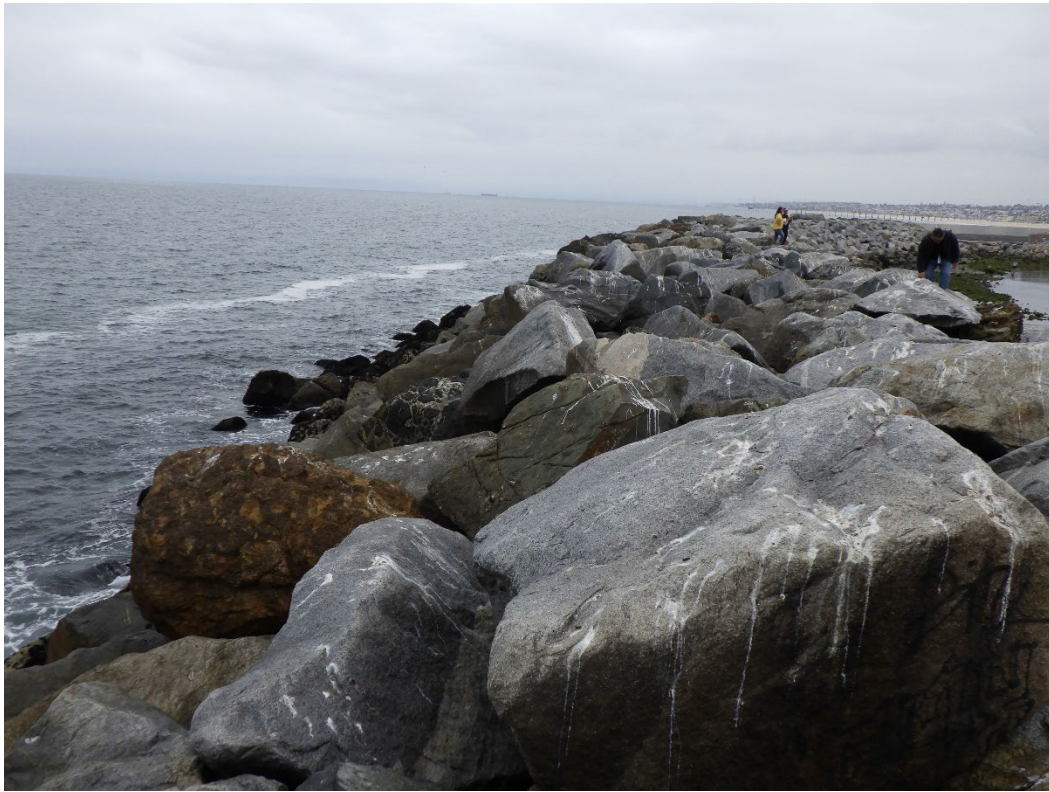
*Figure 12: Loss of interlock on seaward slope, Station 22+00 looking north.*

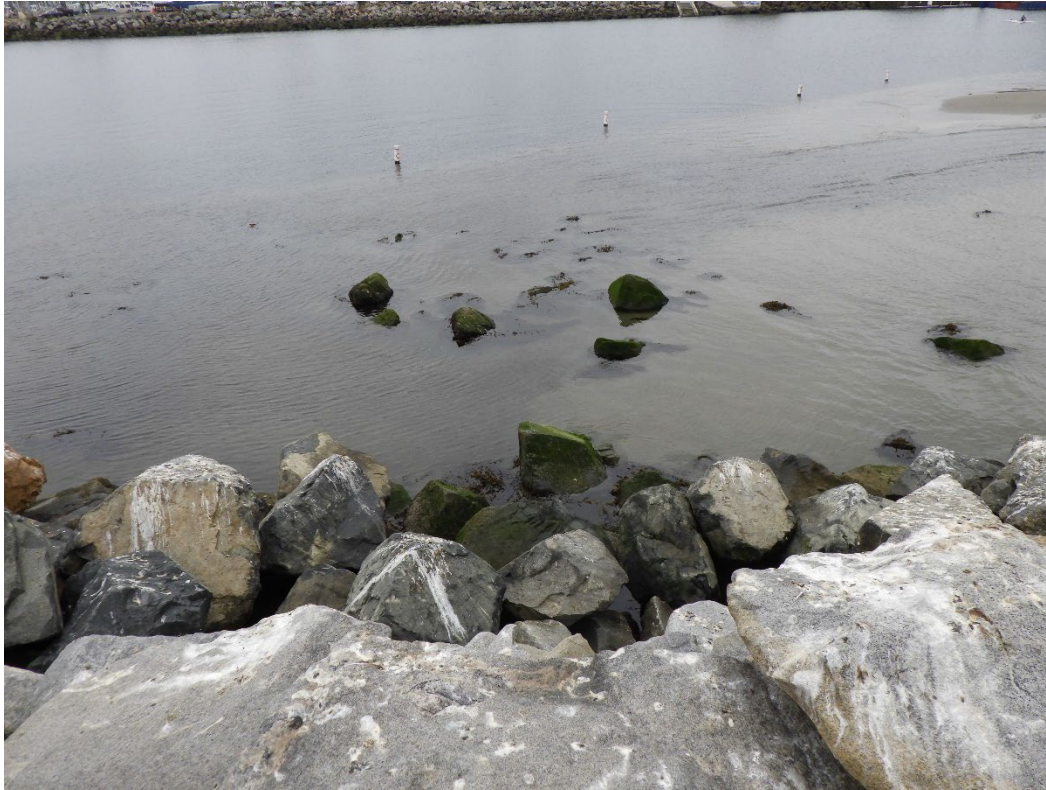
*Figure 13: Ejected stones and damage to harbor side bench, Station 23+15.*

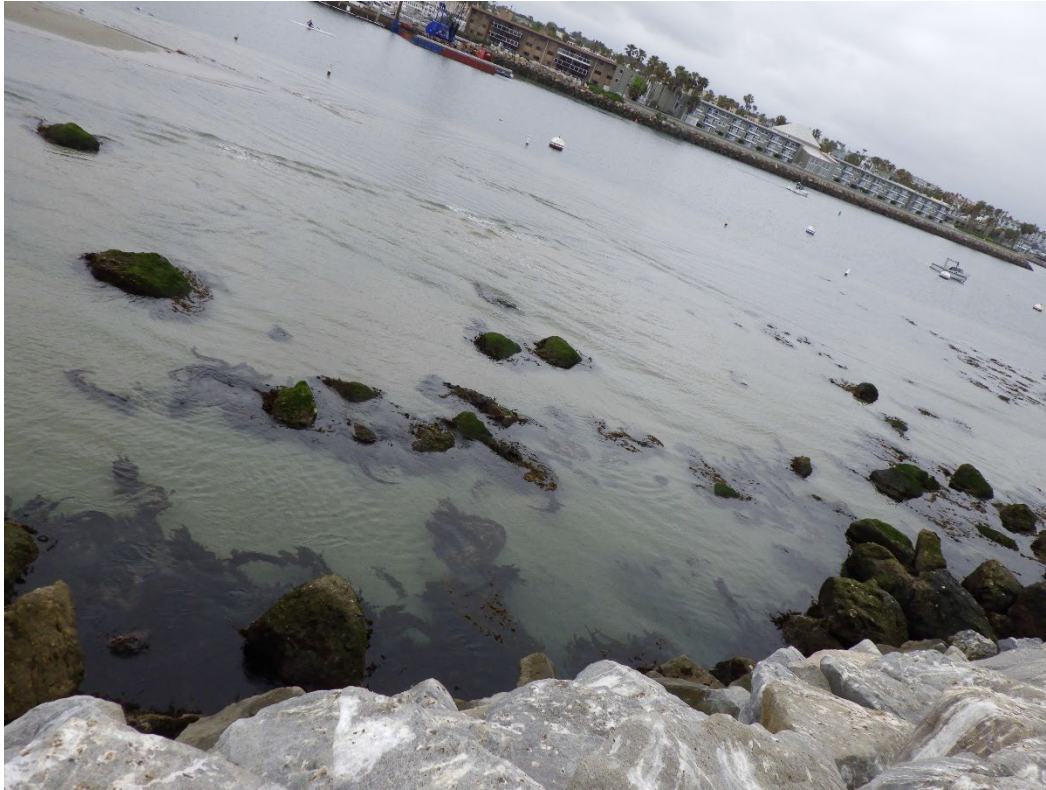
*Figure 15: Several stones visible in water, damaged harbor side bench, wave propagating from seaward side, Station 24+25.*

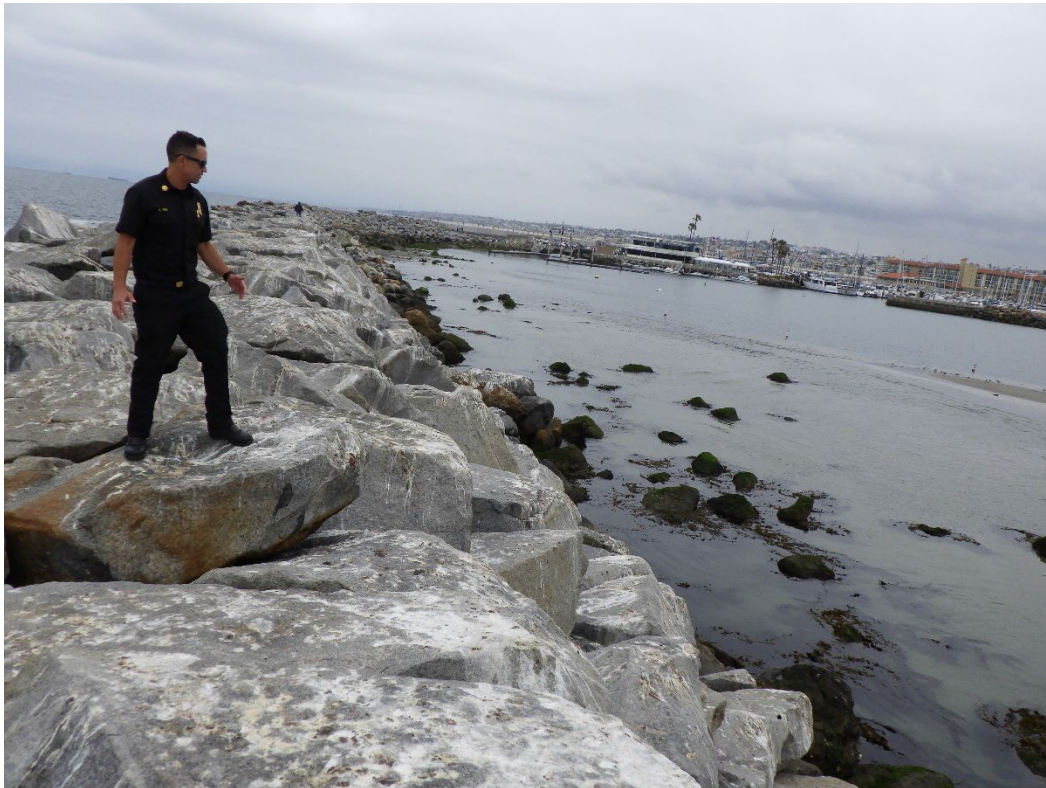
*Figure 16: Harbor sideshoulder looking north from 26+00, damage to harbor side bench*

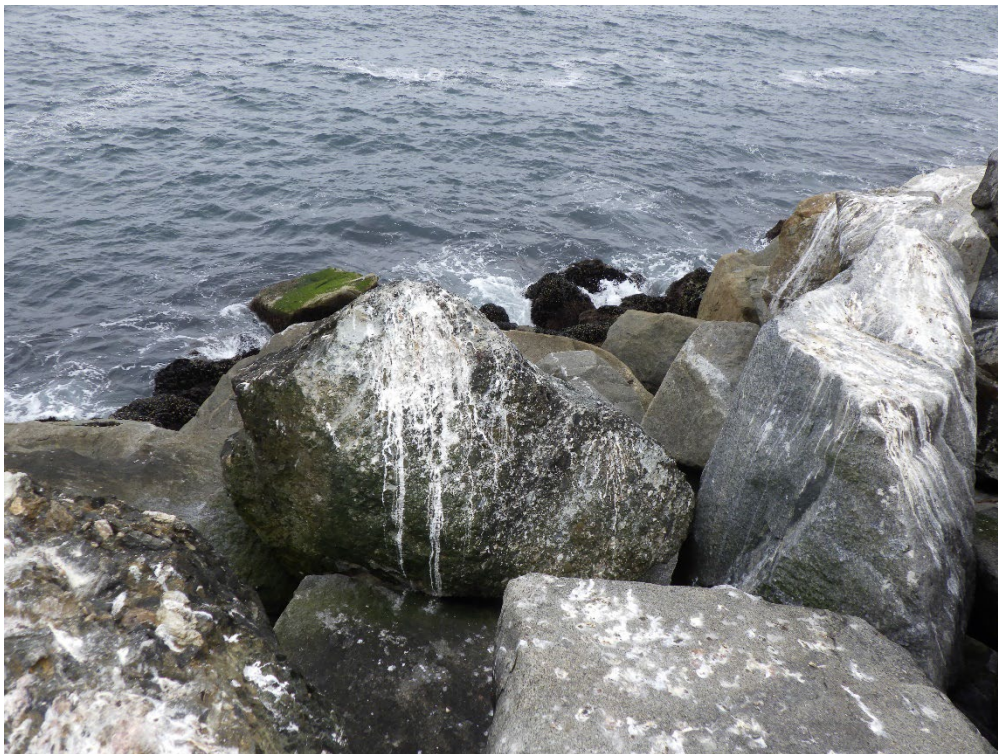
*Figure 18: Loss of interlock and separation from seaward shoulder, Station 29+75.*

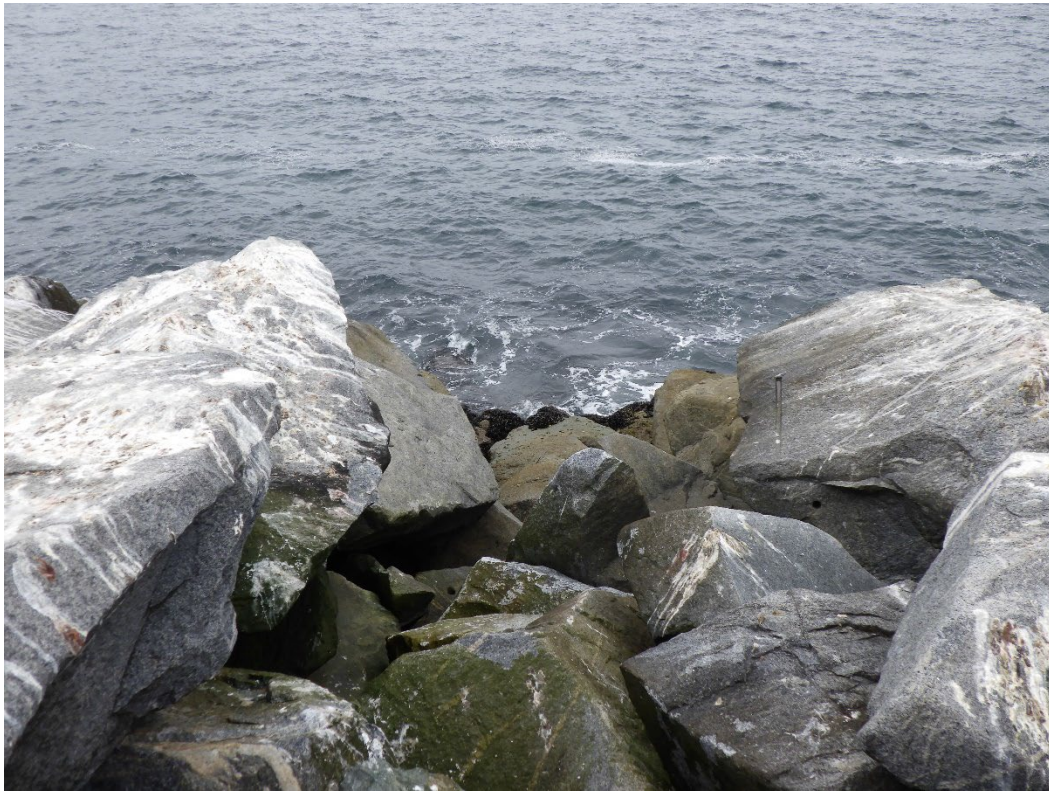
*Figure 20: Loss of armor stone on seaward slope, upturned stone on seaward shoulder, Station 30+25.*

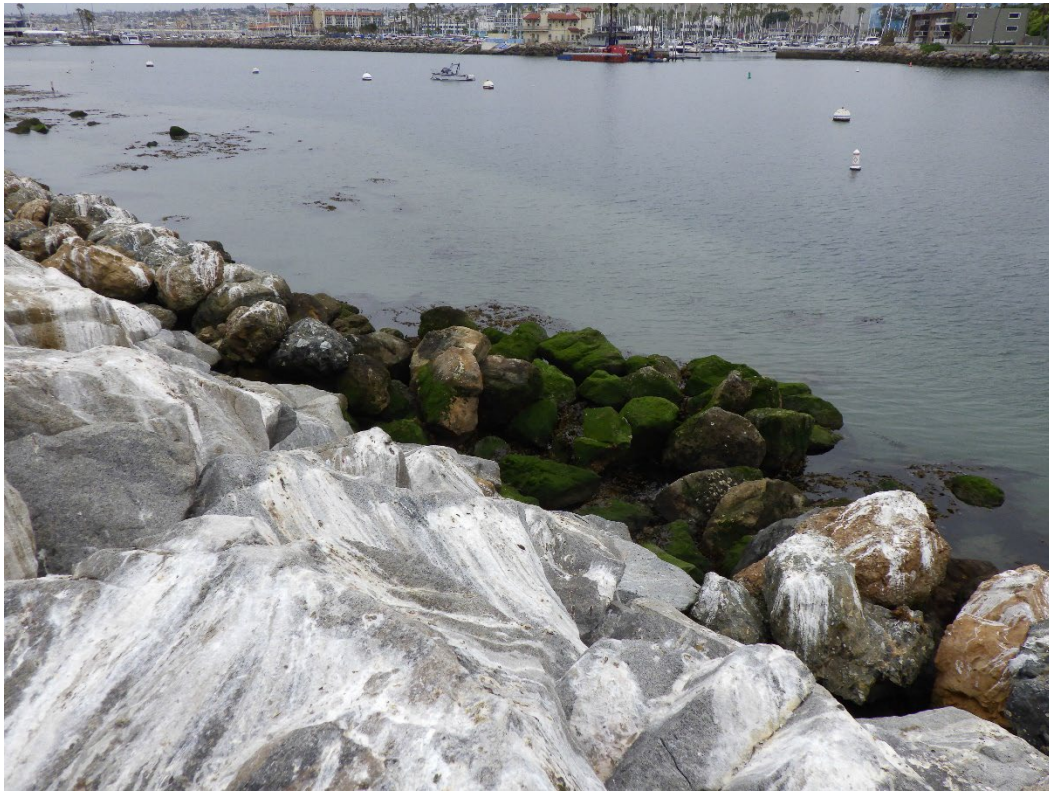
*Figure 22: Separation of stones on harbor side bench at Station 32+00.*

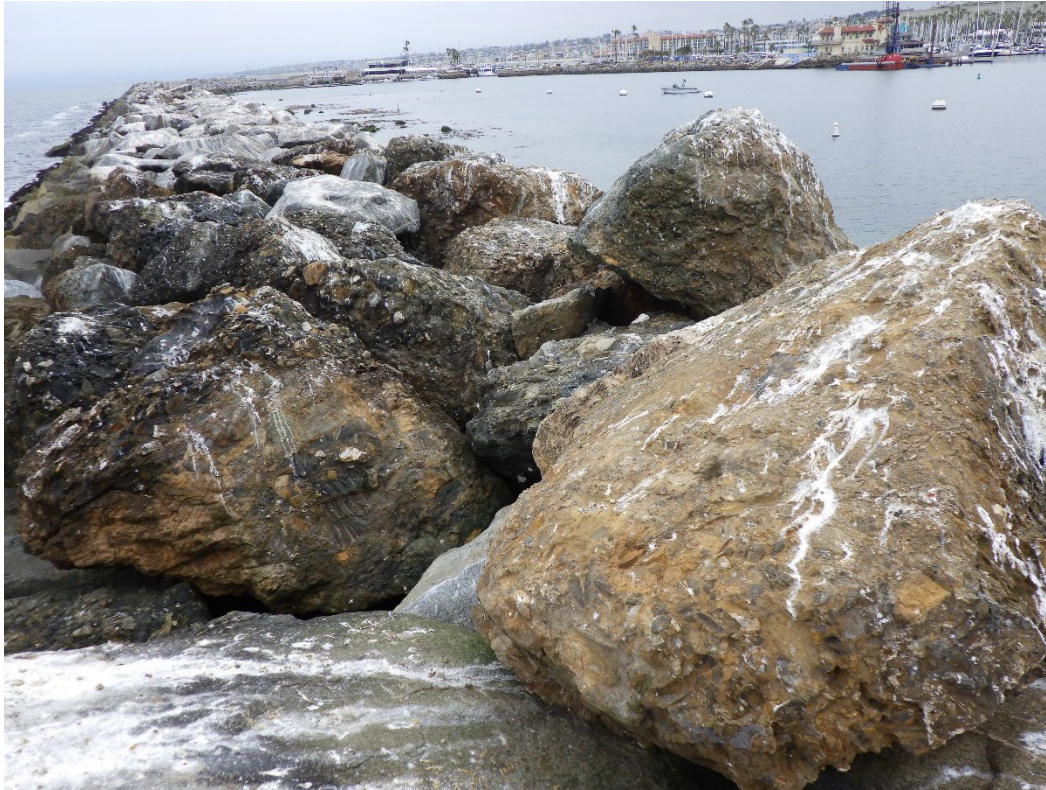
32+05	Condition 1. Upturned stone at seaward waterline.
32+90	Condition 1. Missing multiple stones at seaward waterline resulting in loss of interlock on surrounding slope stones, minor loss of crest elevation, damage approximately 10 feet wide.
33+30	Condition 1. Two stones on the seaward shoulder have been upturned revealing the underlayer of armor stone, surrounding stones are well interlocked.
34+00	Condition 1. Oversteepened slope on seaward side of structure.
34+20	Condition 1. Missing stones and one upturned stone at seaward waterline.
34+80	Condition 1. Damage to harborside bench, several stones separated from structure.
35+25	Condition 2. Three upturned stones on the seaward shoulder exposing the underlayer of armor stones. Stones at waterline are losing interlock and beginning to separate from structure. Minor loss of crest elevation between 35+25 and 35+40.
36+50	Condition 2. One upturned stone on seaward shoulder, two armor stones slumping down seaward slope and one upturned stone at waterline. Result is instability on upper slope and minor loss of crest elevation.

*Figure 23: Two upturned stones on structure crest, Station 33+30.*

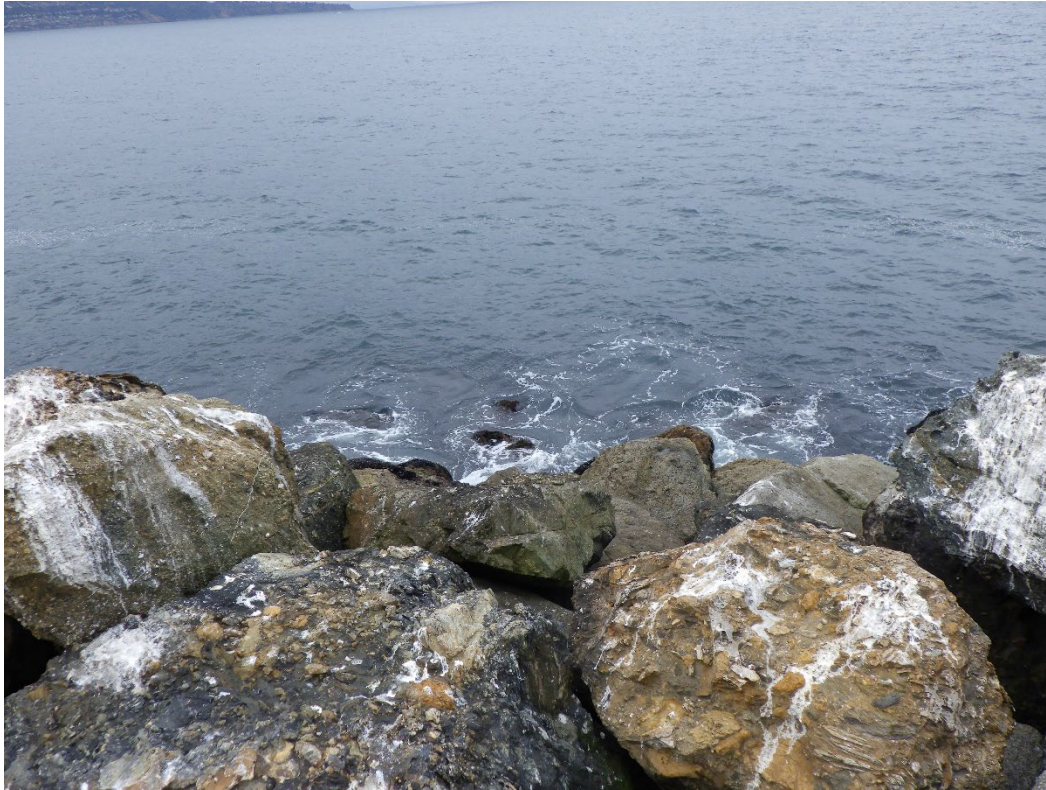
*Figure 25: Oversteepened seaward slope at Station 36+20.*

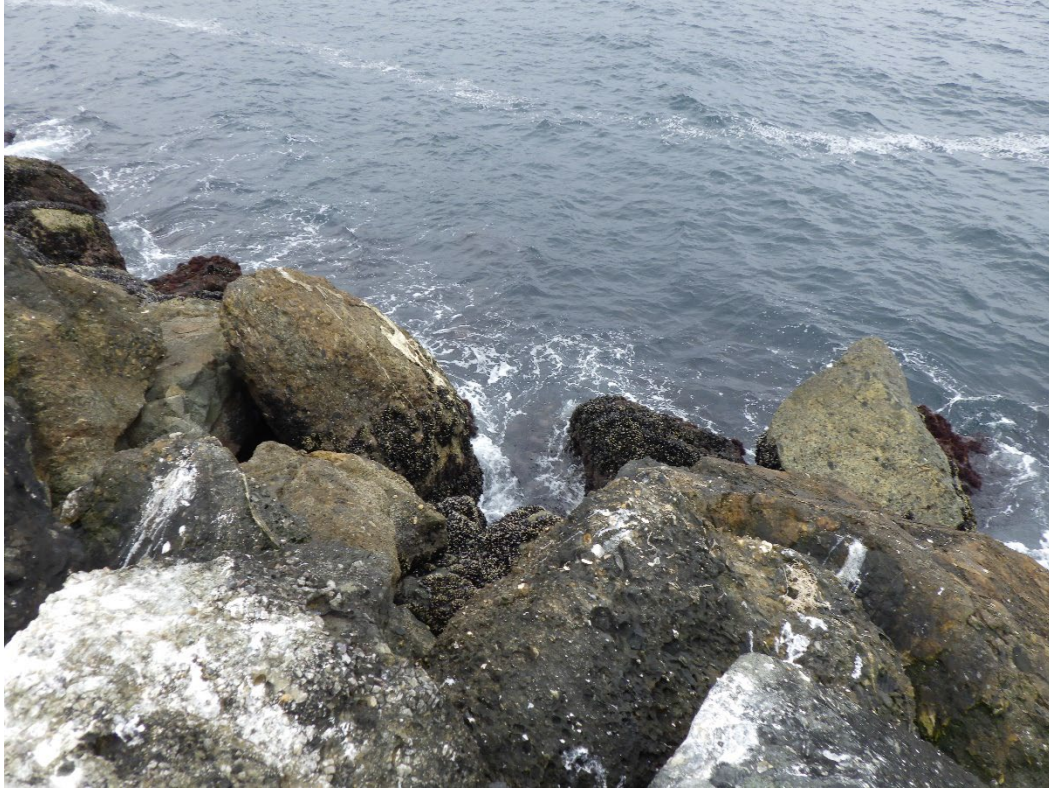
interlocked.
47+00	Condition 3. Damage area 20 feet wide from waterline up to seaward crest of the structure, several stones have fallen away, loss of interlock throughout, several stones on seaward slope have slumped down revealing the underlayer. Area should be repaired.
47+75	Condition 1. Missing stones at seaward waterline causing loss of interlock and sliding of slope stones. Minor loss of crest elevation.
48+00	Condition 3. Missing armor stones from waterline and seaward slope, stones on either side of damage area have started to lose interlock and slump down the slope. Shoulder stone is in place but slope is severely oversteepened. Damage area is 10 feet wide.
48+75	Condition 4. Entire seaward slope has failed, vertical drop from shoulder to waterline. Several stones have fallen away revealing underlayer and core stone. On either side of damage area, stones are losing interlock and slumping down/perched. Damage is visible from waterline up to seaward shoulder – shoulder stones are separating from crest. Damage appears to be accelerating, this area (48+50 – 49+00) should be included in upcoming maintenance repairs.

*Figure 31: Upturned armor stones and loss of interlock, loss of armor stone on seaward slope, Station 47+00.*

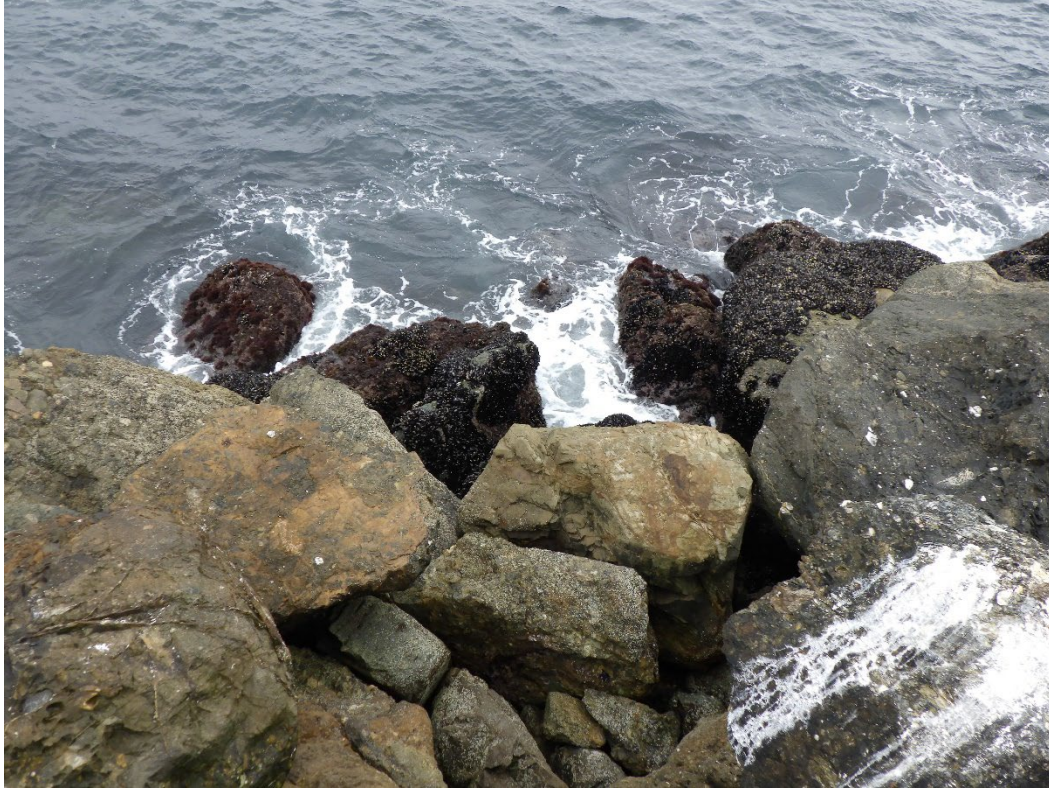
*Figure 33: Missing armor stone at waterline and on seaward slope, loss of interlock, Station 48+00.0.*

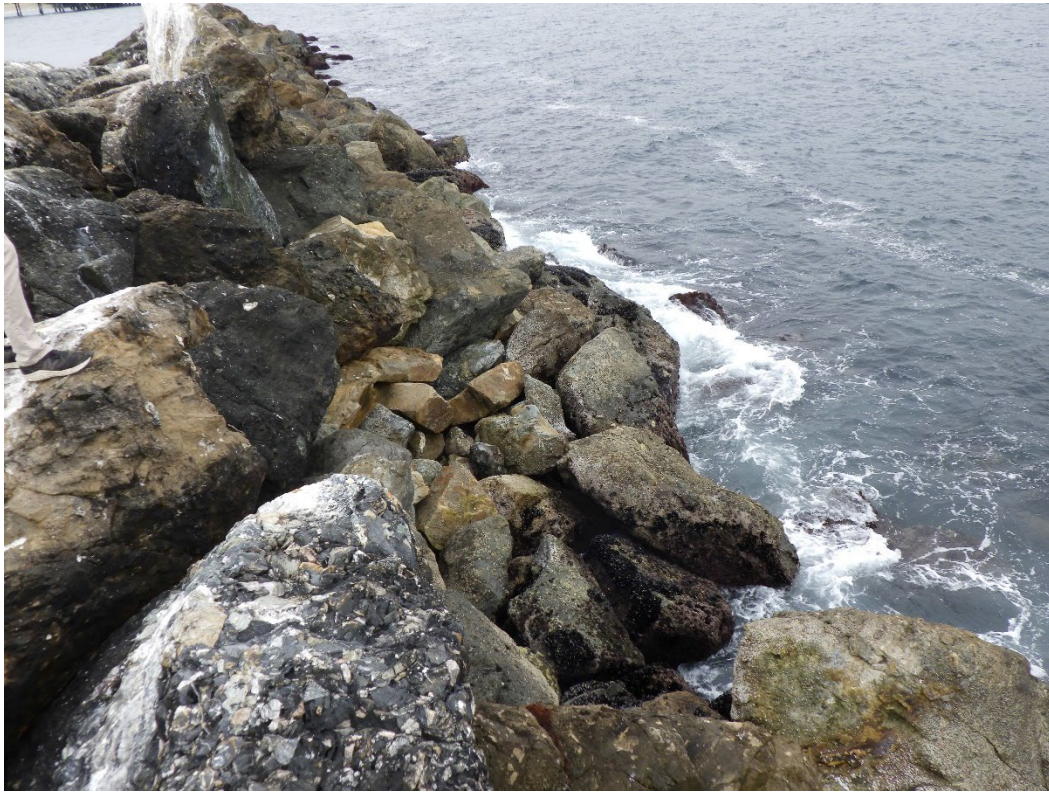
*Figure 34: Failure of seaward slope between stations 48+50 and 49+00.*

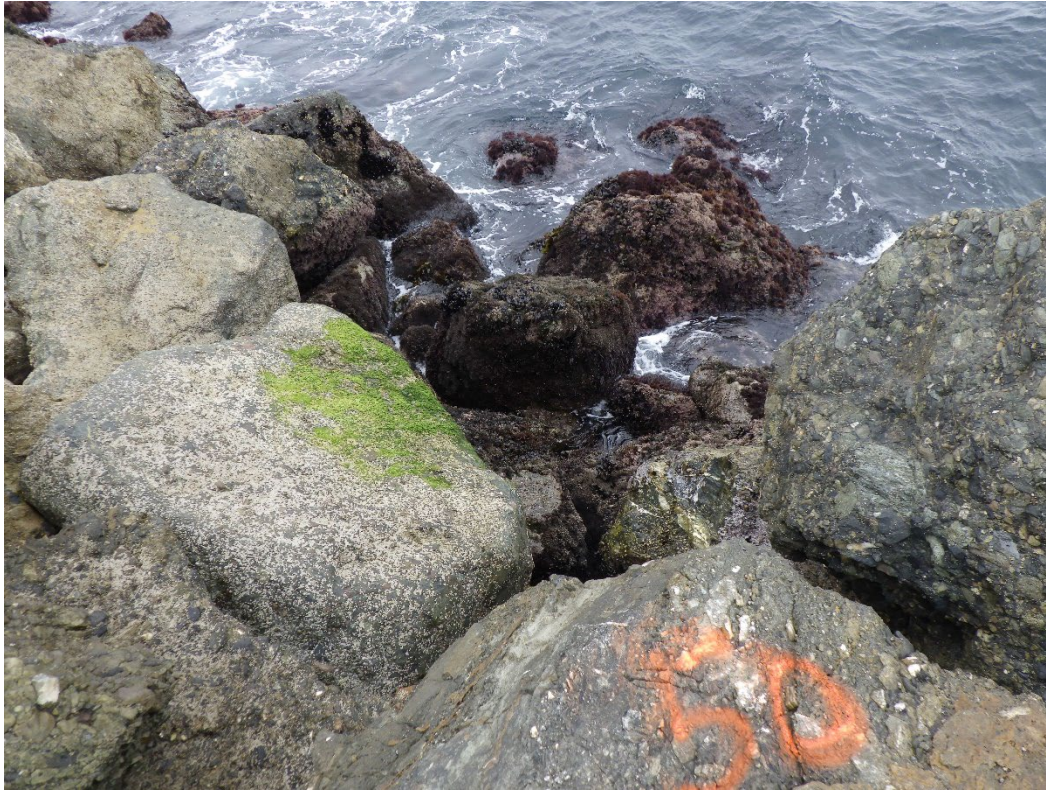
*Figure 35: Near breach, failure of seaward slope at Station 50+00.*

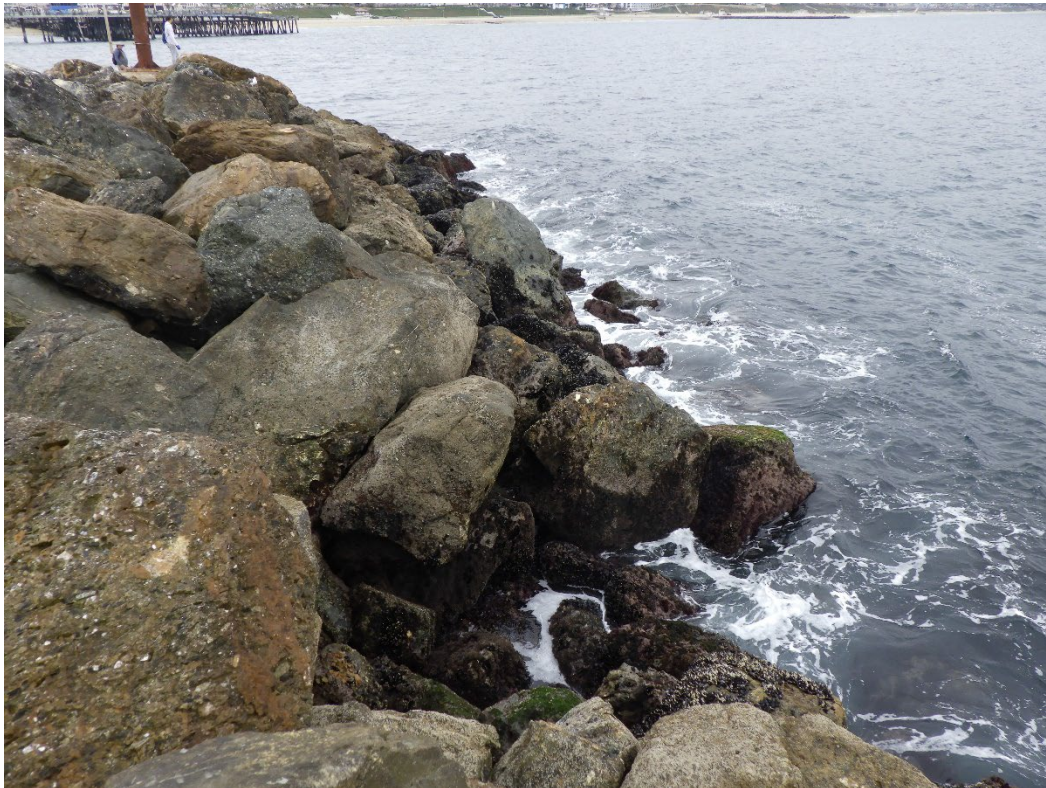
49+50	Condition 3. Several missing stones at the seaward waterline causing slope stones to lose interlock and slide, some bridging occurring above the void. Additional damage visible on harbor side. Damage is immediately following the structure crest elevation transition. Damage extends from the waterline and through the crest on the harbor side.
49+75	Condition 4. Near breach, seaward slope is failing and only harbor side shoulder is intact. No interlock on seaward slope. Upturned armor stone and missing stones at waterline. Damage extends from waterline through central crest and into harborside shoulder.
50+00	Condition 4. Near breach. Seaward slope has failed exposing underlayer and core stone and leaving a vertical drop from center of structure to waterline. Damage extends from waterline into central crest, harborside shoulder remains intact.
50+85	Condition 4. Seaward slope has failed, missing stones at waterline and vertical drop from seaward shoulder. Shoulder stones are intact but perched, underlayer is visible, stones on either side of damage are losing interlock and separating from structure, photo of damage area centered at 50+85 and extends up to 51+10, damage roughly 30 feet wide and extends from waterline to central crest.

*Figure 36: Failure of seaward slope, underlayer visible and several perched stones, Station 50+85.*

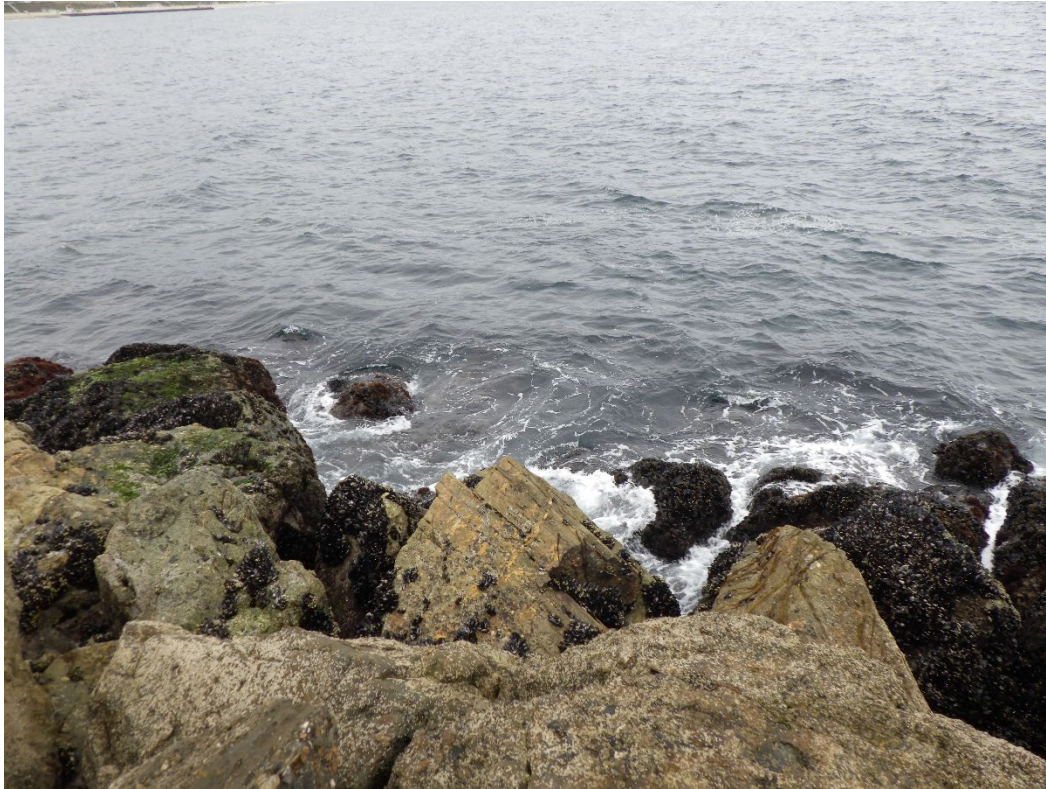
*Figure 37: Separated armor stone at waterline, seaward radial of head section.*

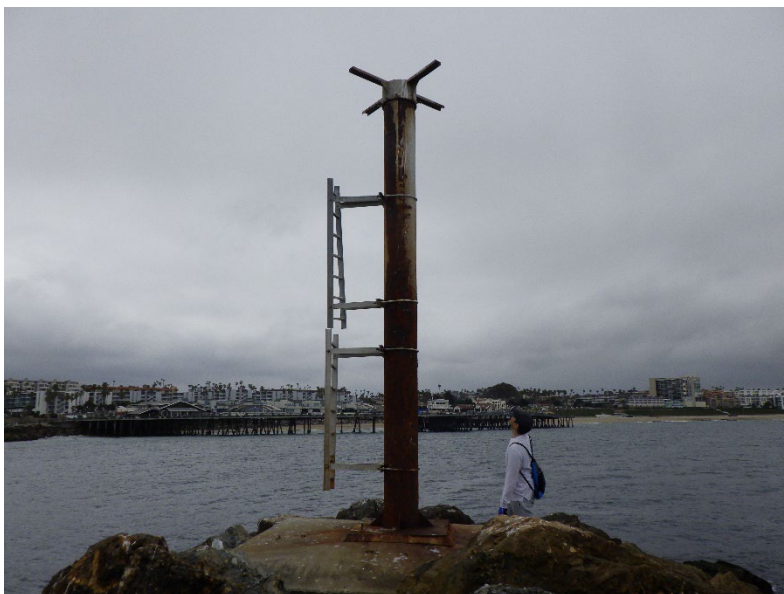
51+00	Condition 3. Missing several stones on seaward slope, shoulder is intact and well interlocked but missing layer of stones on seaward slope. Damage extends from waterline to shoulder and from 51+50 to navigation aid on seaward side.
Navigation Aid	The navigation aid is missing. The pedestal is showing a significant amount of rust but the actual navigation aid on top is gone. Base is in good condition but has some spalling and cracking around the edges. Grouting underneath the pedestal is beginning to spall.
Head Section	Condition 1. Two separated stones at the waterline along the seaward radial and one missing stone missing along central radial. Minor loss of interlock.

*Figure 38: North breakwater navigation aid missing.*

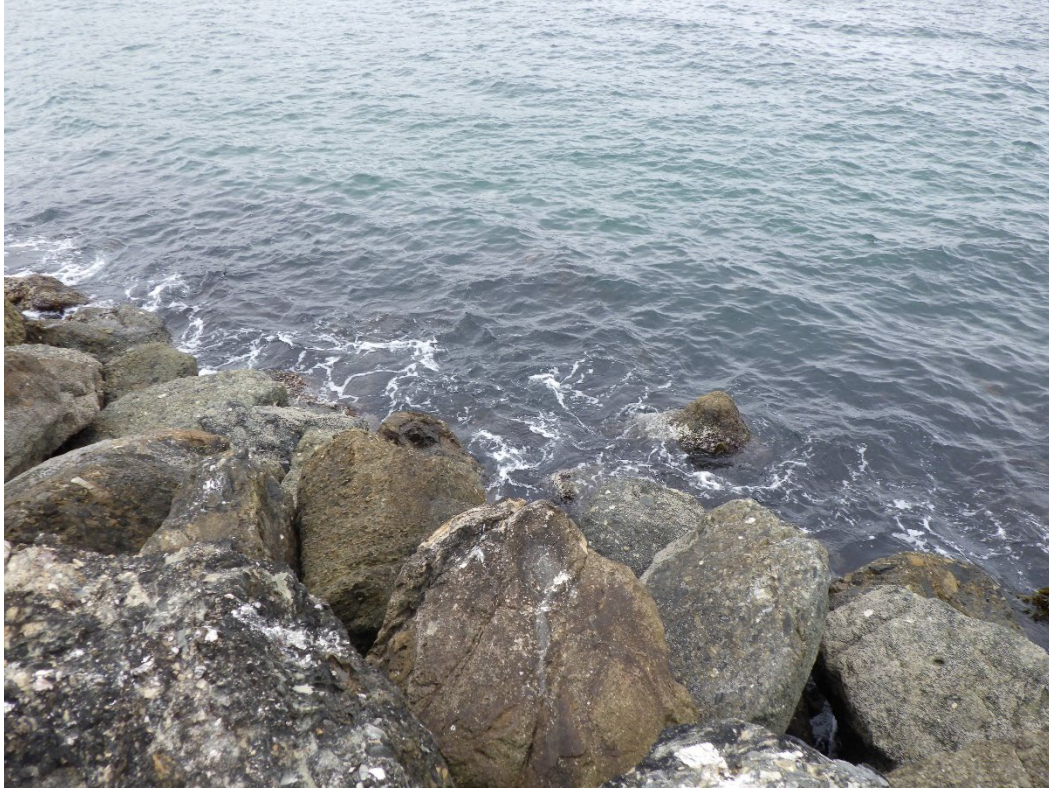
*Figure 43: Displaced stone at waterline, loss of interlock on seaward slope, station 3+60*
