## MEMORANDUM FOR CESPL-PM-N

SUBJECT: 2023 Redondo Beach King Harbor Structure Condition Inspections

Redondo Beach King Harbor  
2023 Condition Inspection  
Field Notes

### Redondo Beach King Harbor June 2023 Condition Inspection Structure Photographs

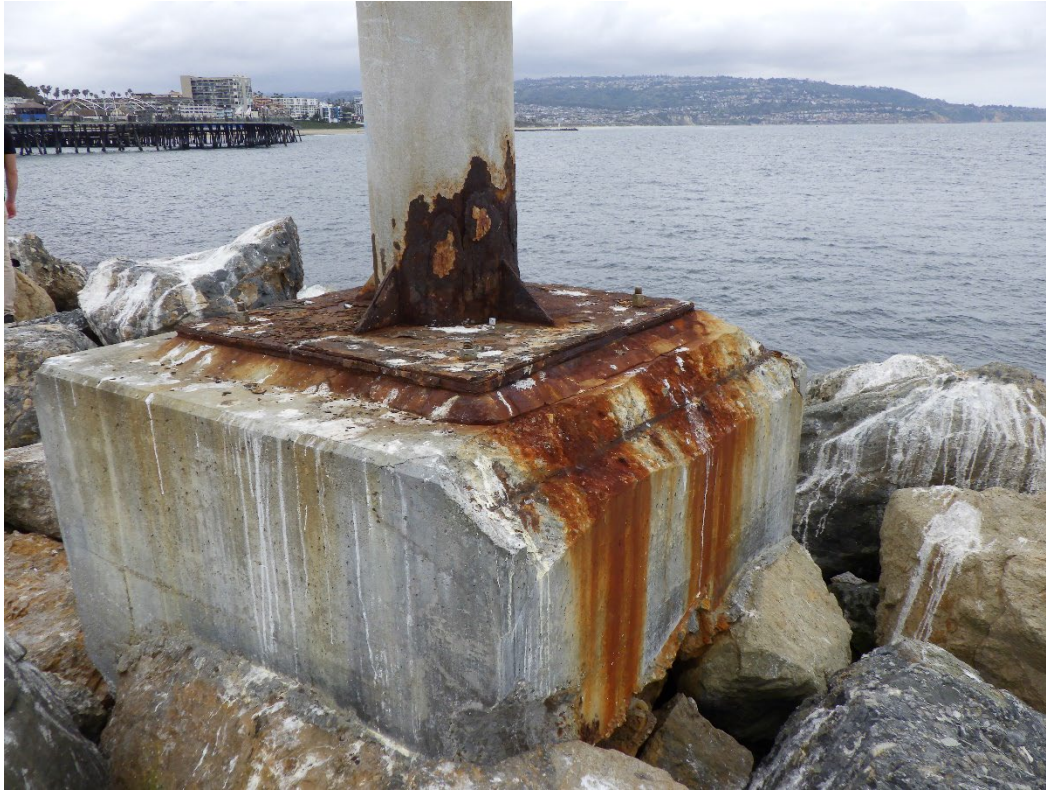
*Figure 47: Rust at bottom of navigation aid pedestal and spalling on concrete base.*
