1974 30' Seaway Lobster Vessel

"CF 5609 TM"

The Findings & Recommendations section is only one section of the "CF 5609 TM" survey report. If received independently, this section should not be mistaken as this vessel's full survey report. **PLEASE BE ADVISED THAT SOME DEFICIENCIES, OBSERVATIONS, AND SUGGESTIONS MAY ALSO BE CONTAINED IN THE BODY OF THE REPORT.**

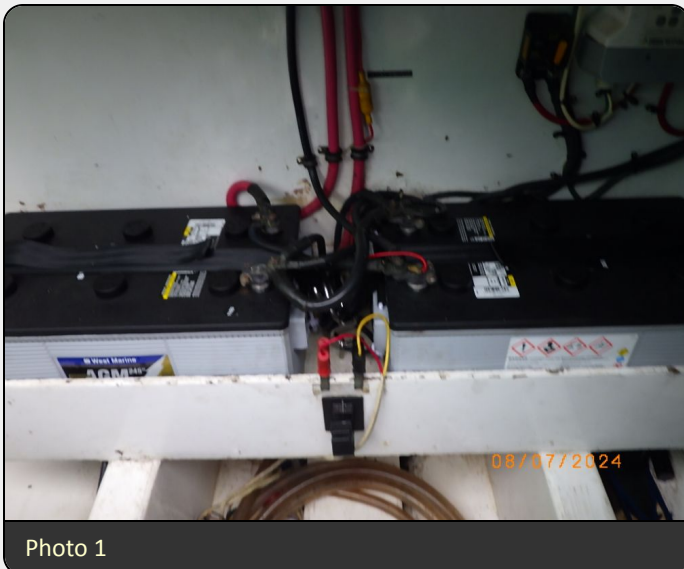
FINDING A-1 BATTERIES

The positive battery terminals did not have protective insulation covers installed.

Install protective terminal insulation covers to prevent accidental shorting or sparking, as necessary.

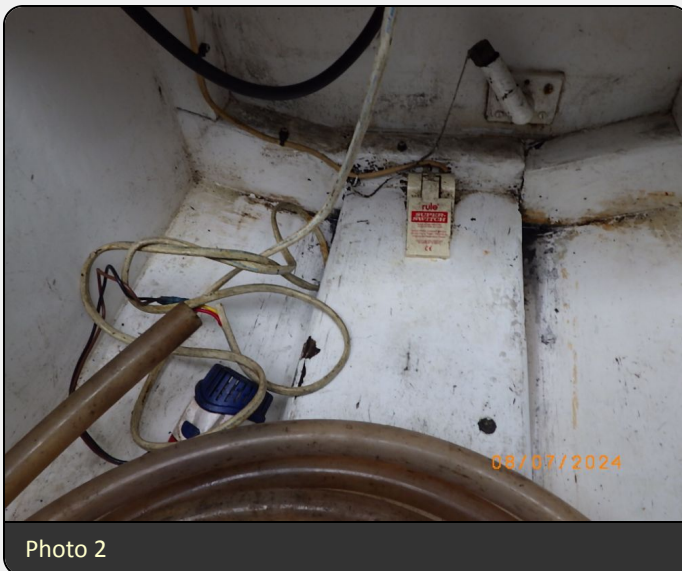
Photo 2

FINDING A-5 ELECTRIC BILGE PUMPING SYSTEMS

The bilge pump was adrift, not plumbed, and non-functional.

Investigate further/trace, and service, repair or replace as necessary.

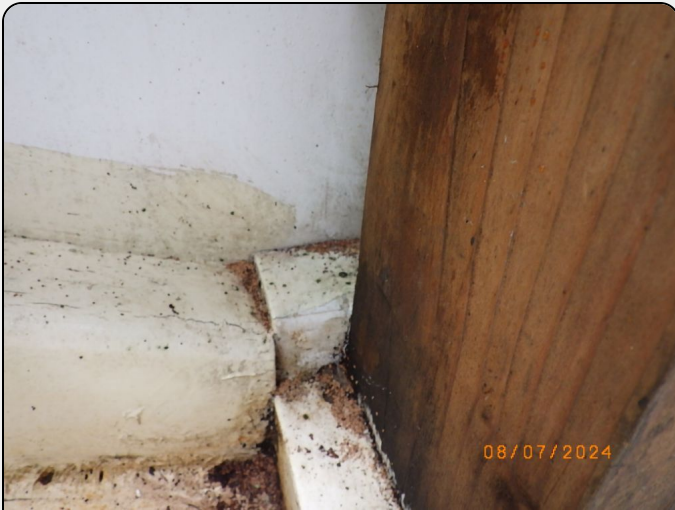
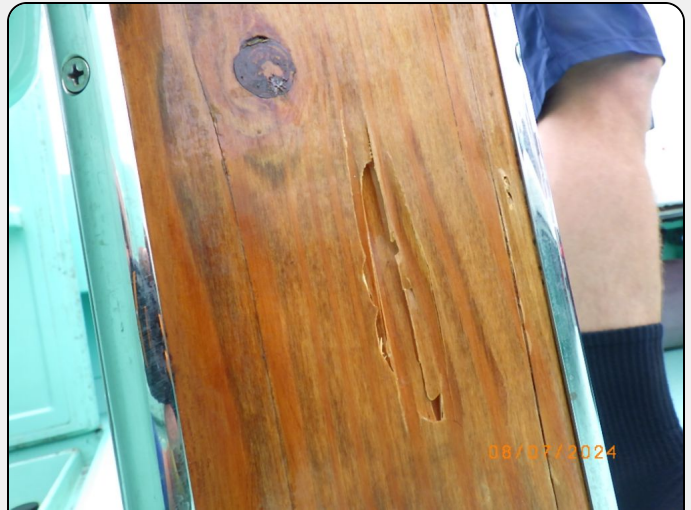
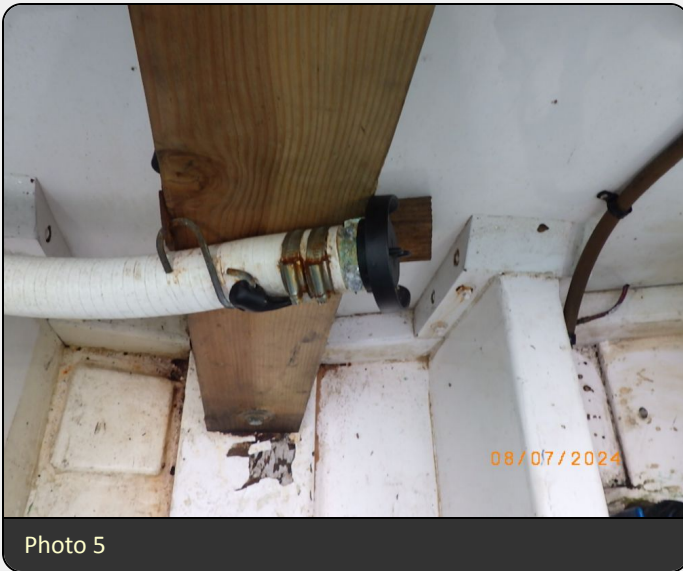
B: SECONDARY PRIORITY / FINDINGS NEEDING TIMELY ATTENTION**FINDING B-1 EVIDENCE OF INSECTS**

Evidence of Termites at the Sampson post.

Employee a pest control specialist to further evaluate the condition and eradicate the infestation as necessary.

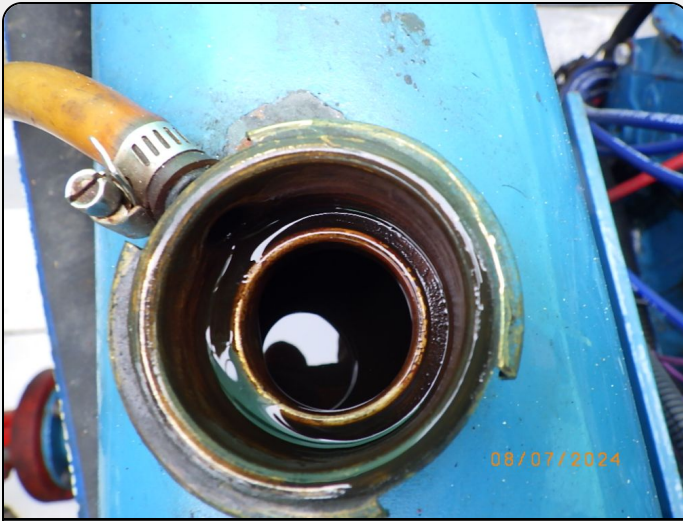
Photo 6

FINDING B-2 MAIN ENGINE COOLANT LEVEL

The port engine Coolant Recovery Expansion tank's level was empty and the header tank was low approximately 1"

Service the cooling systems, as necessary.

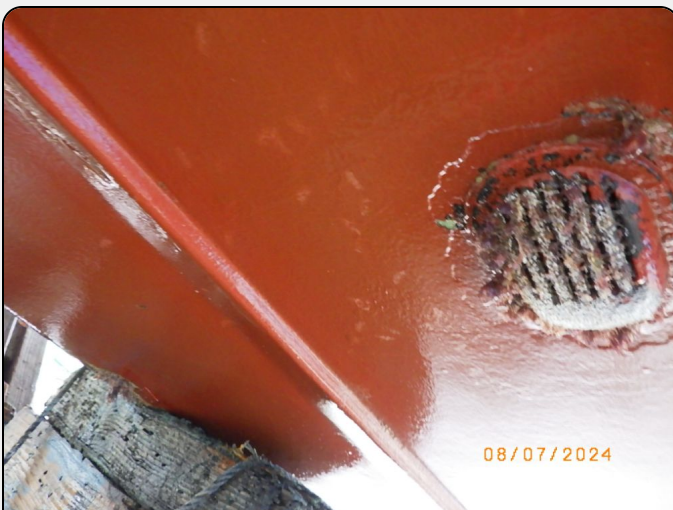
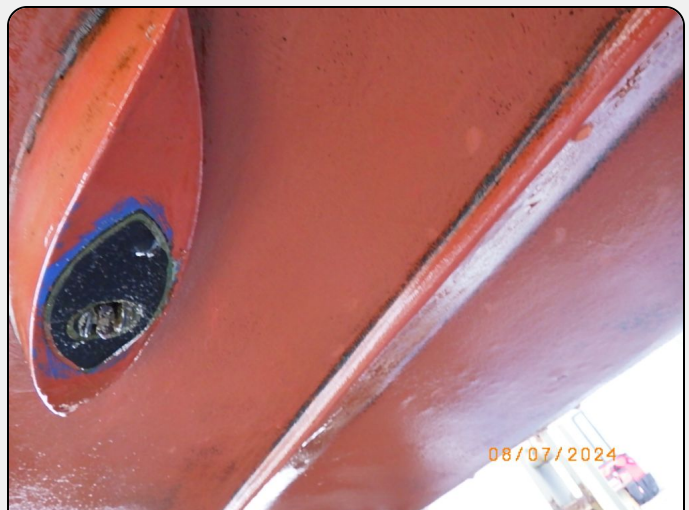
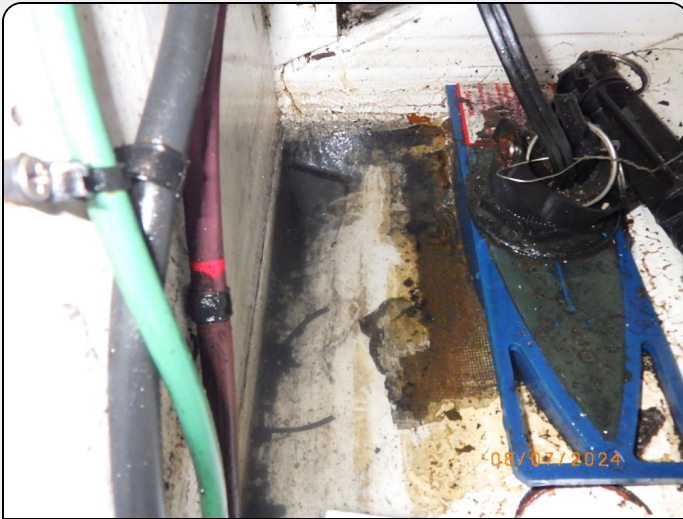
FINDING B-3 PERCUSSION SOUNDING

Anomalous percussion hammer sounds were observed inboard of the port engine raw water intake thru-hull and inboard of the depth transducer.

The sounding inboard of the port engine raw water intake appears to be the plywood having water in it. - Monitor and repair if delamination occurs.

The sounding inboard of the depth transducer indicates some softening and delamination of the core. - Repair according to good marine practices.

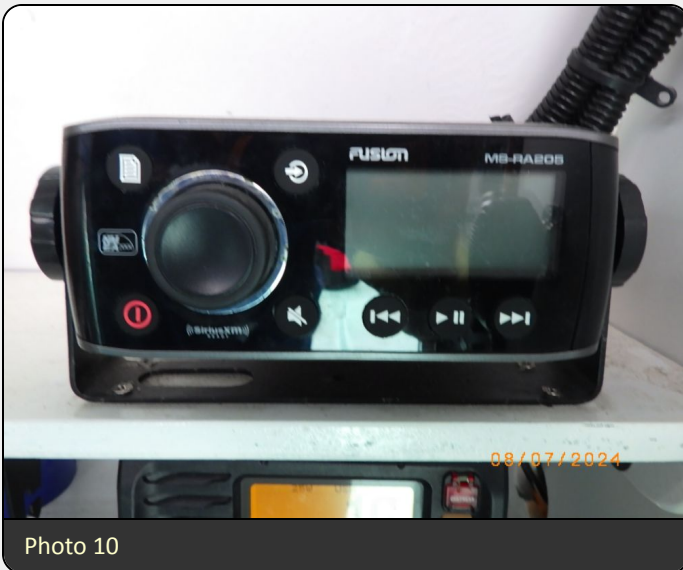
Photo 10

FINDING C-1 STEREO SYSTEM

The volume control malfunctioned when testing the stereo.

Investigate further/trace, and service, repair or replace as necessary.

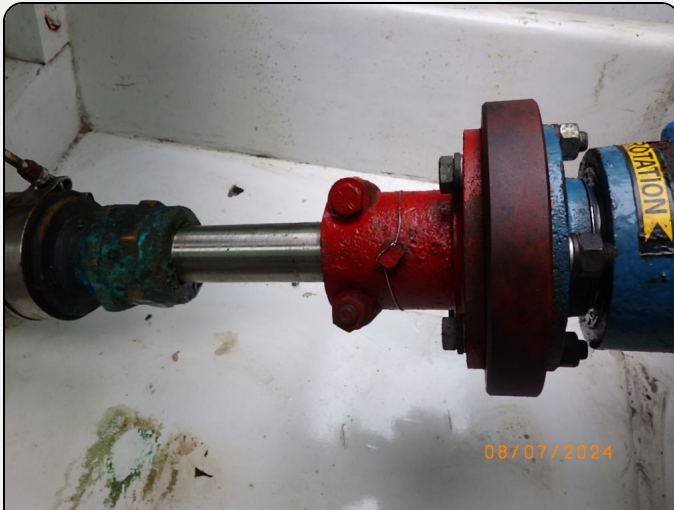
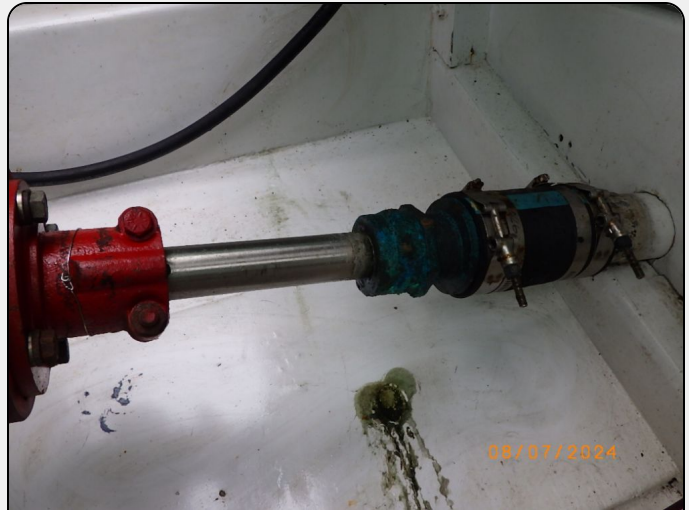
FINDING C-2 PROPELLER SHAFT PACKING GLANDS

Both of the propeller shaft's packing glands leaked excessively.

Properly adjust or repack the glands as needed to restore an appropriate drip rate.
