## MILLS ACT SUBMITTAL

216 N. Catalina Avenue  
North Catalina Historic District

Two-Story Apartment Building  
And Two Cottages

**216 N. Catalina Avenue – Front Building**

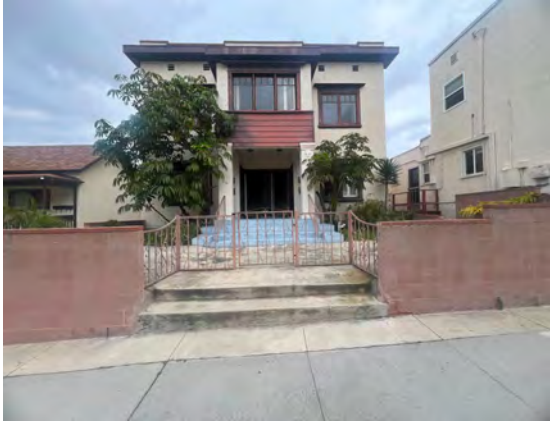
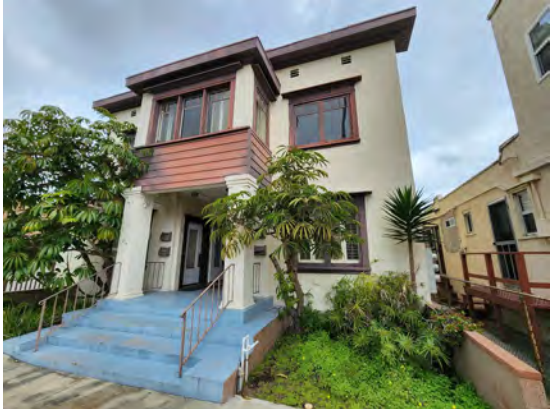
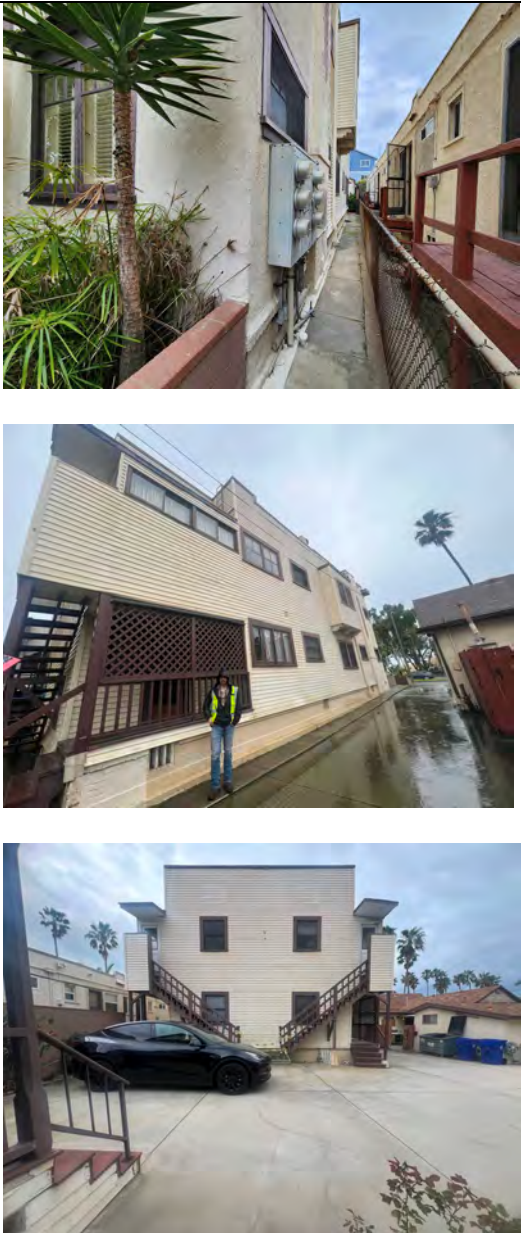
FEATURE	LOCATION/DESCRIPTION	CONDITION	TREATMENT	PHOTOGRAPHS
Sitework	A short concrete block wall fronts the sidewalk with a central set of steps up to the higher grade. The front yard consists of concrete paving with two small areas for planting against the front facade on either side of the entry porch. There is a concrete walk on either side of the building to the back of the building where there is a large concrete paved area. The driveway from the street is part of the adjacent parcel. There is a gate at the front stairs from the sidewalk. There is a separate set of stairs leading up to the paved covered porch at the front entry porch.	The paving is inadequate condition with a few cracks. The concrete paving in back is heavily stained with areas lifted at cold joints.	Paving should be cleaned and repaired and where necessary re-done. Front yard paving can be altered without affecting historic features. New compatible paving can be provided behind the building

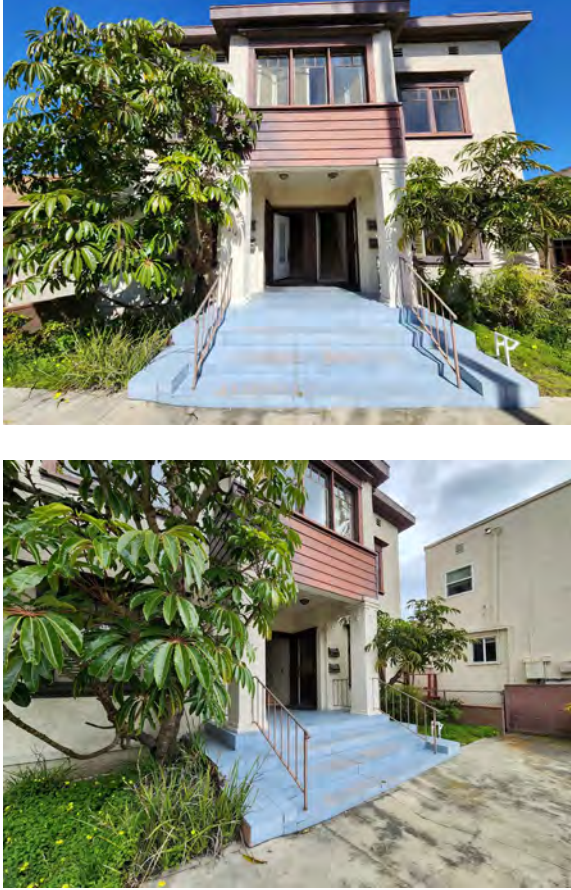
Landscape	<p>The front yard is primarily paving with planting areas on either side of the entry porch. There is a small tree on the south side of the entry and a larger tree on the north and low ground cover at both areas. There is no other landscape on the parcel except the un-planted area at the back of the parcel.</p>	<p>Plantings are untrimmed and too close to the front elevation that can allow moisture to accumulate. The larger tree obscures part of the front facade .</p>	<p>Existing plantings directly adjacent to the residence should be removed or trimmed. ped. Added irrigation may help in maintenance. The larger tree should be significantly trimmed.</p>

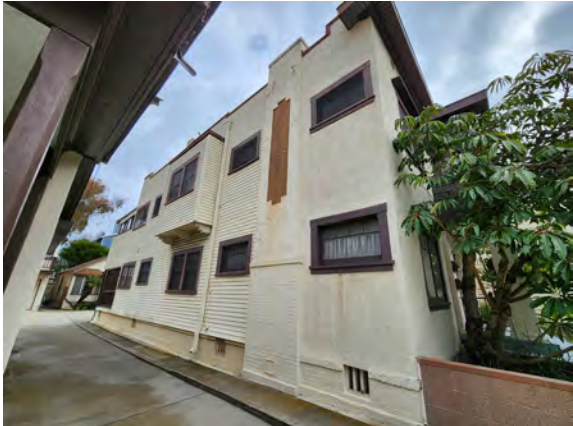
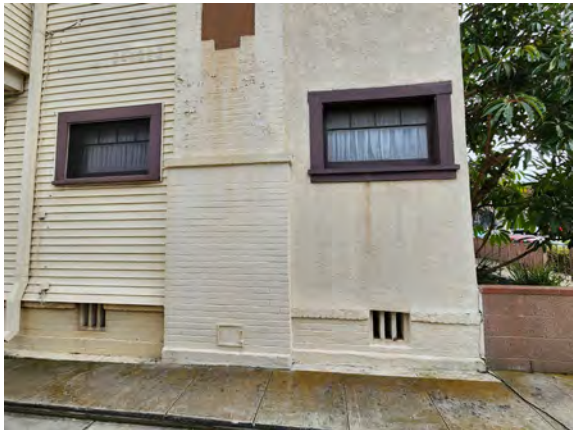
Foundations/ Structural	The residence has typical continuous perimeter footings and internal piers for support of the wood frame structure. From the exterior the lower wall support is brick or has brick cladding. The wood supports viewed above the ceiling appear to be full dimension lumber.	There is no significant cracking in the foundation or building. There may need to be additional review of underfloor	A structural engineer should review. Additional seismic strengthening, may be recommended and any unsafe seismic condition should be strengthened including review of attachments of the wood frame to the footings.

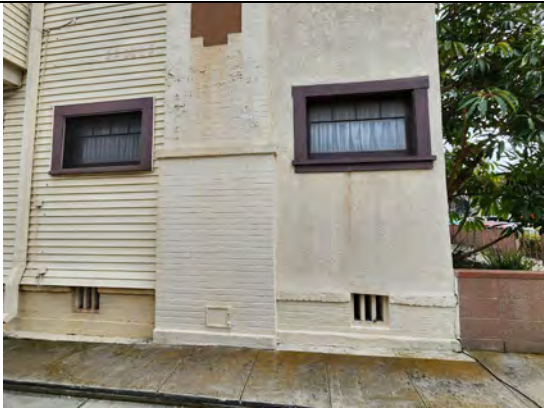
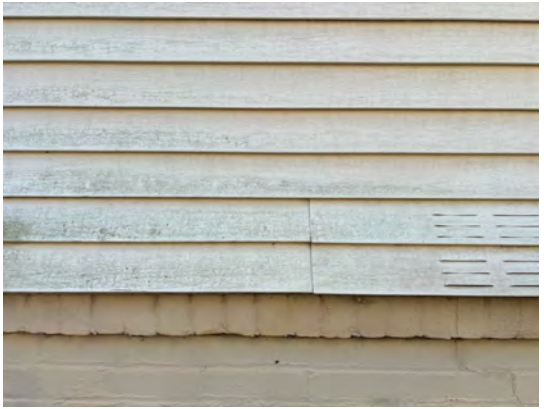
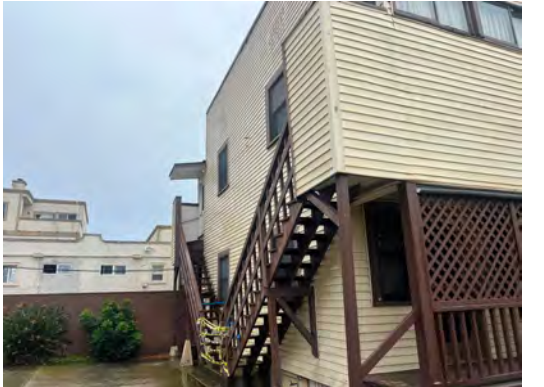
Siding	<p>The building originally had wood siding but that was covered with simulated wood vinyl siding in 1985. The siding starts from the brick chimneys on either side and then wraps the entire building other than the area at the front façade that is now plaster.</p>	<p>The siding appears in adequate condition although soiled. There are no obvious major detachments</p>	<p>The vinyl siding can be cleaned as well as prepped and painted. During the process the attachments should be confirmed as well as connection at top of parapet.</p>

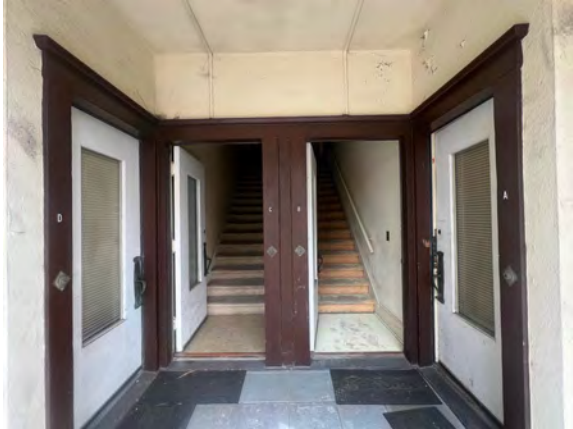
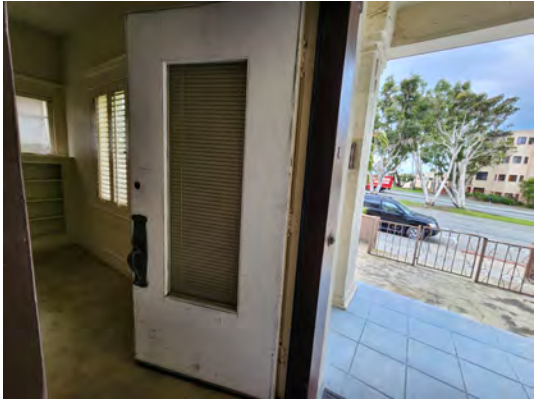
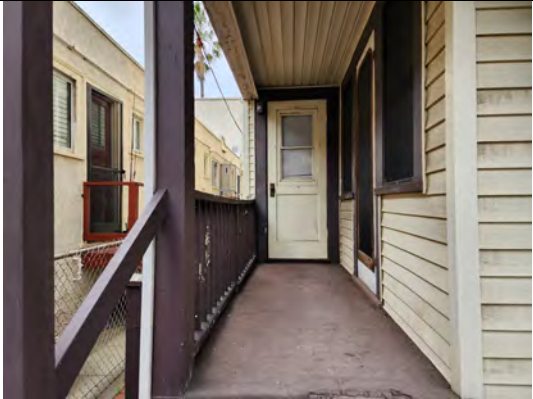
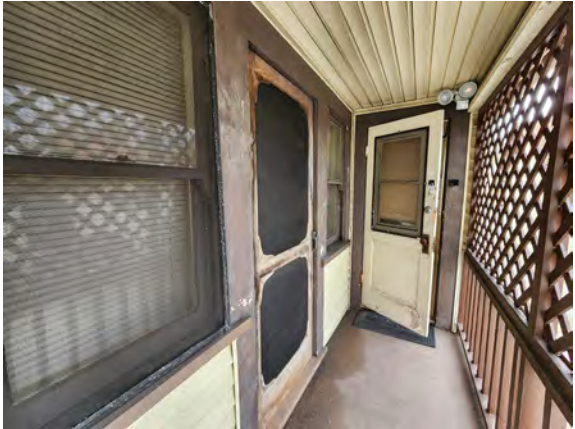
Wood doors	Exterior doors are primarily wood frame with a panel of glass. The doors have extra wide stiles at the front entry. The other entry doors are typical wood doors from pre-1940's residences.	The entry doors are mostly intact although showing years of deferred maintenance and should be preserved where possible, especially the front entry doors.	Doors should be evaluated for repair and rehabilitation. Fully damaged doors can be replaced with new doors with matching profiles. Doors should be prepped and painted on a regular basis.

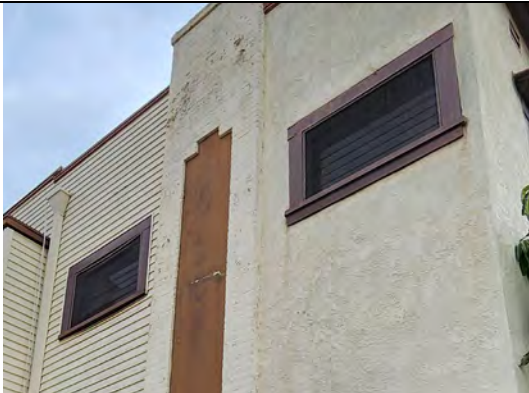
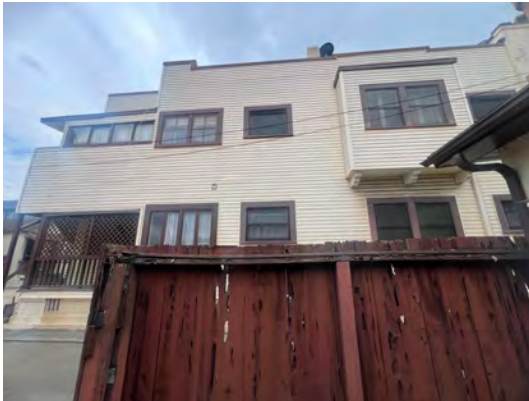
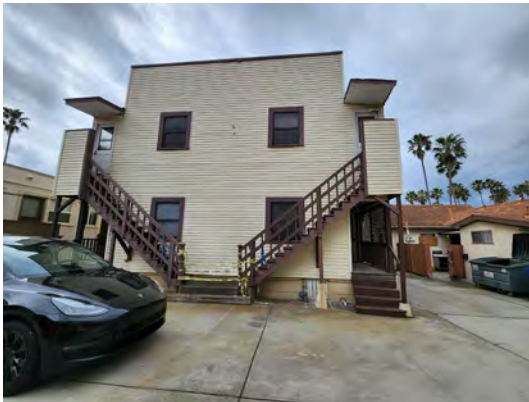
Windows	Many of the windows are original wood windows both double hung and in the front elevation are casement windows with added subdivisions across the top of the sash. A number of windows along the side elevations were replaced with jalousie windows.	Existing windows are in need of refurbishment. Window hardware is missing in places. Replacement jalousie windows are not secure.	Wood windows should be maintained to preserve the wood and avoid water intrusion into frames and walls. The wood windows should be carefully maintained with regular schedule of prep and paint. Ongoing window maintenance programs may consider replacements of the jalousie windows to match original wood windows. Window operation should be reviewed and rehabilitated as needed.	     
---------	---	---	---	--

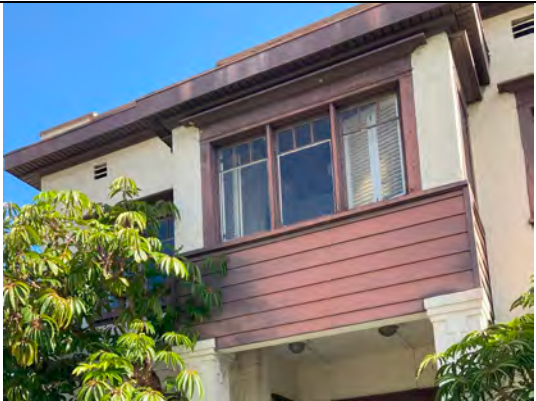
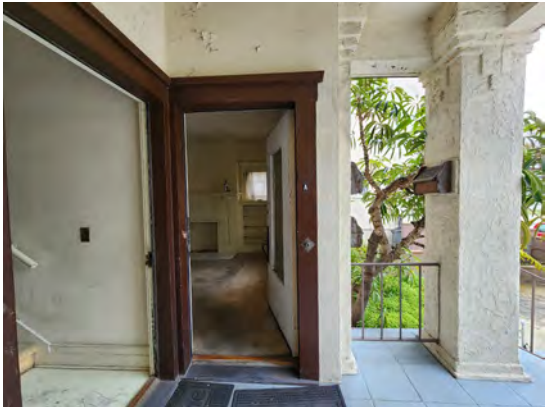
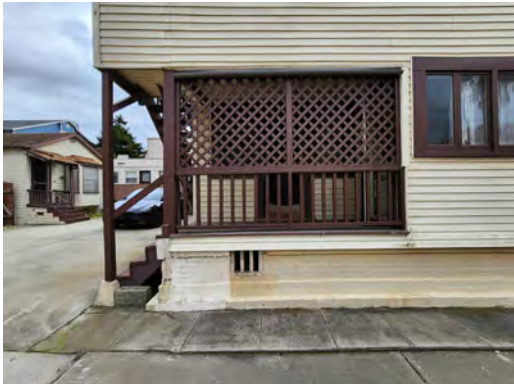
Wood trim and rails	<p>The only remaining wood siding is on the projecting room over the entry porch. The windows all have wood frames and trim with special wood trim on the front facade windows. There is wide wood trim around the doors at the main entry as well as incidental wood trim around the building. At the rear of the ground floor are entry areas with wood railings.</p>	<p>The wood siding and trim all show deferred maintenance.</p>	<p>The wood siding and trim need regular cycle of prep and paint.</p>

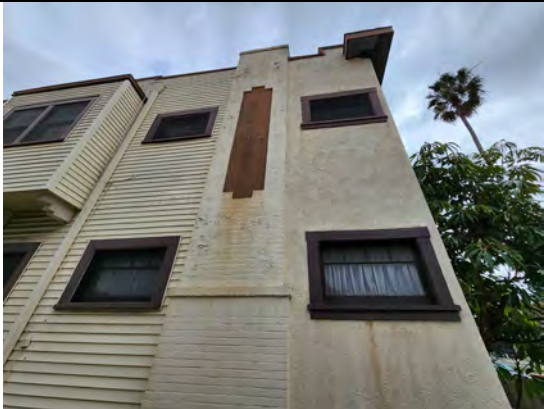
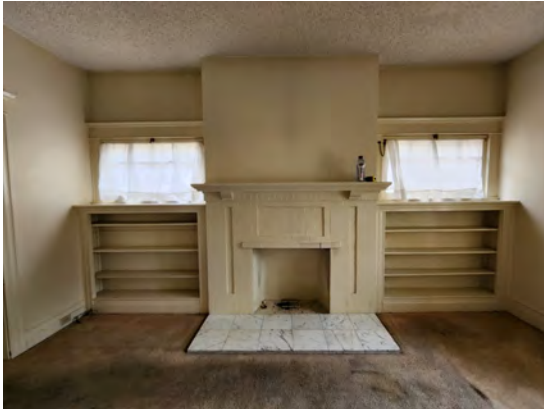
<p>Brick chimney and chimney caps</p>	<p>The fireplaces stack on both sides of the building and create a vertical brick expression on either side of the building</p>	<p>The brick chimneys appear in relatively good condition with no major cracking evident. The chimney flues however have not been specifically reviewed for damage.</p>	<p>The flue should be examined via camera for damage and the chimney caps should be reviewed for attachment. The natural brick recess on the painted chimney should be preserved.</p>

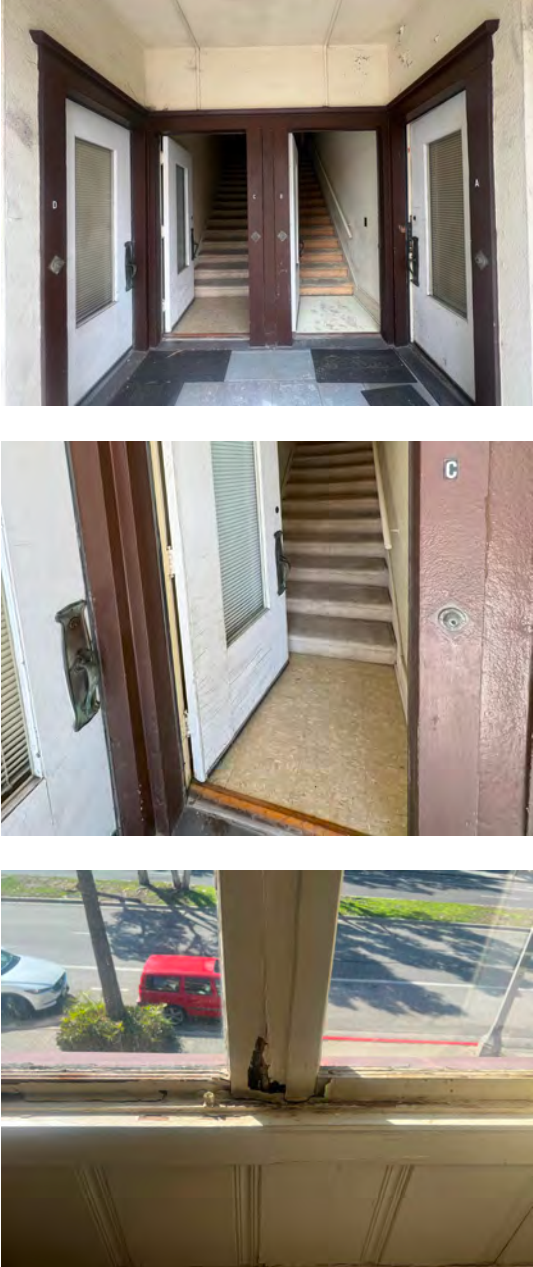
Hardware	There are numerous older pieces of hardware throughout the exterior door and window openings. The front entry door appears to have original or near original hardware.	The front door handle is in satisfactory condition. Window and door hardware elements are missing in places.	The front door hardware should be reviewed and refurbished. Existing hardware should be repaired and refurbished as much as possible. Replacement hardware for windows and doorways should be selected to maintain consistency and compatibility. Window hardware should be reviewed for function and replaced with compatible as needed

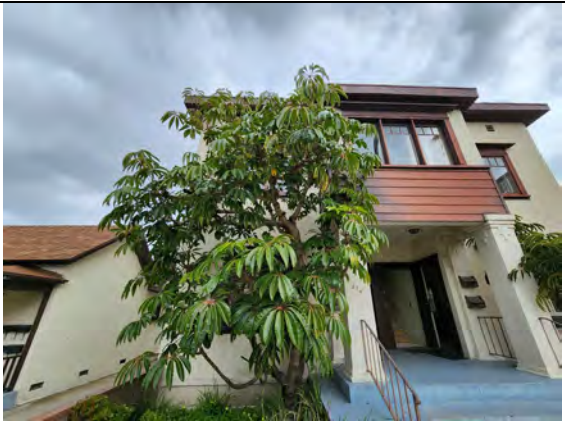
Exterior Lights	There are minimal exterior lights at this building. There is a ceiling mounted porch light at the main entry porch and small light fixtures within the porches at the rear of the building	The exterior lights are in satisfactory condition although they may need re-lamping or replacement with compatible	Existing porch lights can be re-lamped for energy conservation if the appropriate bulb is chosen. The older fixtures should be evaluated for new wiring and other upgrades. New exterior lighting can be added for security or lighting in the landscape that illuminates the building and site but should be carefully considered and installed to be compatible

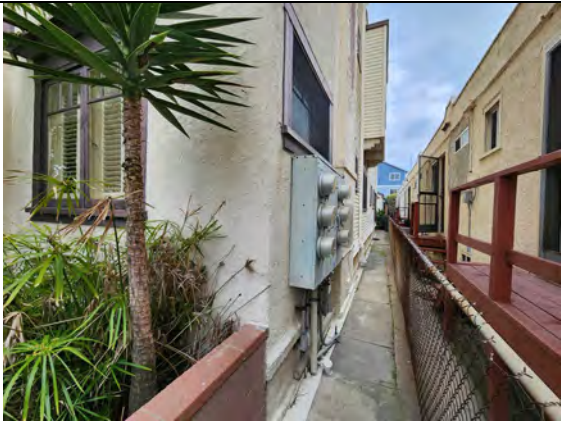
Electrical	The primary electrical appears to have been upgraded in recent years with meters located on the south side of the building near the front.	The electrical meters and service should be reviewed for any needed upgrades.	The electrical service should be reviewed by an engineer. The engineer should review wiring as well as other appropriate upgrades for safety.

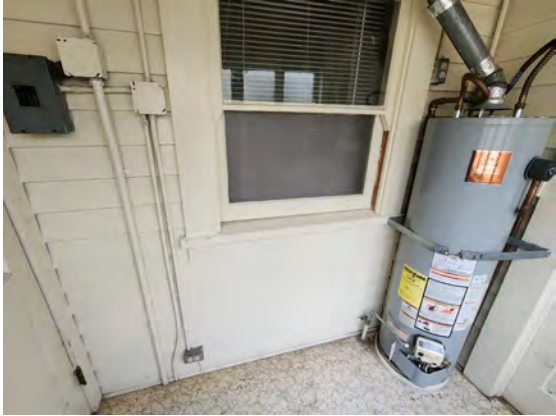
Plumbing	The interior plumbing and underfloor system are partly visible	The plumbing service including sewer has not been investigated. Much of the plumbing throughout the building is likely older piping and may need replacement. .	Plumbing should be reviewed. New service and drain lines may be necessary. Hot water may be switched from gas

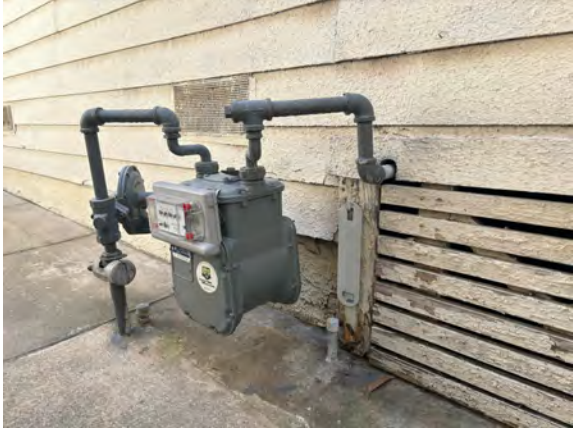
Mechanical/ Heating	There is gas service to the building so that both water and space heating is gas.	The system is currently operable	Mechanical systems including water heating may require update as electrical. Review gas shut off for safety. Humidity should be considered.

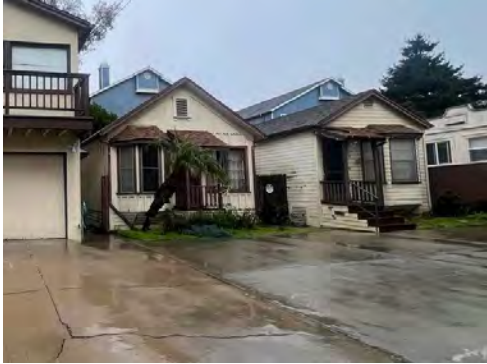
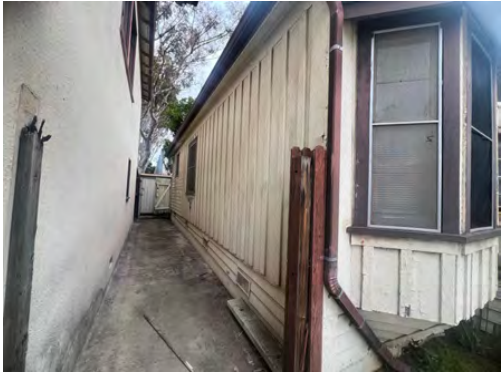
FEATURE	LOCATION/DESCRIPTION	CONDITION	TREATMENT	PHOTOGRAPHS
Sitework	The cottages are sited on mostly flat land with only concrete paving around except behind the cottages	The paving is in adequate condition with a few cracks. The paving in front is stained with areas lifted at cold joints.	Paving should be cleaned and repaired and where necessary re-done. Paving, subject to reviews can be altered without affecting historic features

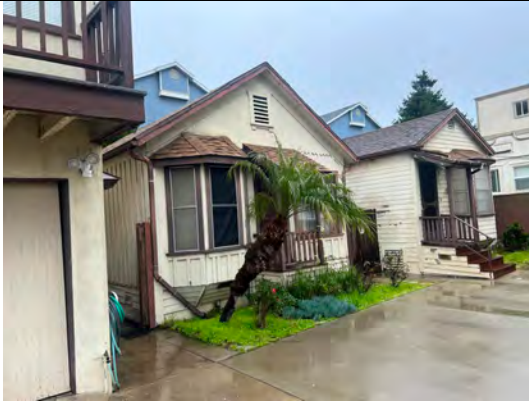
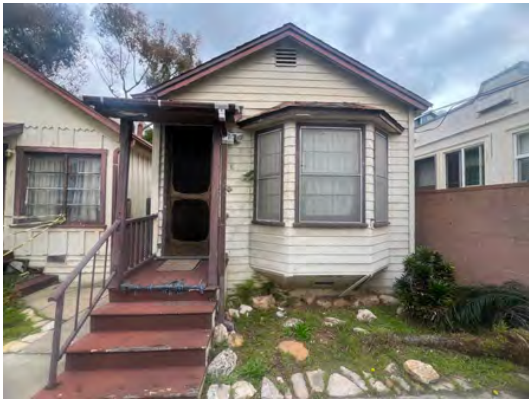
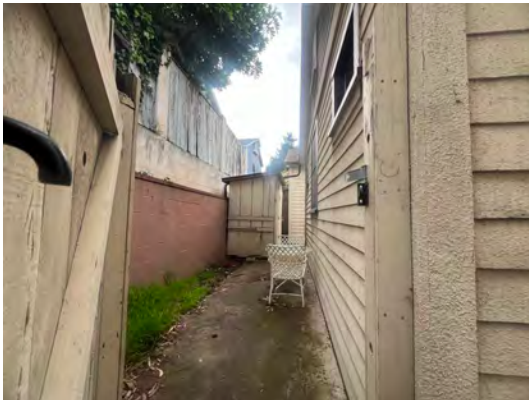
Landscape	There are small area of landscape directly in front of each cottage. The landscape is primarily ground cover with a small palm in front of the north cottage. The rear yards are unplanted.	Plantings may be too close to the front elevation and allow moisture to accumulate.	Existing plantings directly adjacent to the residence should be removed or trimmed. Added irrigation with care not to direct near the building may help in maintenance. The rear yard can be developed with plantings or deck.

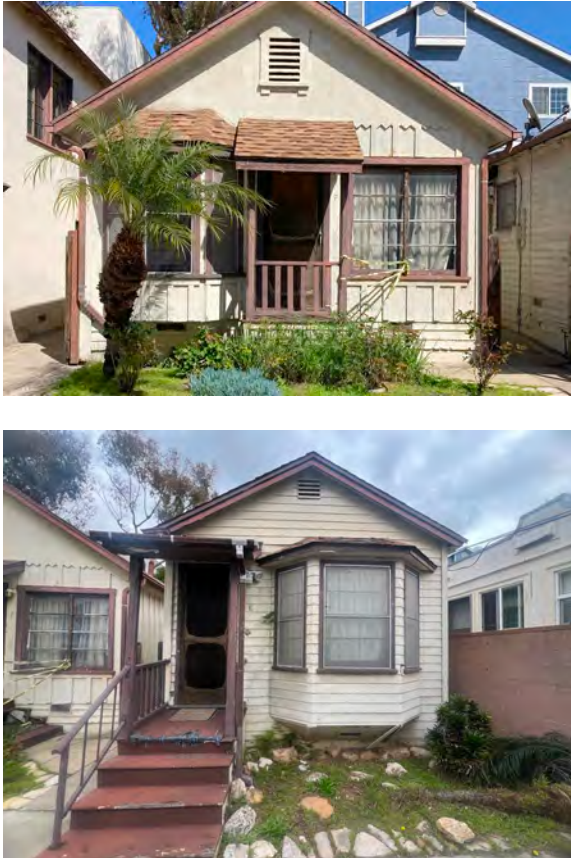
Foundations/ Structural	The residence has typical continuous perimeter footings and internal piers for support of the wood frame structures. There are concrete footings, but little is visible as wood siding finish continues to grade.	The foundations do not show obvious failures. It is unknown if any seismic upgrade.	A structural engineer should review. Additional seismic strengthening may be recommended and any unsafe seismic condition should be strengthened including review of attachments of the wood frame to the concrete footings.	 
----------------------------	---	---	--	---

<p>Entry Porches</p>	<p>Both cottages have wood entry porches extending from the front façade. The northern cottage has steps that turn parallel to the front while the porch on the south cottage is entered straight on with steps that protrude out into the small front yard. There are also minor porches for secondary entry on the side of each bungalow facing the central concrete path.</p>	<p>The porches are in fair condition with the south cottage porch showing significant deterioration.</p>	<p>All of the porch woodwork needs refurbishing and refinishing. Rotted pieces should be replaced with matching. The porch roof on the south is relatively flat and should be reviewed for drainage including front gutter</p>

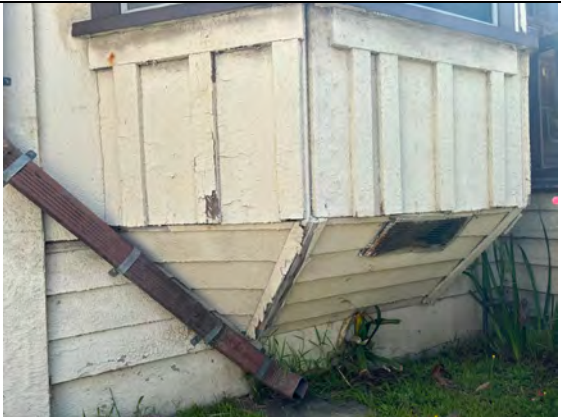
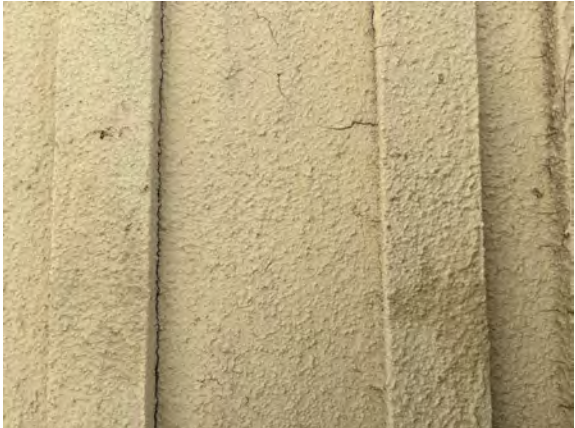
Wood siding	Both cottages are clad in wood siding. The north cottage is a board and batten pattern with a decorative zig zag trim on the front façade while the south bungalow has horizontal siding.	The wood siding is in fair to poor condition in need of refurbishment. A textured paint coating was applied over the siding	Siding needs full treatment of prep and paint. Rotted wood should be replaced with matching pieces. Methods should be tested to determine if textured finish can be removed.	     
-------------	---	---	--	--

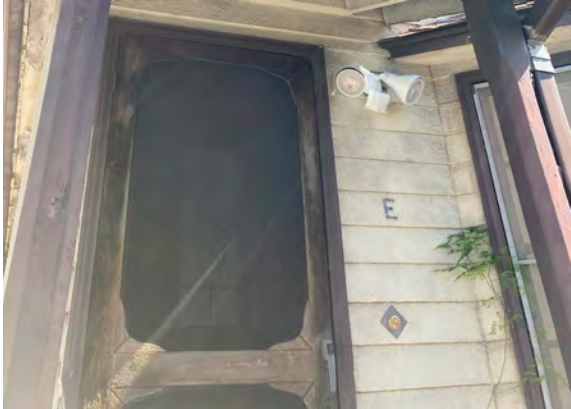
Wood doors	Exterior doors are primarily wood frame with glass insert. They also have a wood screen door that is used across the site.	The existing older doors are mostly intact although showing years of deferred maintenance and should be refurbished where possible.	Doors should be evaluated for repair and rehabilitation where possible. Fully damaged doors can be replaced with new doors with matching profiles. Doors should be prepped and painted on a regular basis. Original hardware that can be repaired should be maintained or as needed replaced with compatible hardware.

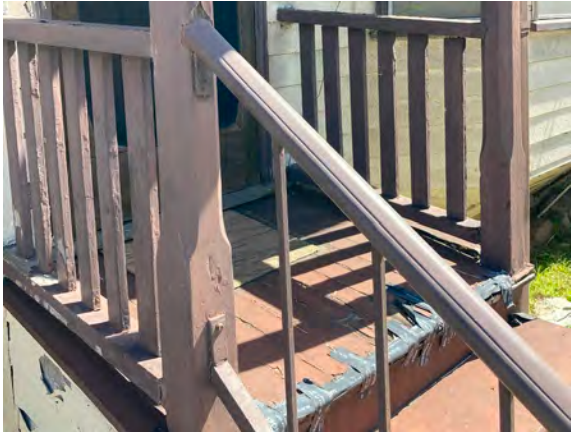
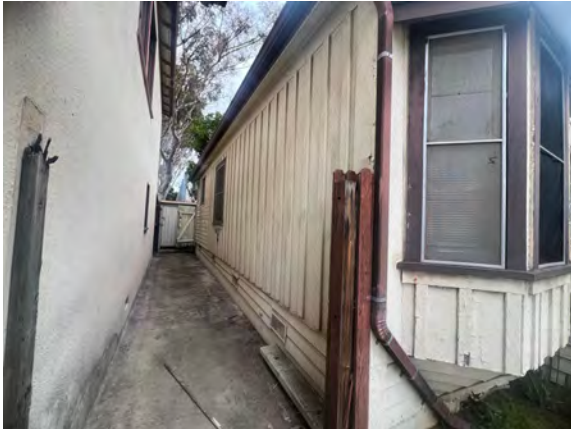
Windows	<p>The majority of openings have wood windows of various types. A few service (bathroom) windows were changed to aluminum sliders.</p>	<p>Existing windows are in need of refurbishment. Window hardware is missing in places. Not all windows provide a tight seal to the exterior. Many of the windows are significantly deteriorated</p>	<p>Wood windows need to be maintained to preserve the wood and avoid water intrusion into frames and exterior walls. The wood windows should be carefully maintained with a regular schedule of prep and paint. Window operation should be reviewed and rehabilitated as needed.</p>	     
---------	--	--	--	--

Wood trim and rails	The wood trim surrounds windows and is located on the front eaves and porch entries	The woodwork is all in need of significant rehabilitation	The wood trim should undergo a full cycle of prep and paint. Rotted and highly deteriorated pieces can be replaced with matching wood.

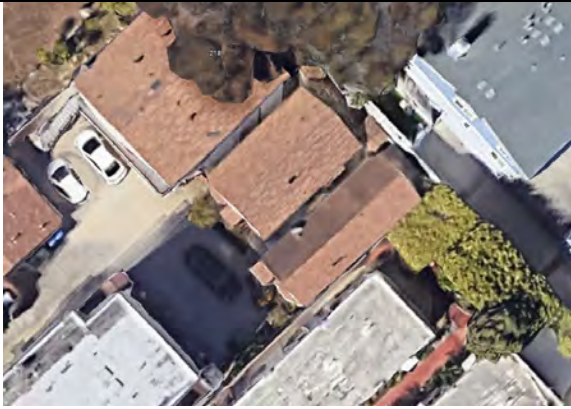
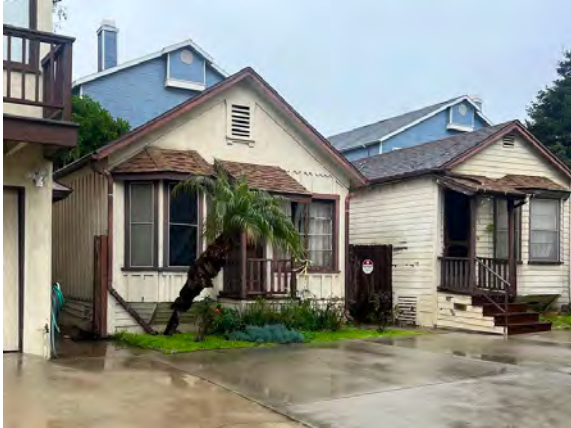
Roofing	The cottages roofs are covered with asphaltic shingles, light brown in color throughout. The roof edge trim is dark brown metal.	The current roofing may be adequate in most areas for the next few years	Roof life cycle should be evaluated. A new roof may be needed over the next years. Any leaks should be identified and repaired expeditiously.

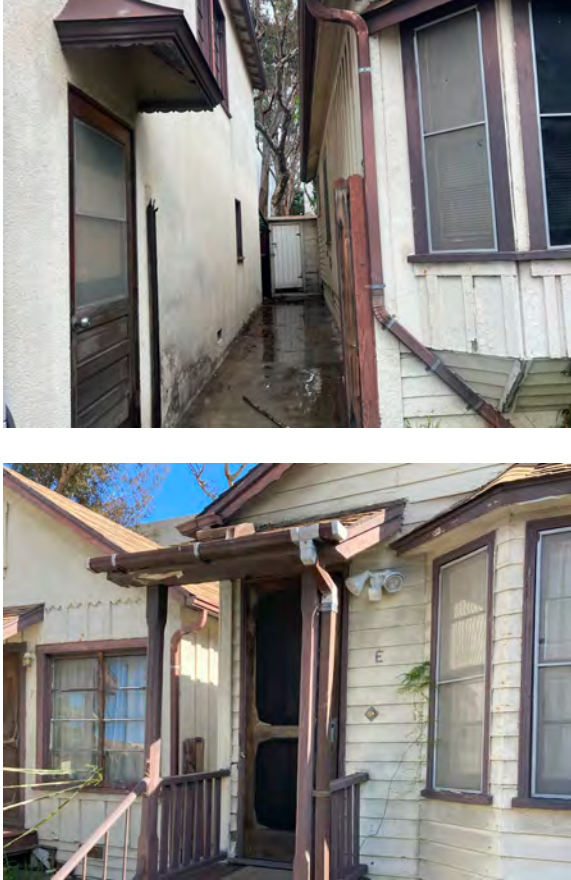
<p>Gutters and Drainage</p>	<p>The gabled roof slopes down to gutters along the sides of the cottages. Downspouts on the north cottage come to the ground right at the front corners of the building with one downspout wrapping into the front landscape. The south cottage has a downspout towards the back and there is no gutter on the south side next to the property line.</p>	<p>The gutters and downspouts are painted metal. They are in relatively poor condition with exposed supports and splices.</p>	<p>Gutters and downspouts should be repaired and painted and where necessary replaced with similar profile gutters. Drainage should be reviewed. The front porch on the south cottage has an unsightly gutter and downspout at the front.</p>

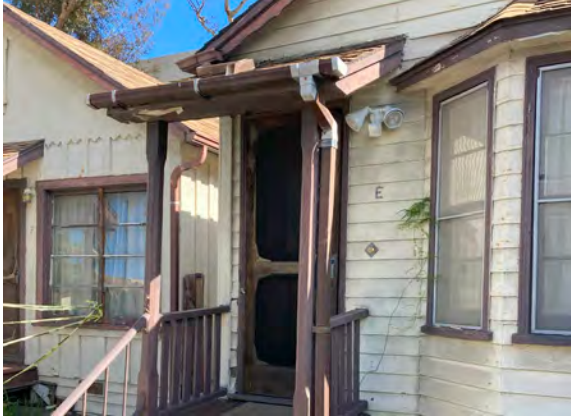
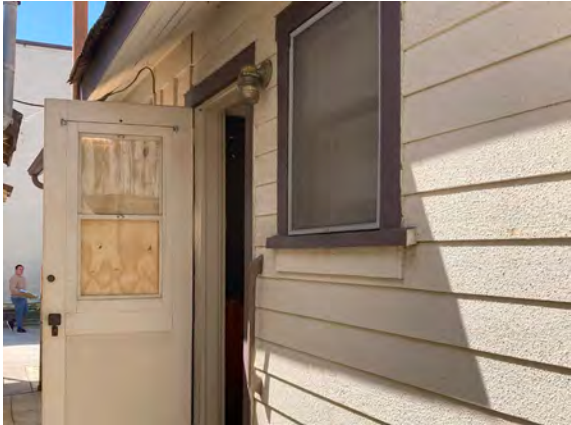
Hardware	Hardware is not original but front doors have older hardware	The front door hardware is in fair condition. Window hardware is missing at some openings.	The front door hardware should be reviewed and refurbished. Existing hardware should be repaired and refurbished as much as possible. Replacement hardware for windows and doorways should be selected to maintain consistency and compatibility.	   
----------	--	--	---	---

Exterior Lights	There are a few exterior lights both security type fixtures with motion detectors and modest porch lights	The lights are in satisfactory condition although they may need reconsideration for appearance as well as re-lamping for energy.	Existing porch lights should be evaluated for new wiring and other upgrades. New exterior lighting can be added for security or lighting in the landscape that illuminates the residence and site but should be carefully considered and installed to be compatible. There is large unsightly fixture at the front porch of the south bungalow

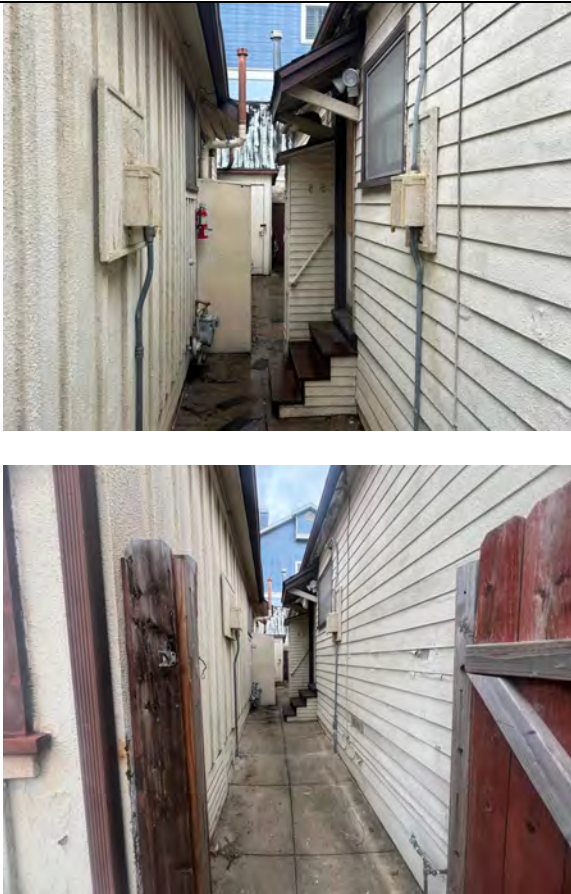
Electrical	The electrical appears to enter the residences in the side walls at the central pathway.	The electrical meters may to be in need of update and other equipment may need upgrades.	The electrical service should be reviewed by an engineer. The electrical service may be in need of update. The structure should be rewired as well as other appropriate upgrades for safety.

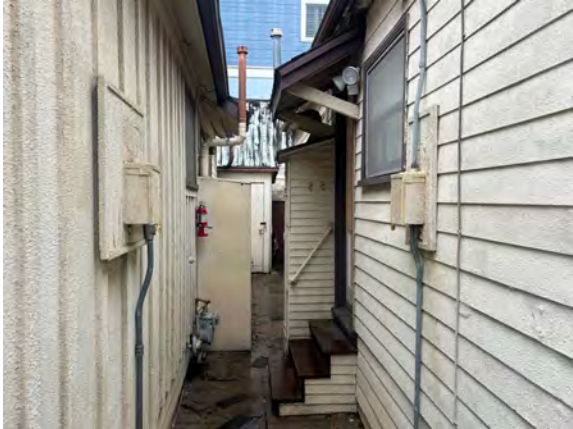
Plumbing	The interior plumbing and underfloor system are not visible	The plumbing service including sewer has not been investigated. Much of the plumbing throughout the house is older piping and likely in need of replacement.	Plumbing should be reviewed. New service and drain lines may be necessary.

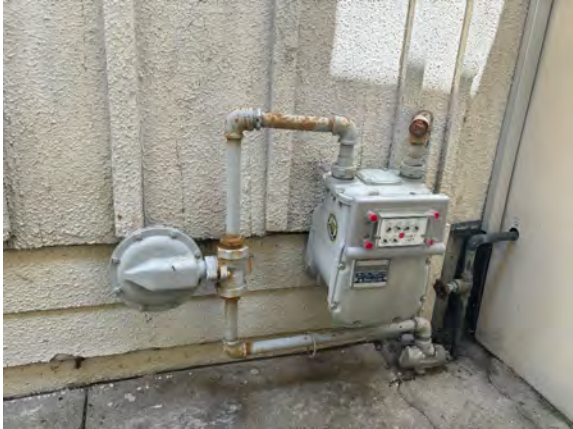
Mechanical/ Heating	There is gas service to the building so that both water and space heating is gas.	The system is currently operable	Mechanical systems including water heating may require update. Review gas shut off for safety. Humidity should be considered.
