MILLS ACT SUBMITTAL

218 N. Catalina Avenue
North Catalina Historic District

218 N. Catalina Avenue

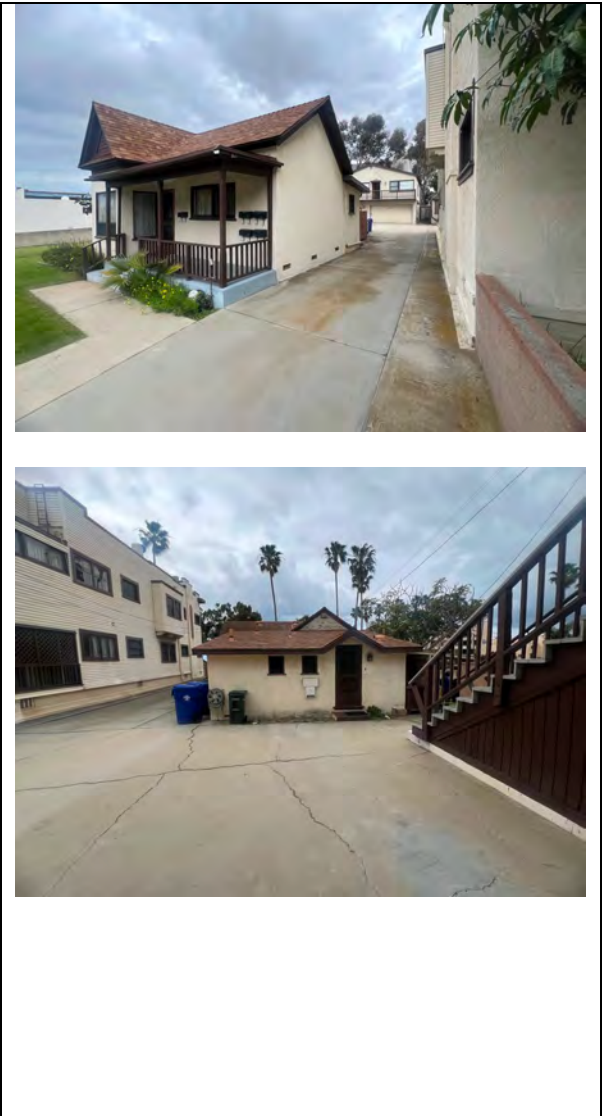
FEATURE	LOCATION/DESCRIPTION	CONDITION	TREATMENT	PHOTOGRAPHS
Sitework	<p>The site is elevated from the street with a low stepping concrete block wall along the sidewalk. There is a short concrete walk along the north side of the concrete driveway that turns perpendicular to reach the front porch steps. The driveway continues around to the paved area behind the residential building.</p>	<p>The paving is in adequate condition with a few cracks. The paving in back is heavily stained and with cracking across the drive.</p>	<p>Paving should be cleaned and repaired and where necessary re-done. Front yard paving can be altered without affecting historic features. Rear concrete can similarly be refurbished or replaced with compatible material.</p>

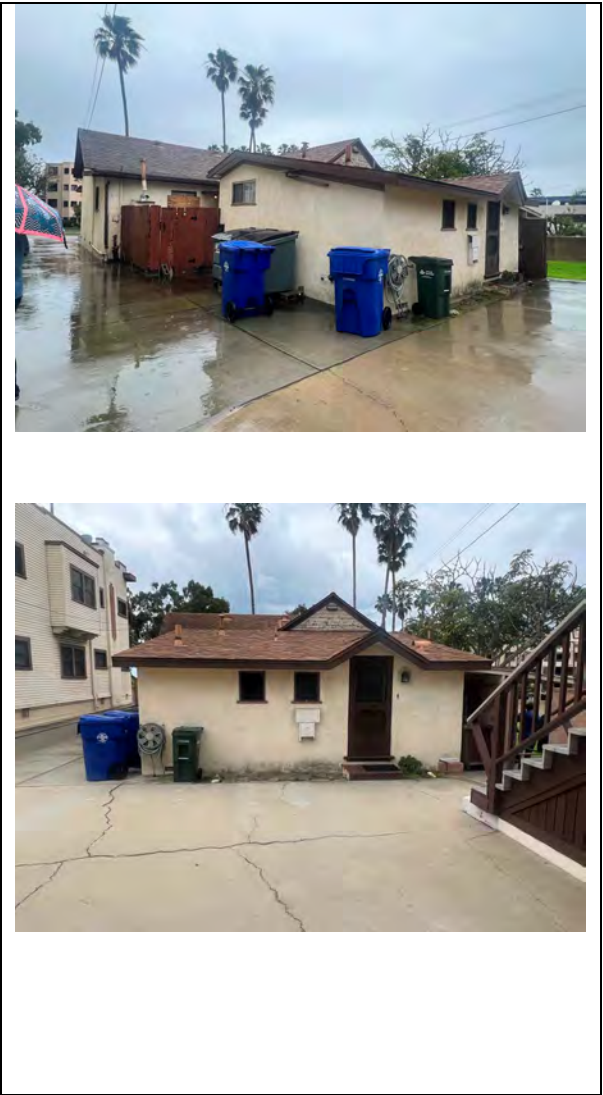
<p>Landscape</p>	<p>The front yard is primarily lawn with small plants against the front façade and a small tree around the northwest corner. There is a thin strip of soil along the back elevation of the residence that is unplanted with a few pavers. There is also an unplanted area behind the rear building that is not easily accessible. The remainder of the site is paved.</p>	<p>Plantings are sparse. A small strip along the rear elevation is barren. The east and north side of the property is otherwise completely paved. The rear yard of the site behind the back building is not landscaped.</p>	<p>Existing plantings directly adjacent to the residence should be relocated or trimmed. The grass lawn will require upkeep. Irrigation should be reviewed</p>	 
------------------	---	---	--	--

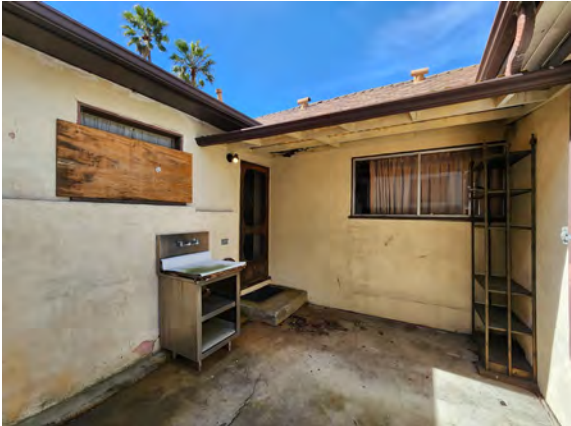
<p>Foundation / Structural</p>	<p>The residence has typical continuous perimeter footings and internal piers for support of the wood frame structure. There are concrete footings, but little is visible as plaster finish continues to grade. although the front along the north especially at the living room has settled substantially Underfloor review may reveal seismic improvements. The rear portion of the residence also appears to have a raised floor but low to the grade.</p>	<p>The foundations do not show significant failures. There is no evident subsidence although the rear portion is close to grade. There is minor horizontal cracking along the top of the foundation in the court area.</p>	<p>A structural engineer should review. Any unsafe seismic condition should be strengthened including review of attachments of the wood frame to the concrete footings. There should be underfloor inspection for potential rotted wood.</p>

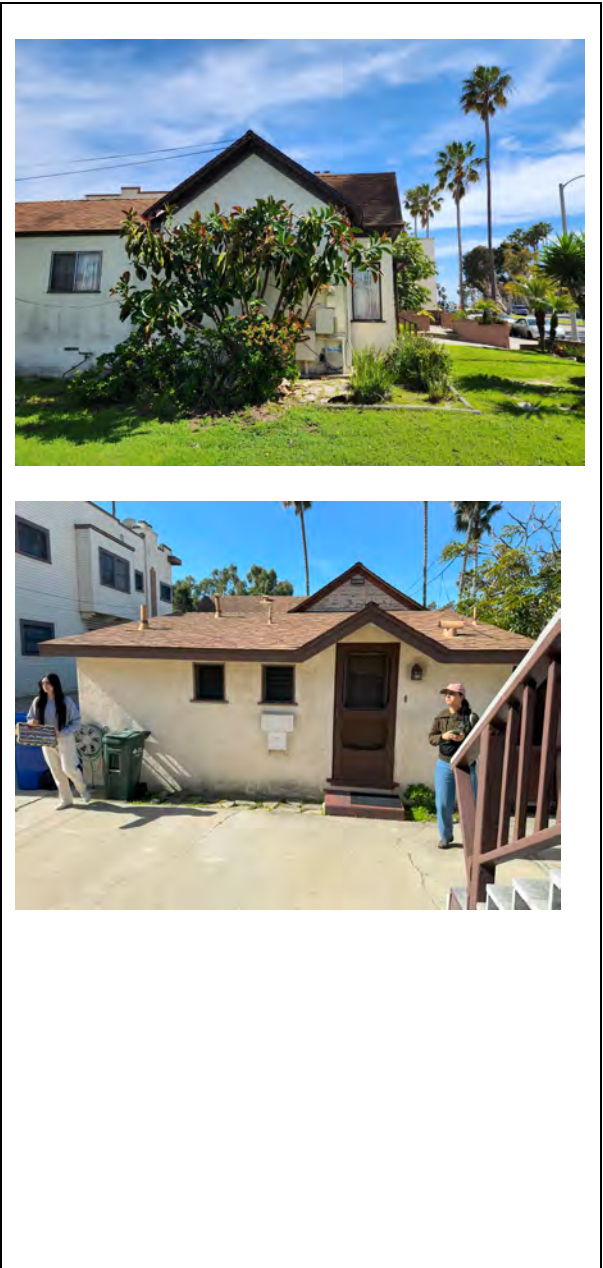
<p>Windows</p>	<p>Most of the windows appear to have been modified or changed over time with aluminum frames and jalousie windows in most locations. There are several horizontal window openings and very small windows for the back portion of the building.</p>	<p>Existing windows are in need of refurbishment. Window hardware is missing in places. Jalousie windows are not secure.</p>	<p>Aluminum window sash may pit near the ocean and where appropriate should be replaced with compatible window types. Window operation should be reviewed and repaired as needed. Ongoing window maintenance programs may consider replacement of the aluminum and jalousie windows for wood windows. Compatible window shapes should be considered.</p>	 
----------------	---	--	--	--

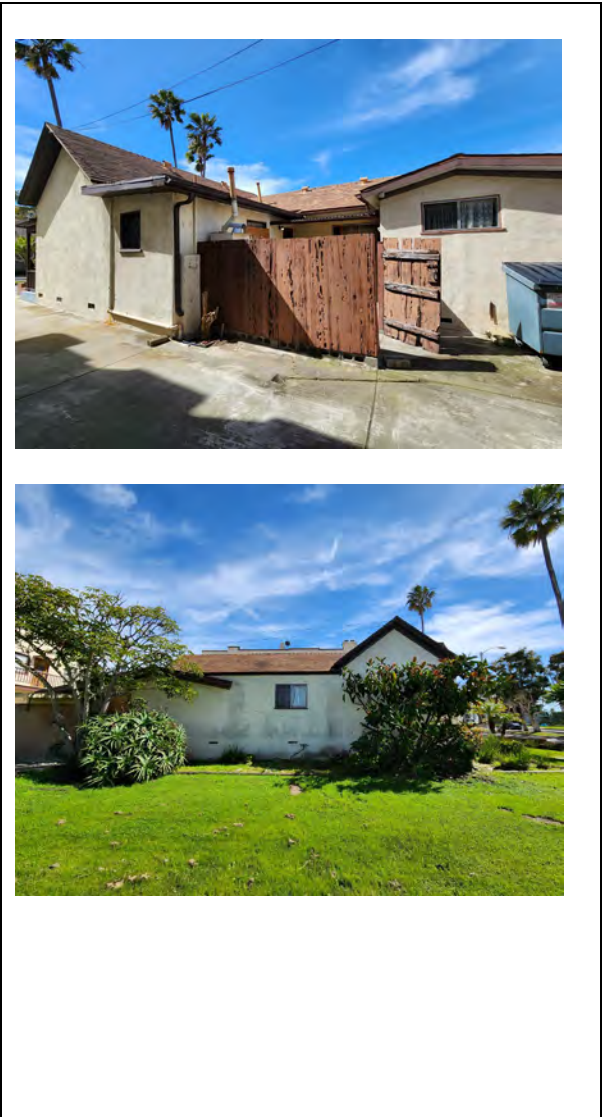
<p>Wood trim and railings</p>	<p>The window openings are generally cased with wood surrounds. The eaves and fascia boards are wood. The front porch is a key feature with wood columns and porch ceiling on the front as well as scalloped shingles in the front facing pediment.</p>	<p>Most of the wood frames appear in satisfactory condition although in need of cycle of care..</p>	<p>The wood details and railings should be periodically refurbished, painted and continually maintained</p>	 
-------------------------------	---	---	---	--

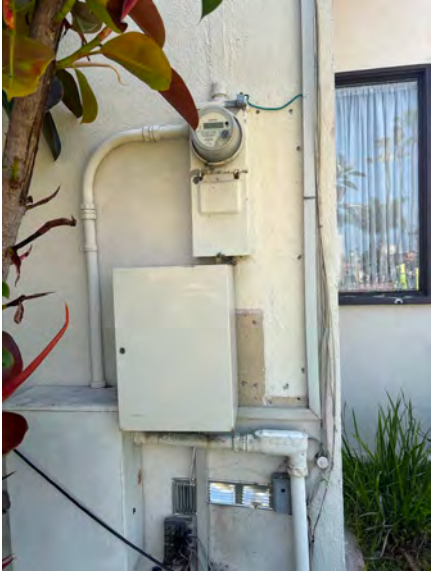
<p>Electrical</p>	<p>The primary electrical is underground to the house.</p>	<p>The electrical equipment and wiring may need upgrades</p>	<p>The electrical service should be reviewed by an engineer. The building should be rewired as needed as well as other appropriate upgrades for safety.</p>

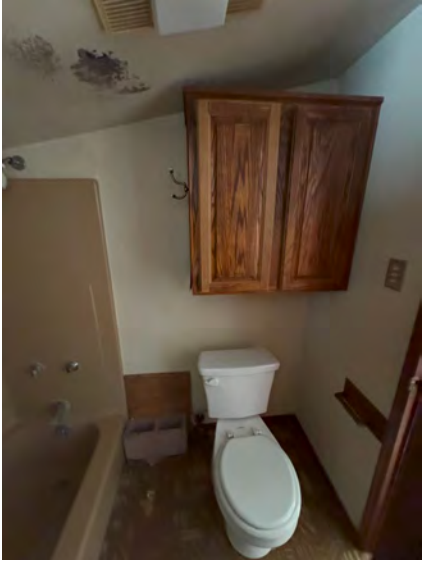
<p>Plumbing</p>	<p>The interior plumbing and underfloor system is dated. The plumbing to the rear bathroom is awkward with a sunken tub</p>	<p>The plumbing service including sewer has not been investigated. Much of the plumbing throughout the house is older piping and may need replacement. The bathroom plumbing is leaking, damaging the finishes and structure..</p>	<p>Plumbing should be reviewed. New service and drain lines may be necessary.</p>

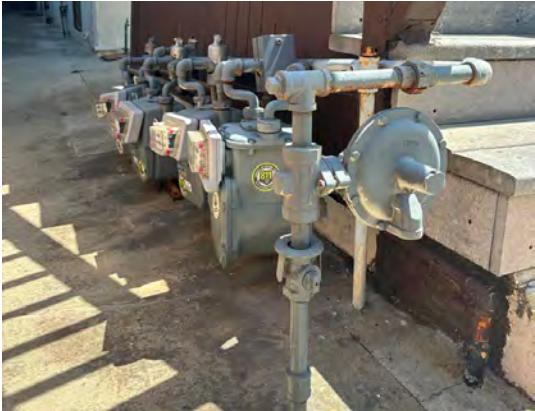
<p>Mechanical and Heating</p>	<p>There is gas service to the building so that both water and space heating is currently gas.</p>	<p>The system is operable but needs upgrade</p>	<p>Mechanical systems including water heating and HVAC may require update or change to electric. Review gas shut off for safety.</p>
