CITY COUNCIL MEETING June 14, 2022

CONTINUED PUBLIC HEARING TO CONSIDER THE FISCAL YEAR 2022-23 PROPOSED BUDGET, FIVE-YEAR CAPITAL IMPROVEMENT PROGRAM, AND ASSOCIATED BUDGET RESPONSE REPORTS

Re: 2021/22 Pier Parking Structures Condition Assessment

CITY OF REDONDO BEACH NORTH PIER PARKING STRUCTURE 2021-CONDITION ASSESSMENT

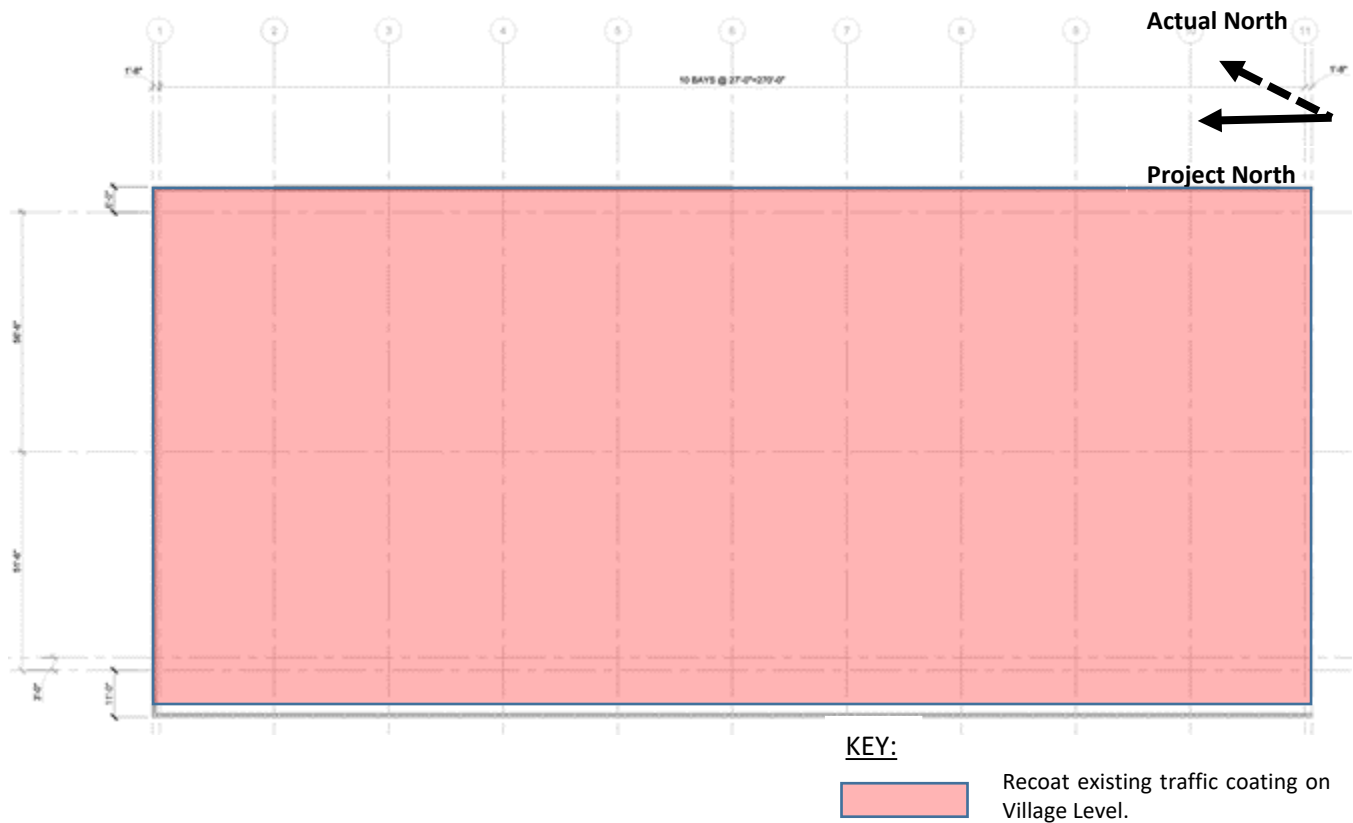
Figure 10– Recoat traffic membrane, North Parking Pier Structure – Village Level

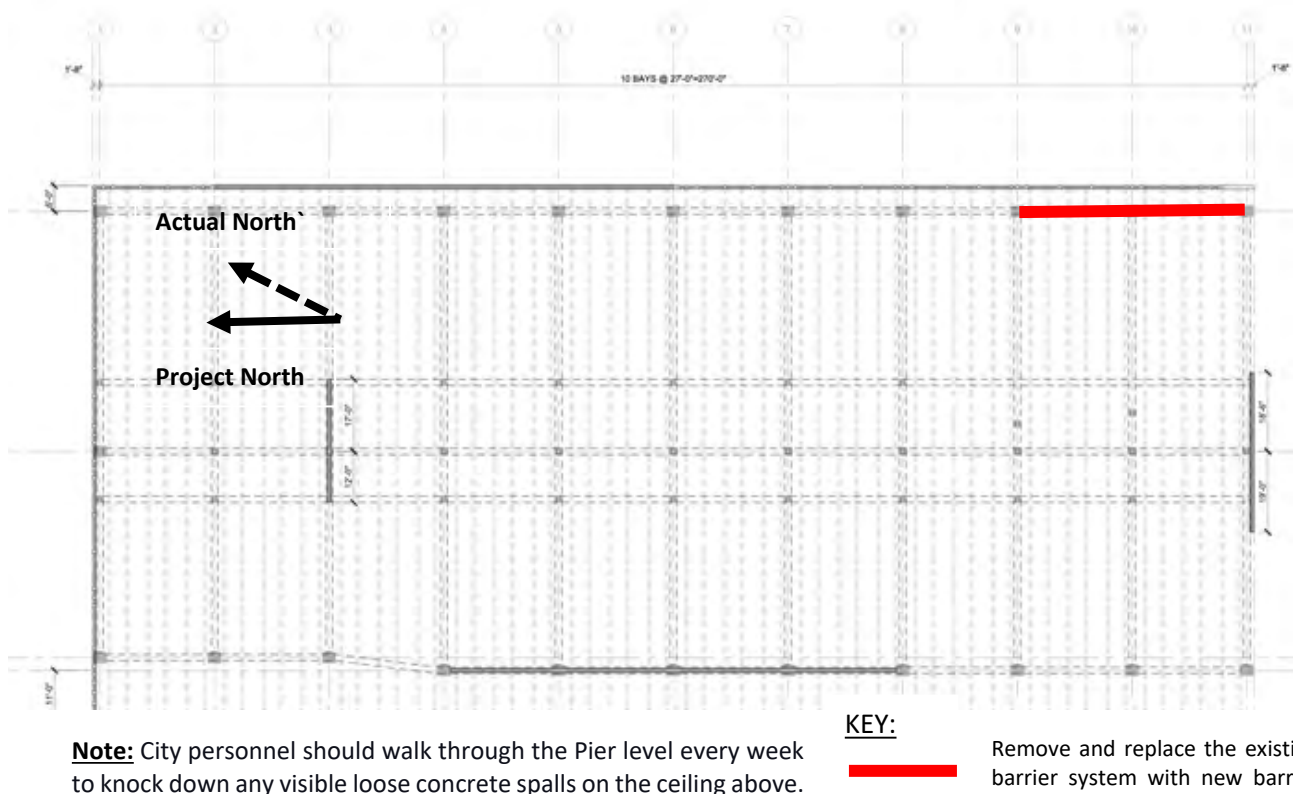
Figure 11– Immediate Repair location, North Parking Pier Structure – Pier Level

- Remove all loose and delaminated concrete from the slab soffit and beam underside where delaminated concrete appears on the surface. Repairs to these areas can be deferred and addressed during the implementation of the base repair program shown below. This work should be performed by either City personnel or private contractors working under the direction of the City of Redondo Beach.
- Remove and replace corroded barrier system posts on the Pier Level. Particularly on the north and west end of the parking structure.

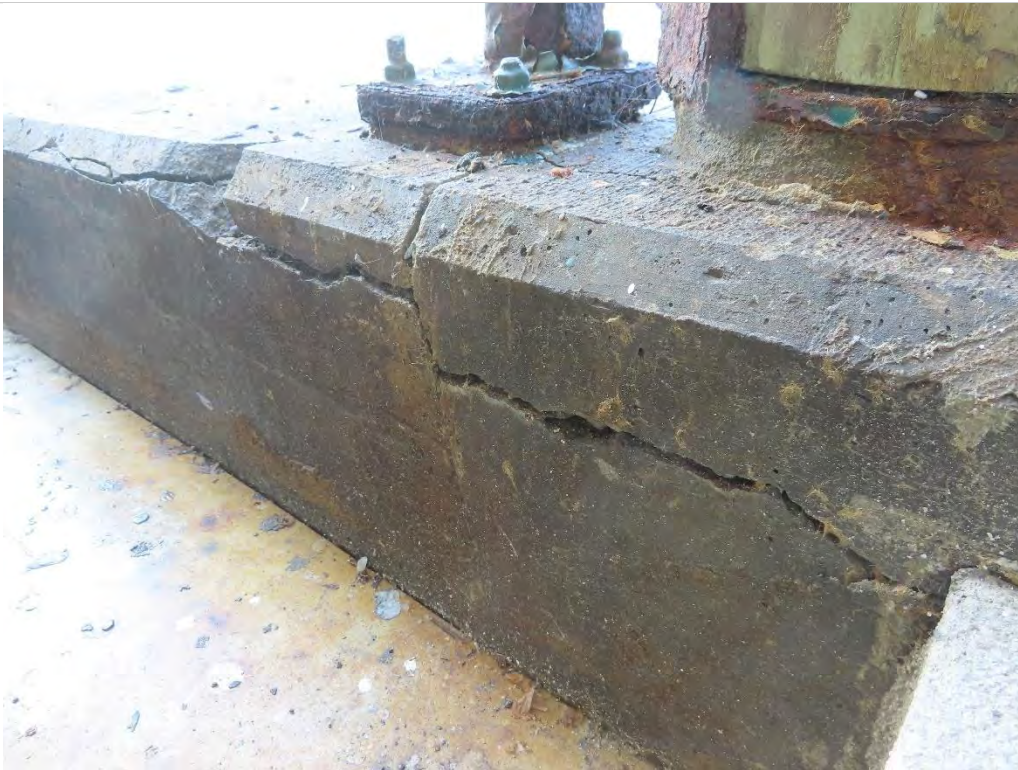
Photo 1.12- Concrete curb spall, Pier Level (SH3-35)

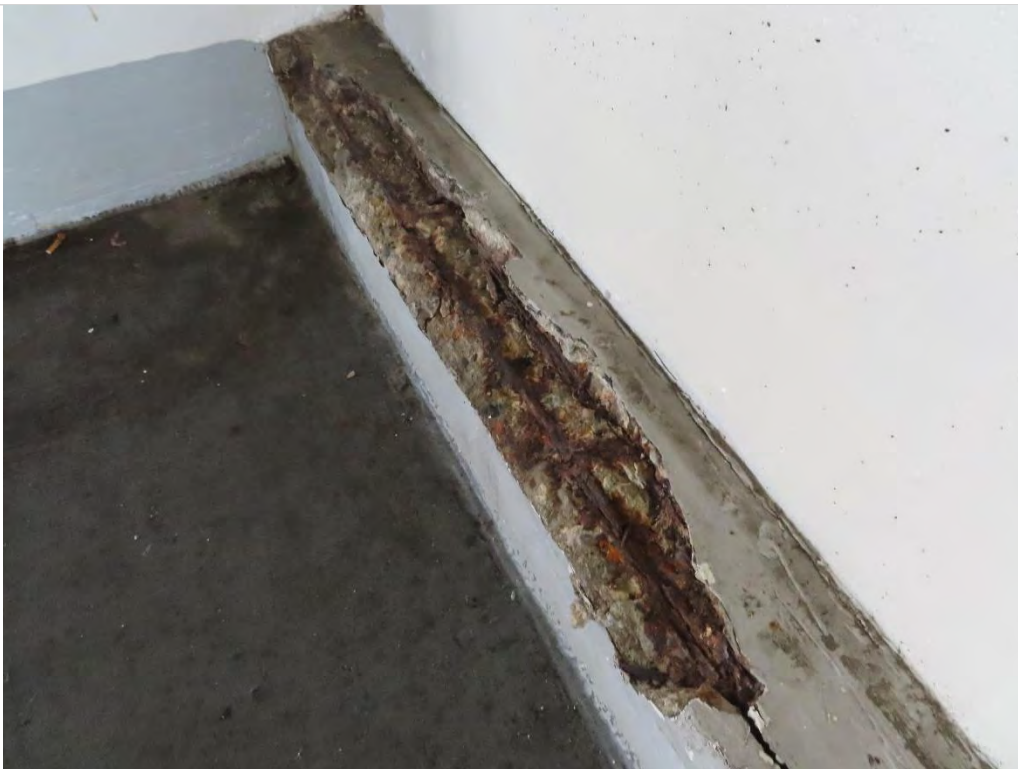
Photo 1.13- Concrete curb spall, Pier Level (SH3-189)

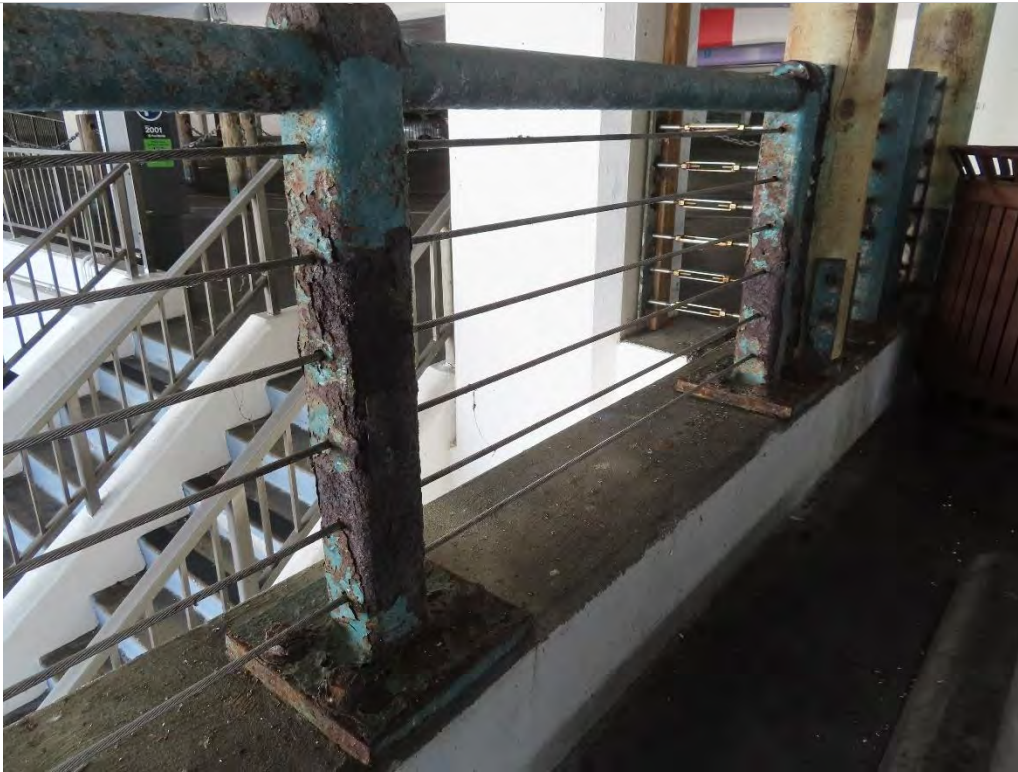
Photo 1.14- Corroded barrier post, Pier Level (SH3-192)

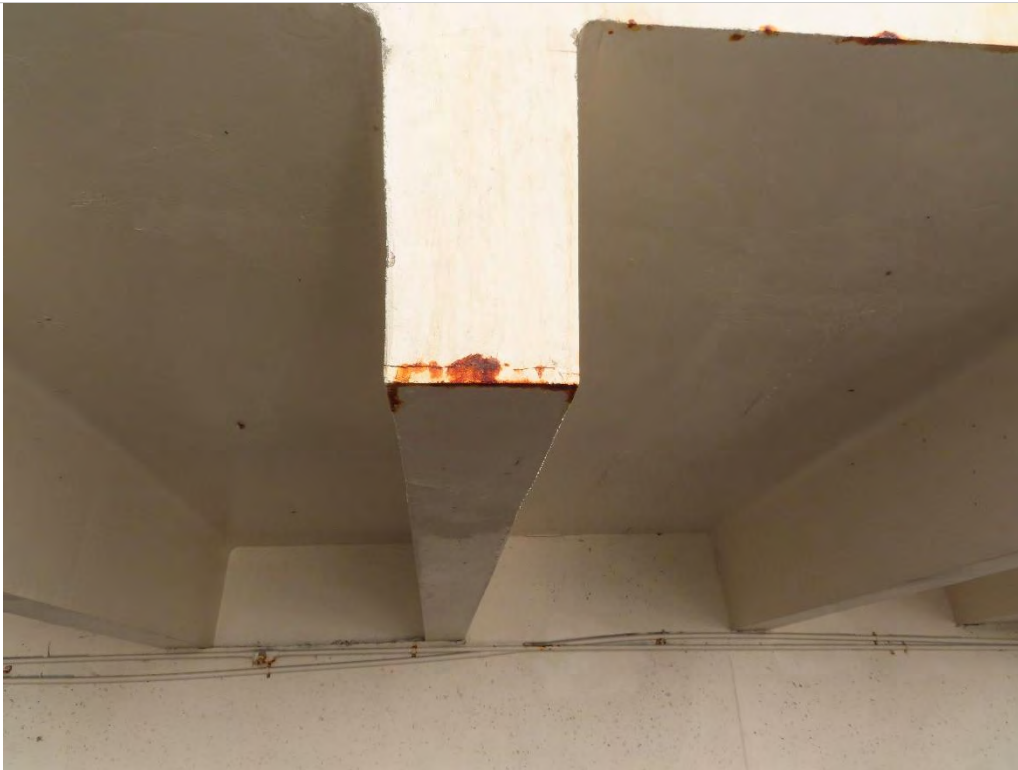
Photo 1.22 - Visual signs of rebar corrosion, Exterior - West elevation (SH2-343)

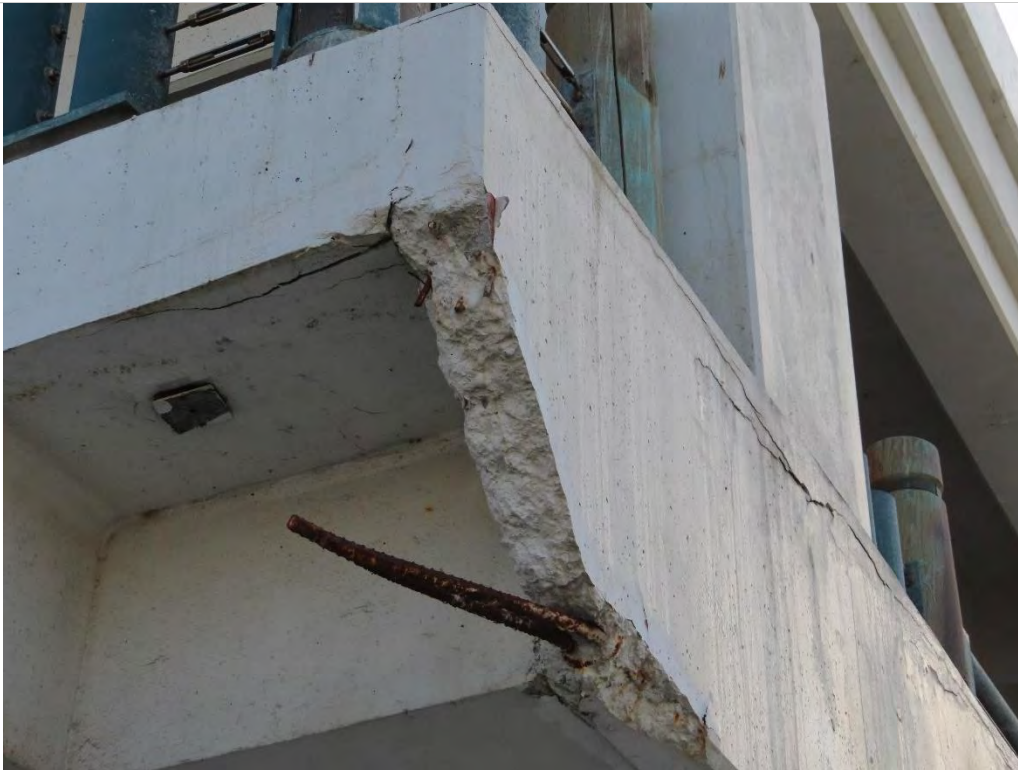
Photo 1.24- Concrete spandrel beam spall with exposed rebar, Exterior – North-east elevation (SH2-362)

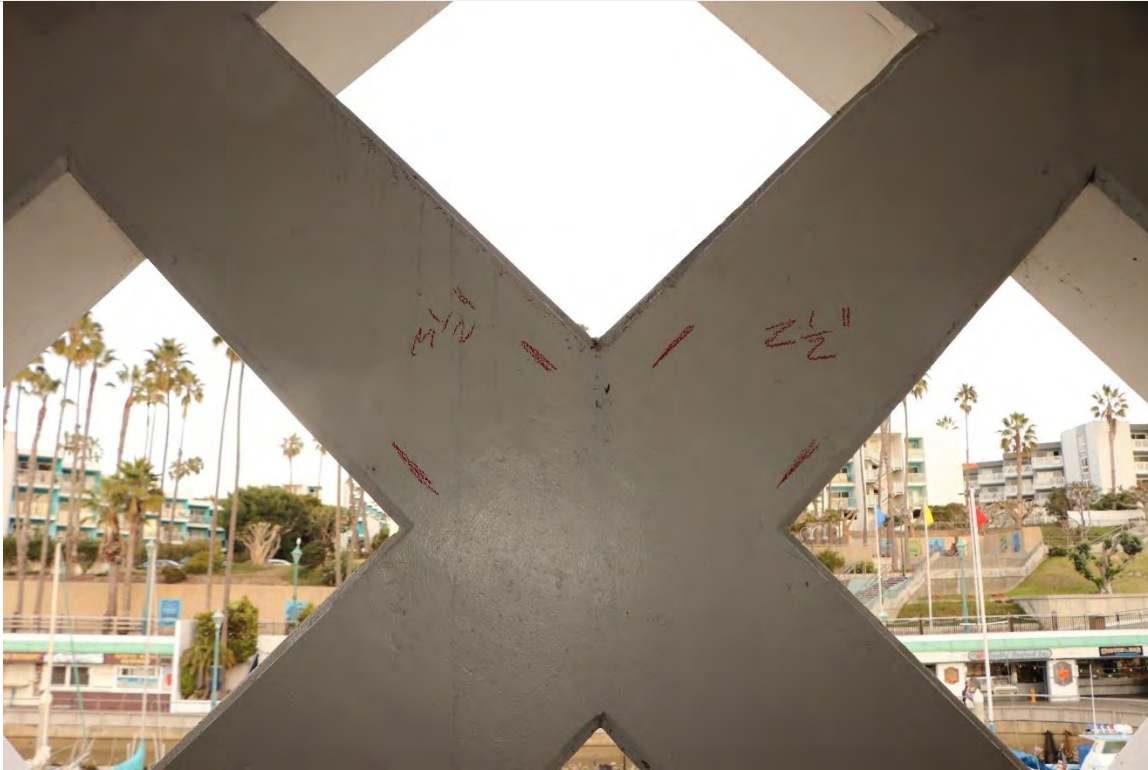
Photo 2.3- Wall steel reinforcement detected using GPR, only longitudinal bar was found, No confinement bar was present, East Wall, 1992 Retrofit – Pier Level (BA2-197)

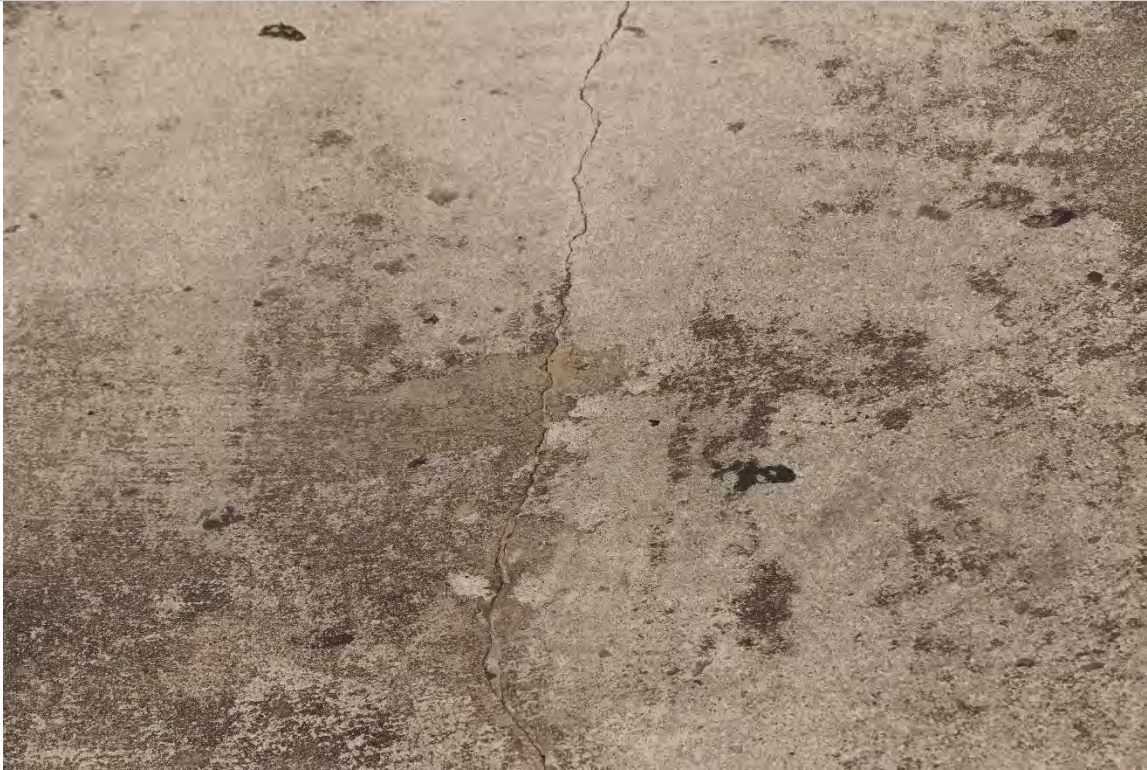
Photo 1.5- Cracks on concrete floor slab, Village level (BA1-80)

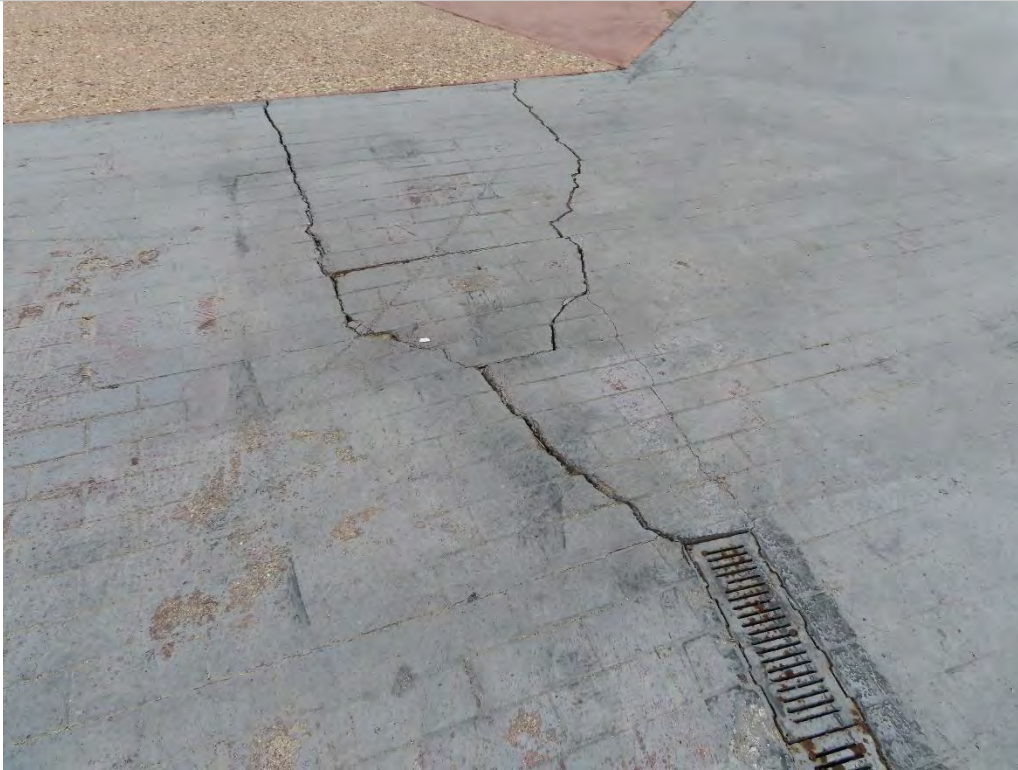
Photo 1.11- Typical spalled and cracked pavers, Village level (SH1-190)

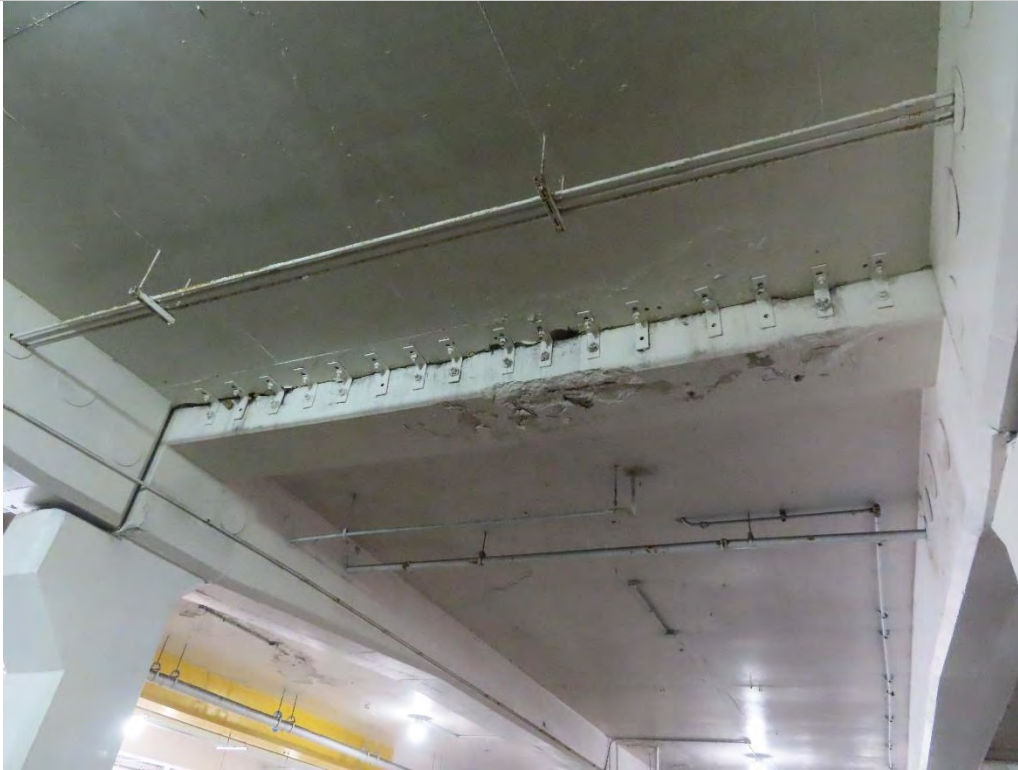
Photo 1.29- Concrete beam spalling below the expansion joint, Pier level (MM1-45)

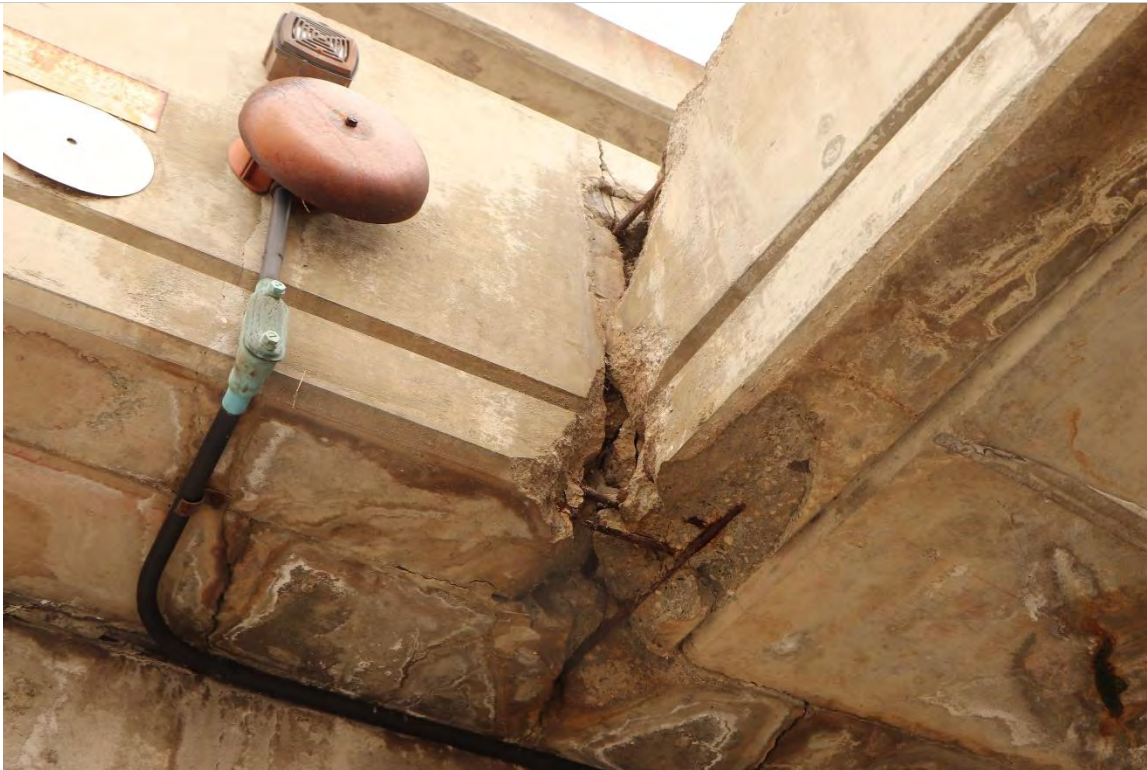
Photo 2.7- Soffit slab deterioration and spalls with exposed reinforcement, Pier level (BA1-327)

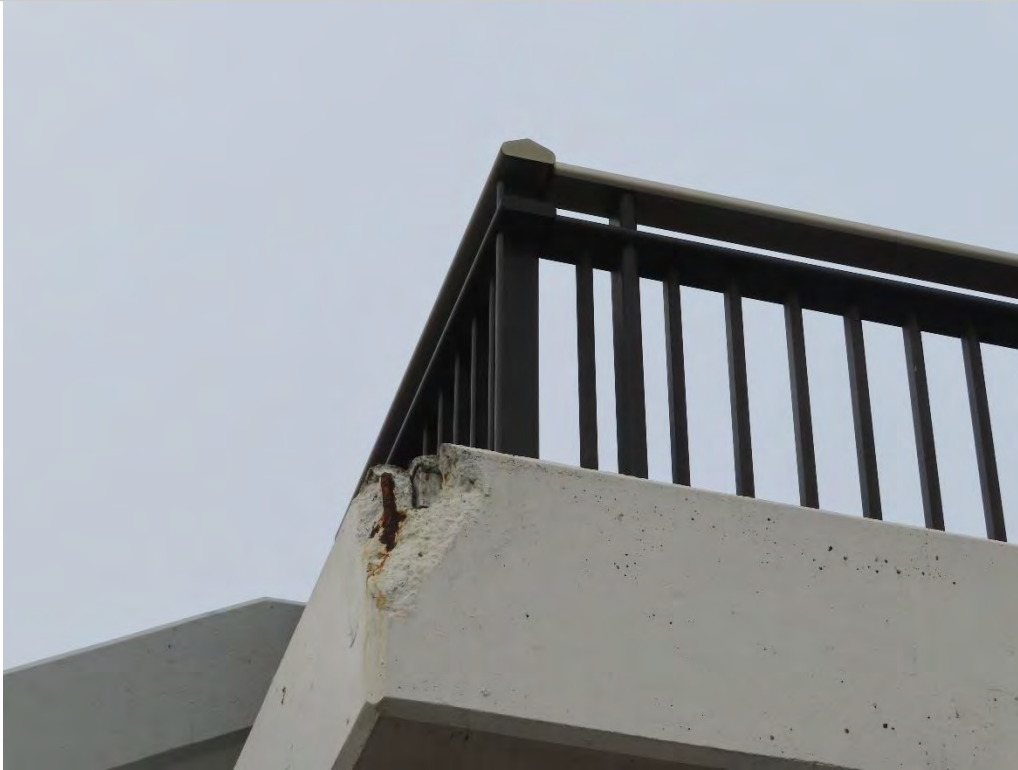
Photo 3.1- Exposed and corroded rebar, Exterior - South elevation (SH2-252)
