Re: 2021/22 Pier Parking Structures Condition Assessment

CITY OF REDONDO BEACH NORTH PIER PARKING STRUCTURE 2021-CONDITION ASSESSMENT

CITY OF REDONDO BEACH
Redondo Beach, CA

WALKER
CONSULTANTS

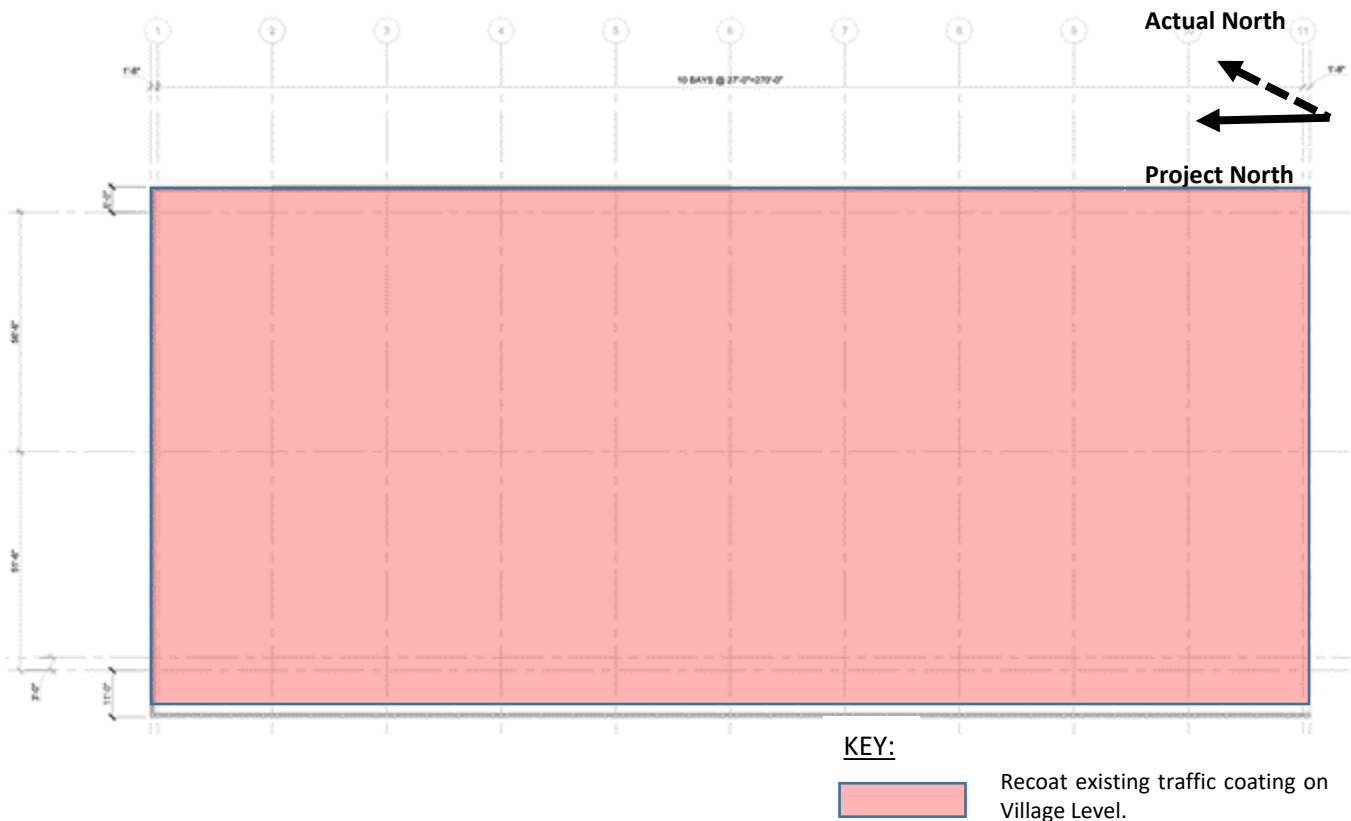
Figure 10– Recoat traffic membrane, North Parking Pier Structure – Village Level

Remove existing traffic coating with new Urethane traffic coating.

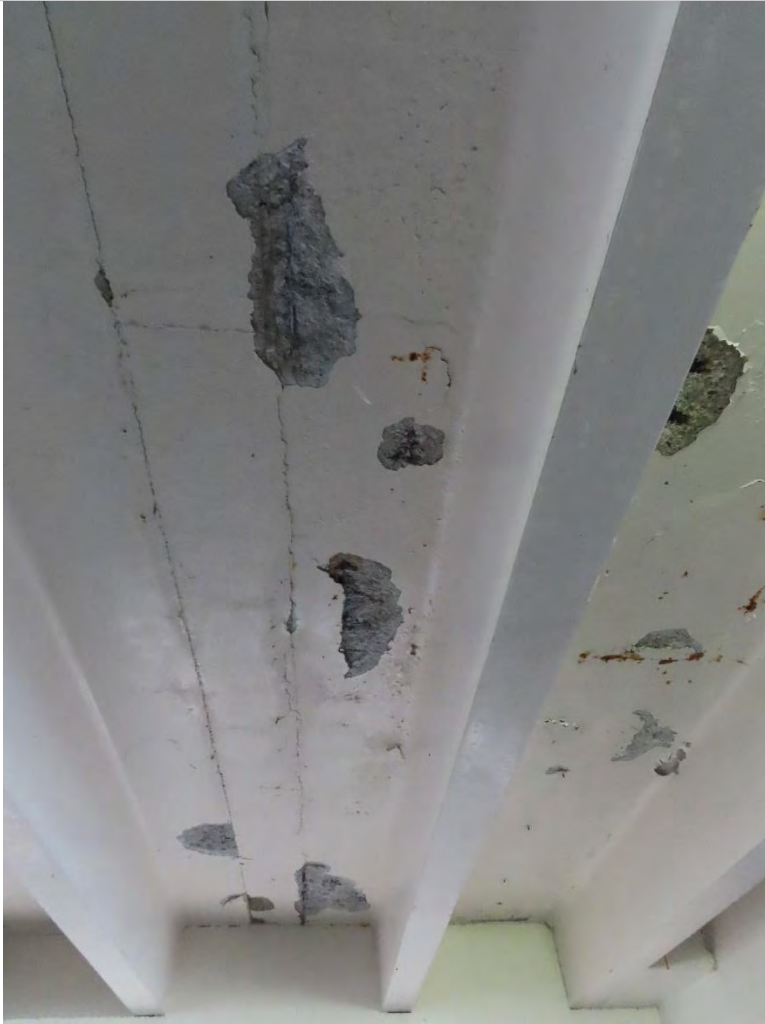
Photo 1.3- Soffit slab deterioration and spall with exposed reinforcement, Village Level (SH3-96)

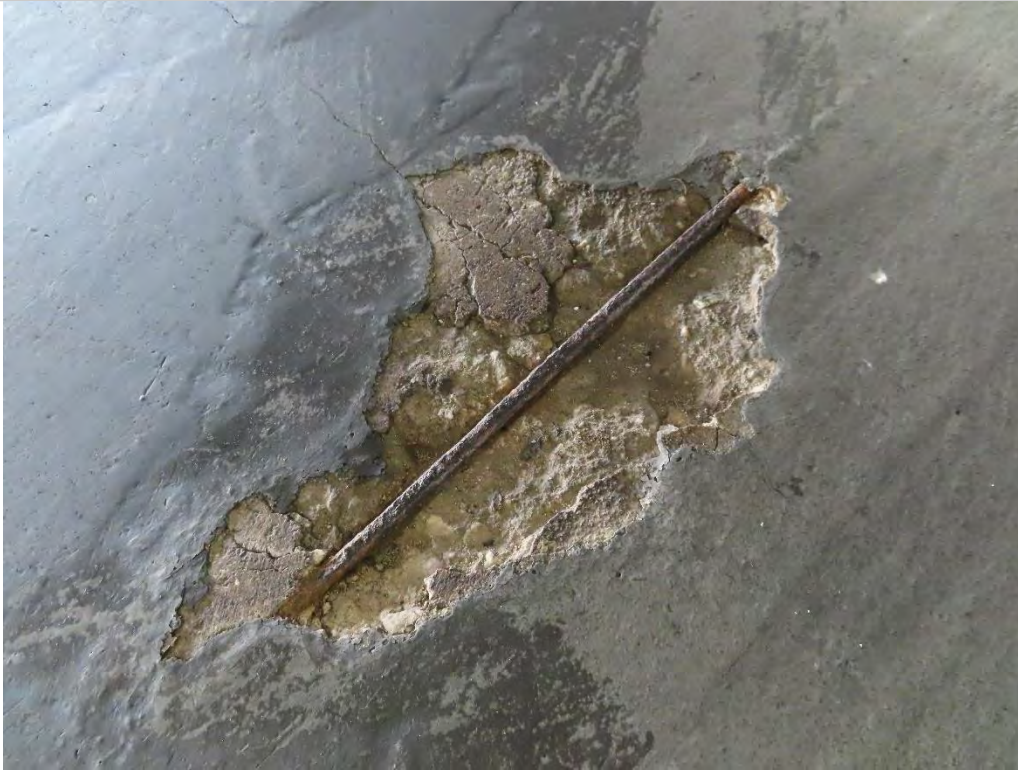
Photo 1.6- Concrete delamination with exposed rebar, Pier Level (SH3-206)

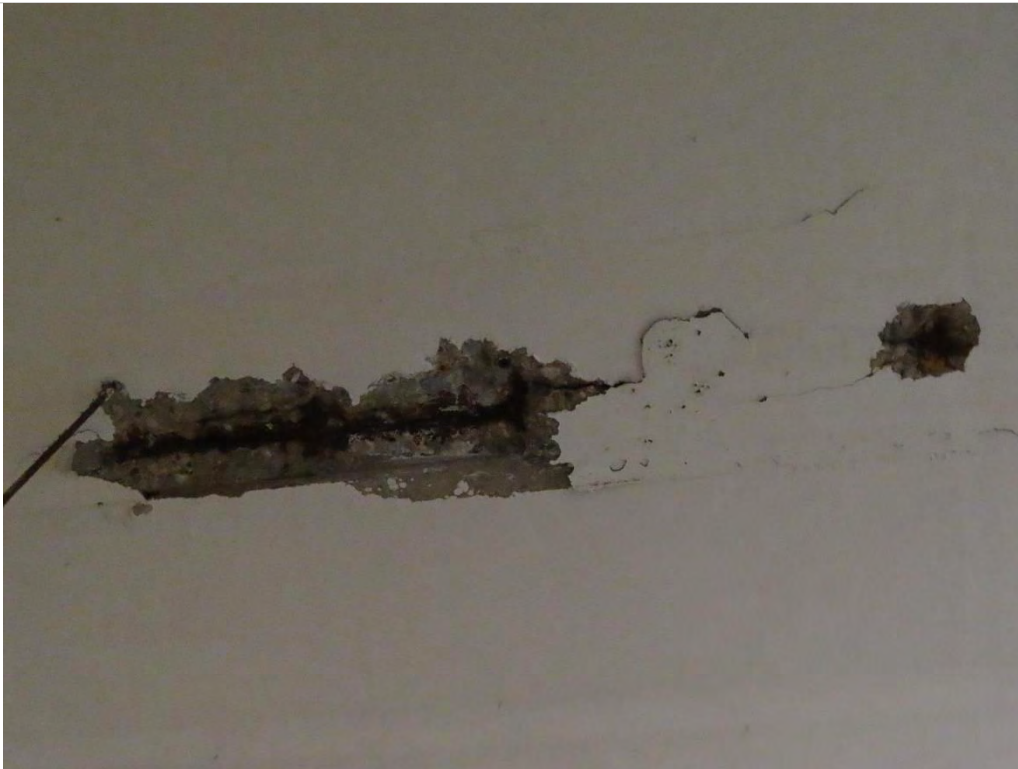
Photo 1.7- Soffit slab deterioration and spall with exposed reinforcement, Pier Level (SH3-312)

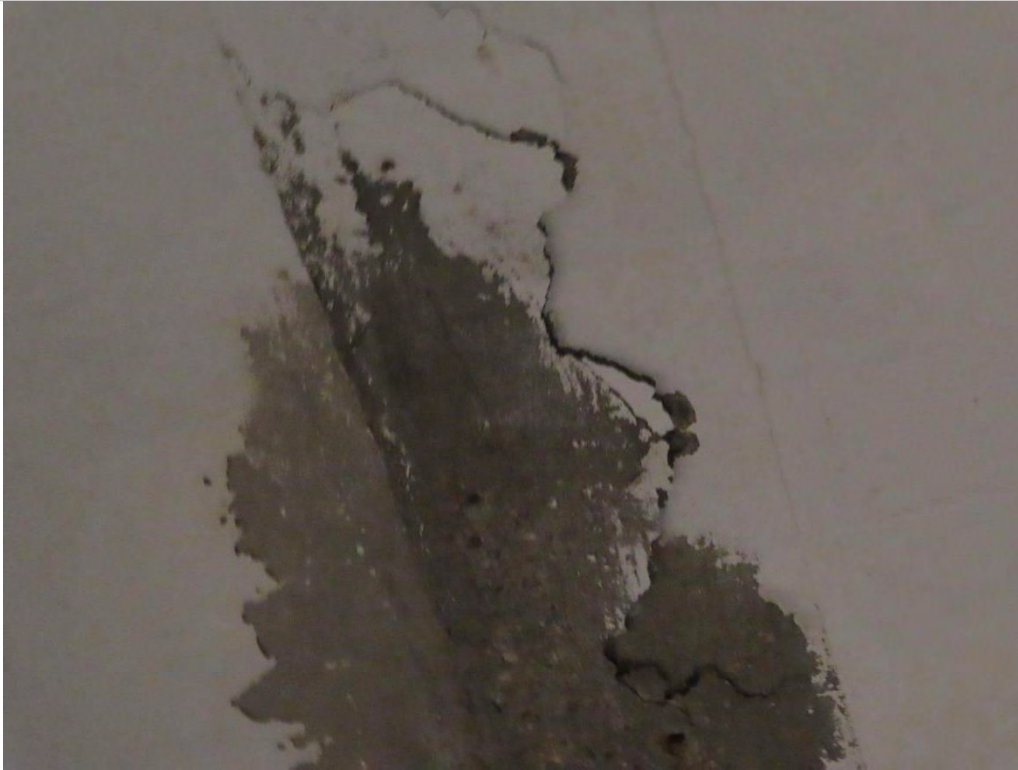
Photo 1.8- Soffit slab deterioration and spall, Pier Level (SH3-267)

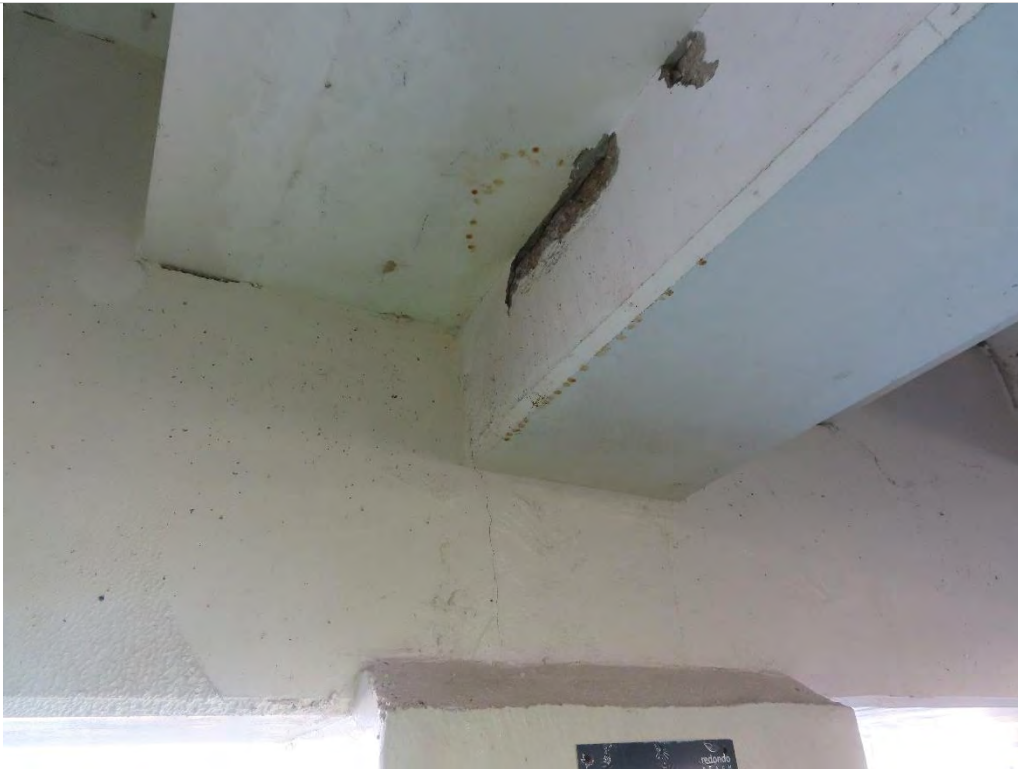
Photo 1.9- Concrete beam spalls with exposed reinforcement, Pier Level (SH3-31)

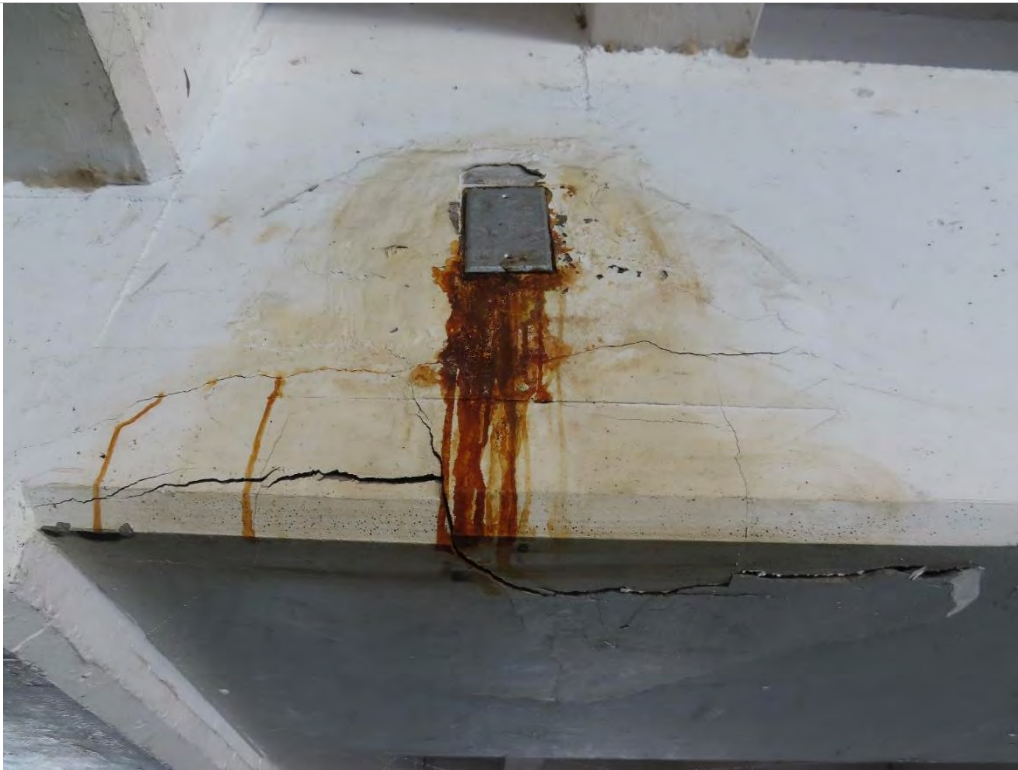
Photo 1.10- Concrete beam spall, Pier Level (SH3-201)

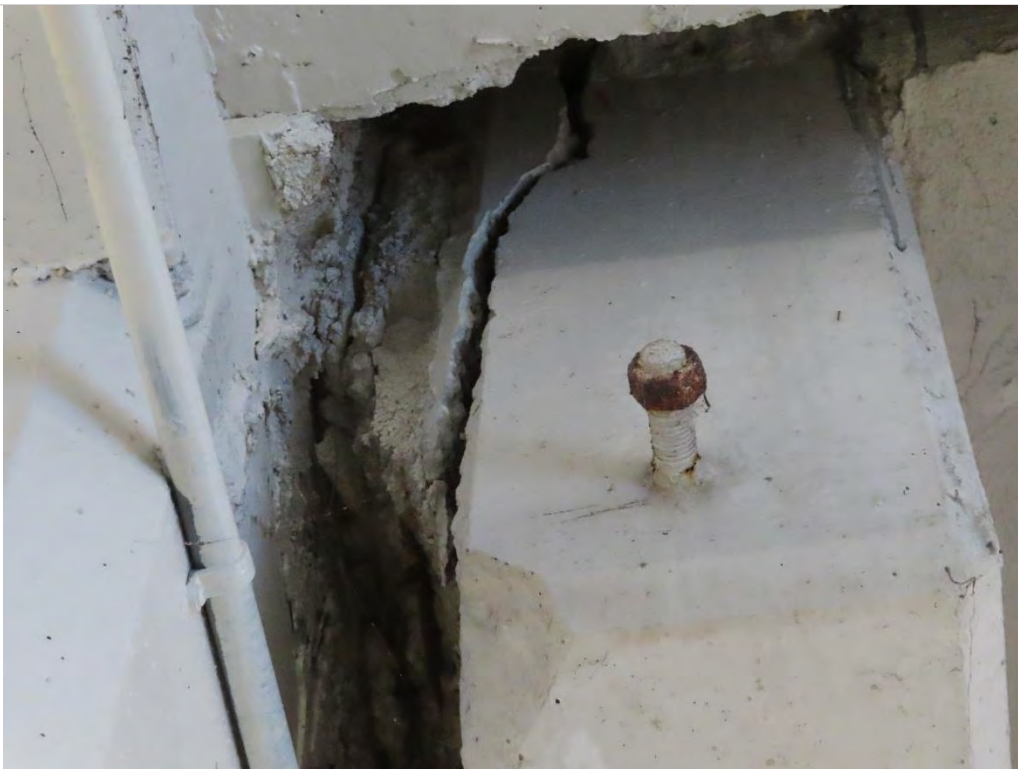
Photo 1.11- Concrete beam spall, Pier Level (SH3-197)

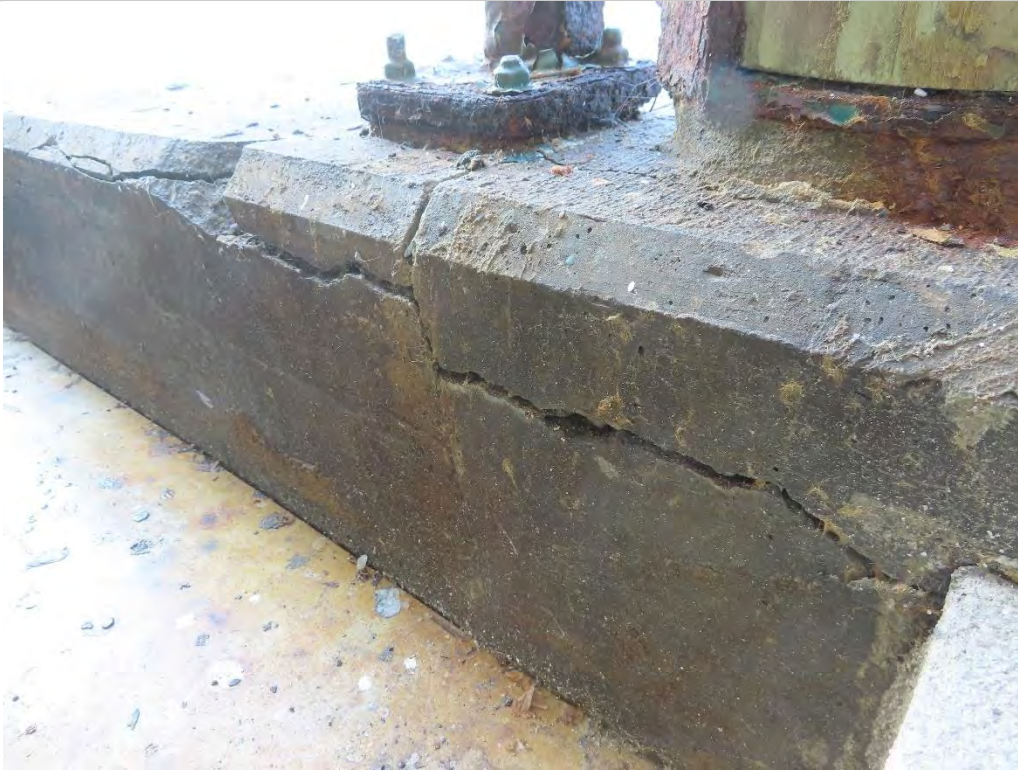
Photo 1.12- Concrete curb spall, Pier Level (SH3-35)

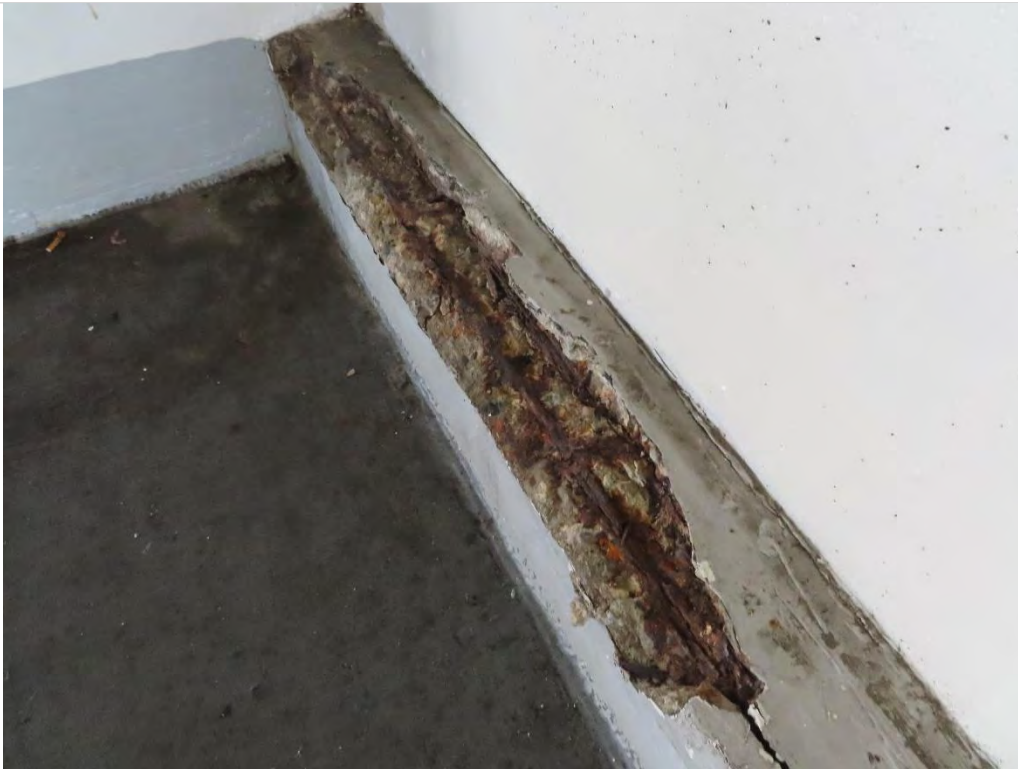
Photo 1.13- Concrete curb spall, Pier Level (SH3-189)

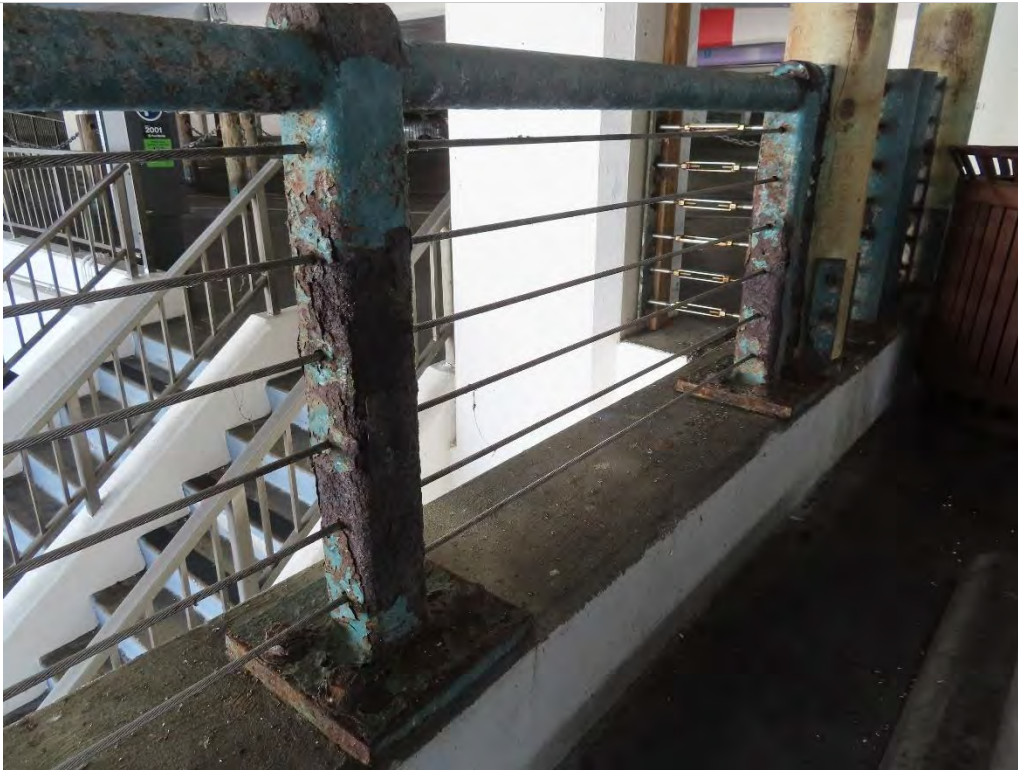
Photo 1.14- Corroded barrier post, Pier Level (SH3-192)

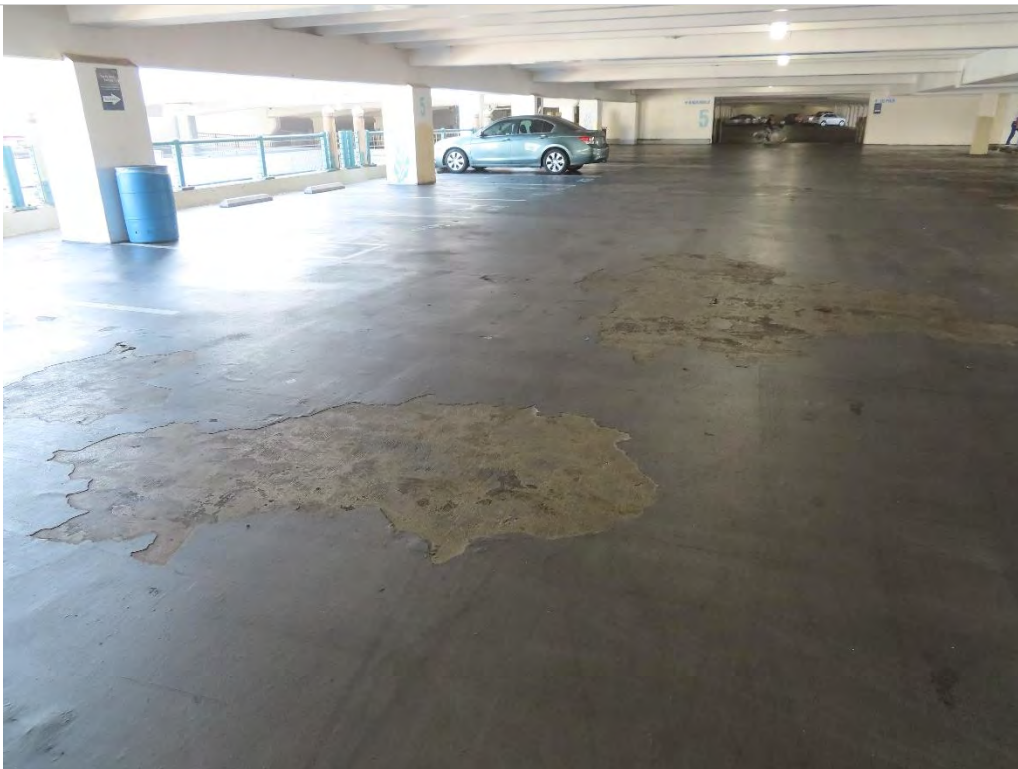
Photo 1.15- Compromised traffic coating, Pier Level (SH3-211)

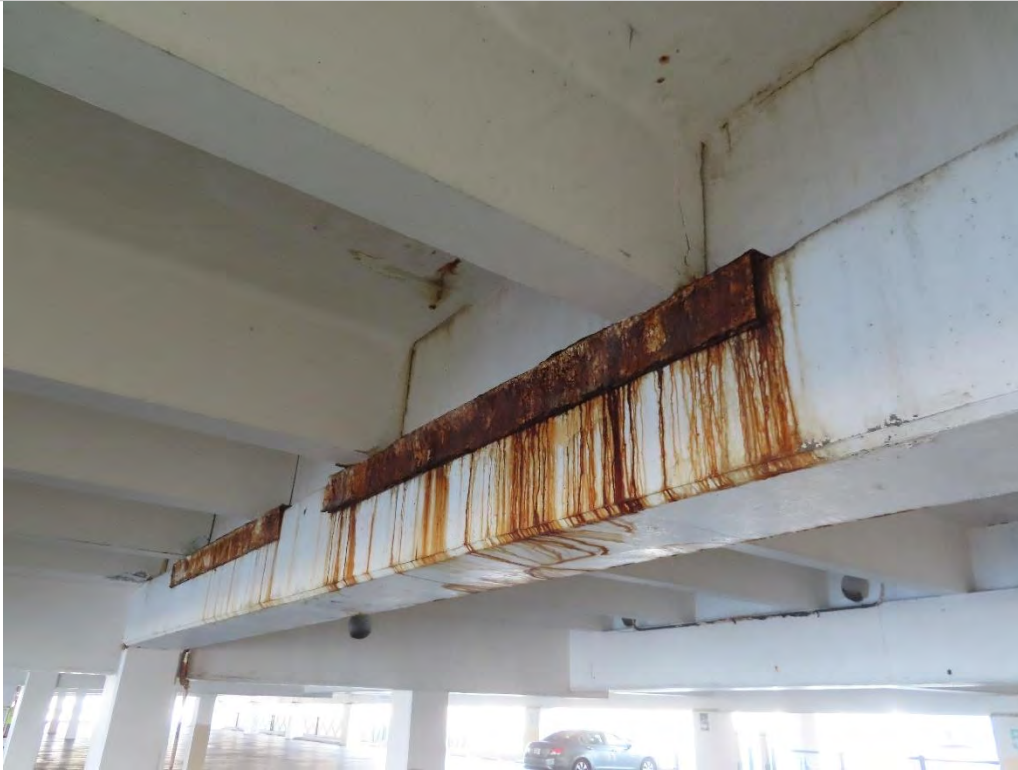
Photo 1.16- Corroded beam ledge, Pier Level (SH3-136)

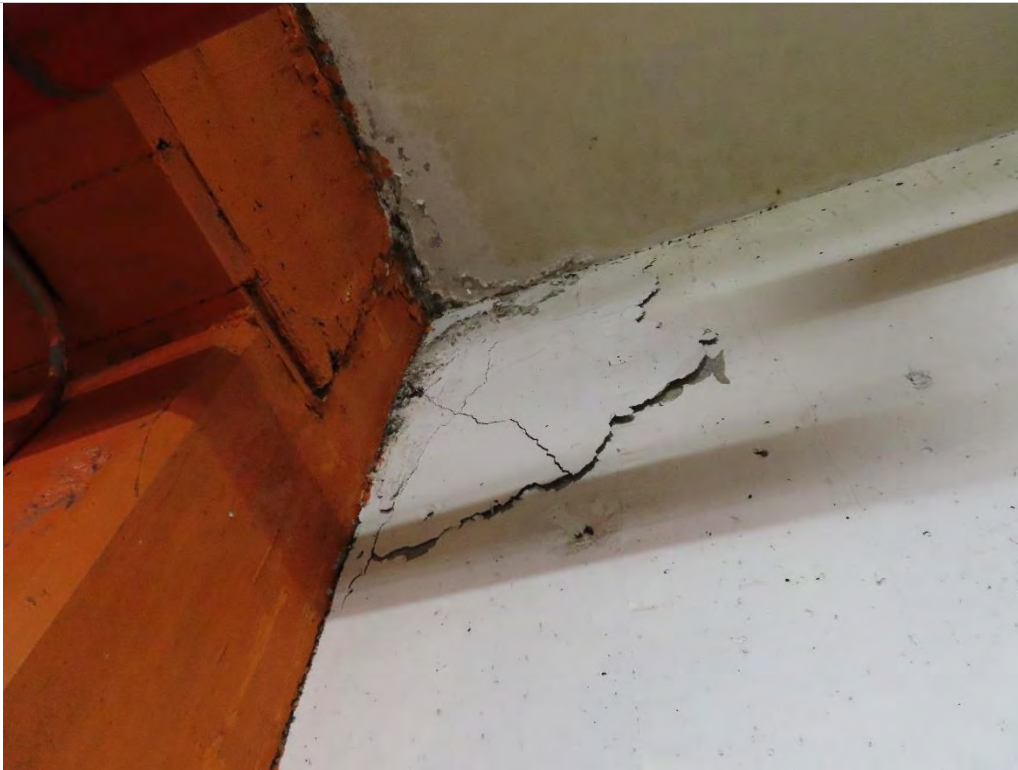
Photo 1.18- Exposed rebar on wall, Basement Level (SH3-308)

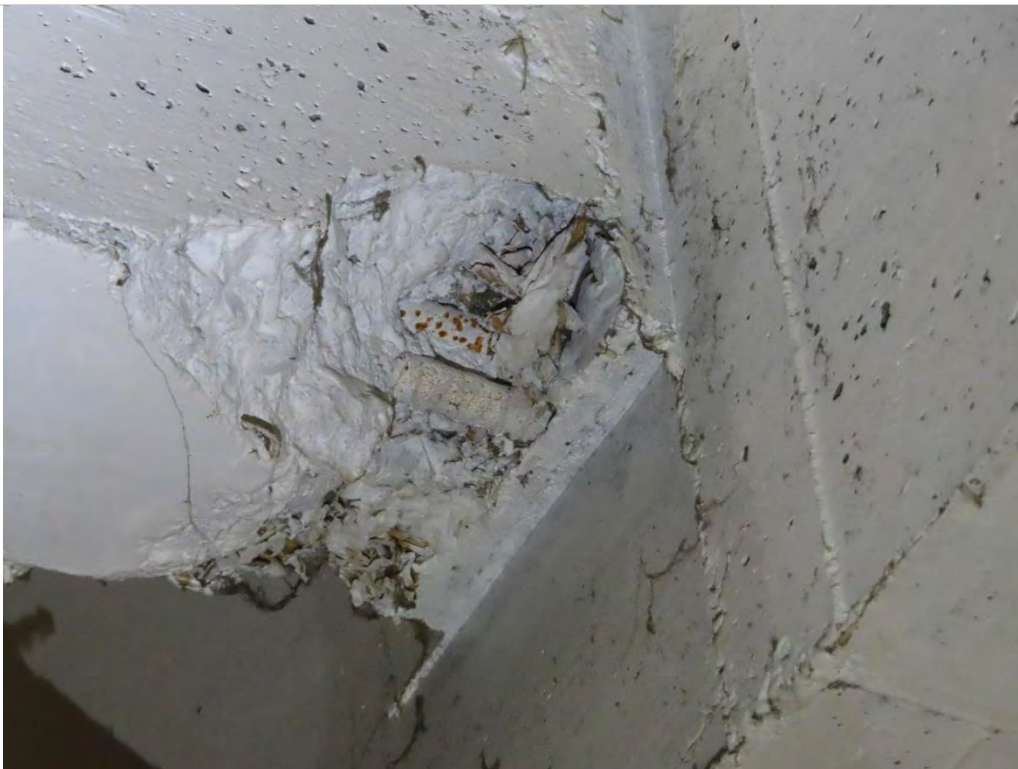
Photo 1.19- Concrete beam spall with exposed rebar, Basement level (SH3-303)

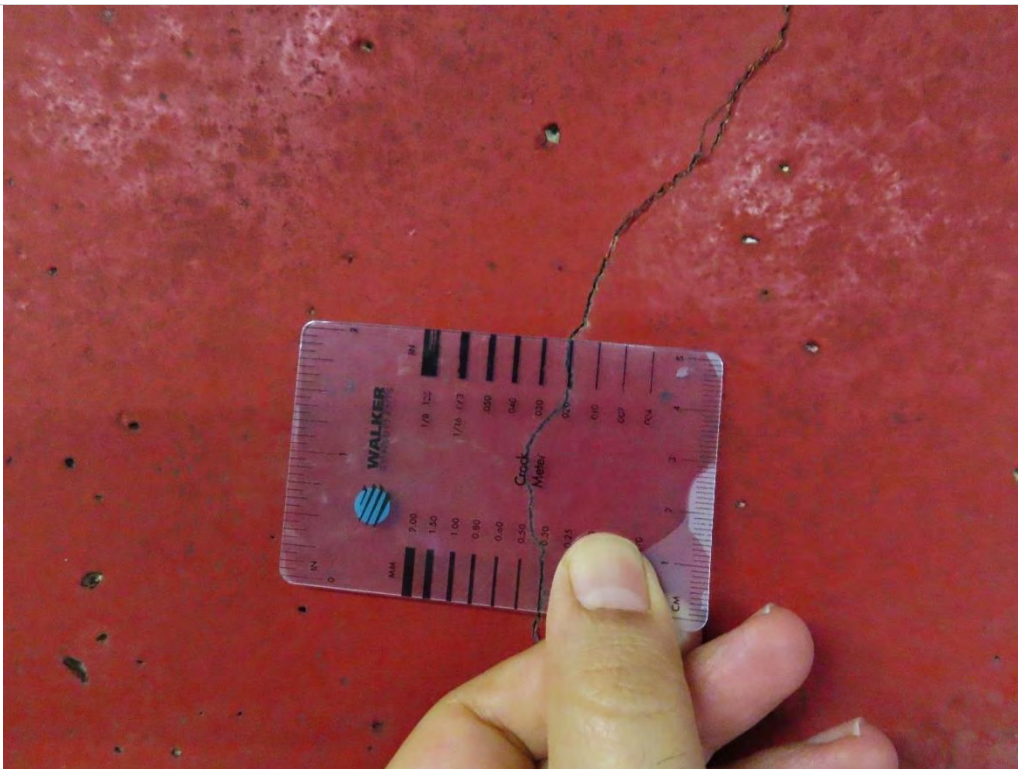
Photo 1.21- Concrete wall crack, Basement Level (SH3-256)

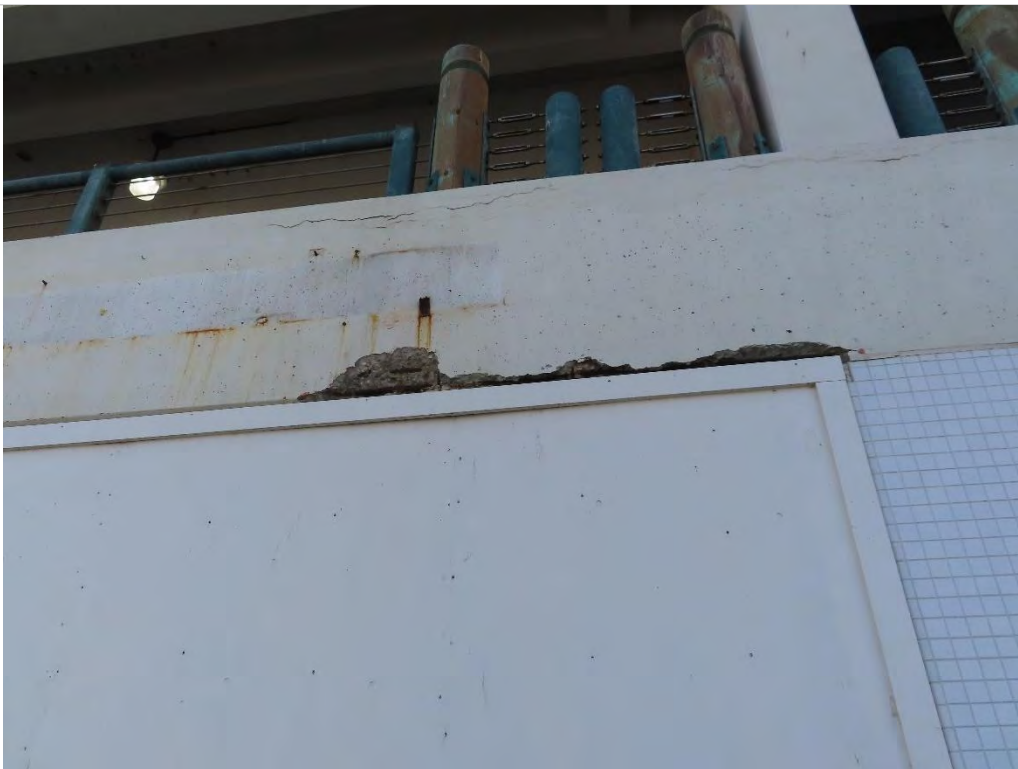
Photo 1.23- Concrete spandrel beam spall with exposed rebar, Exterior - North elevation (SH2-356)

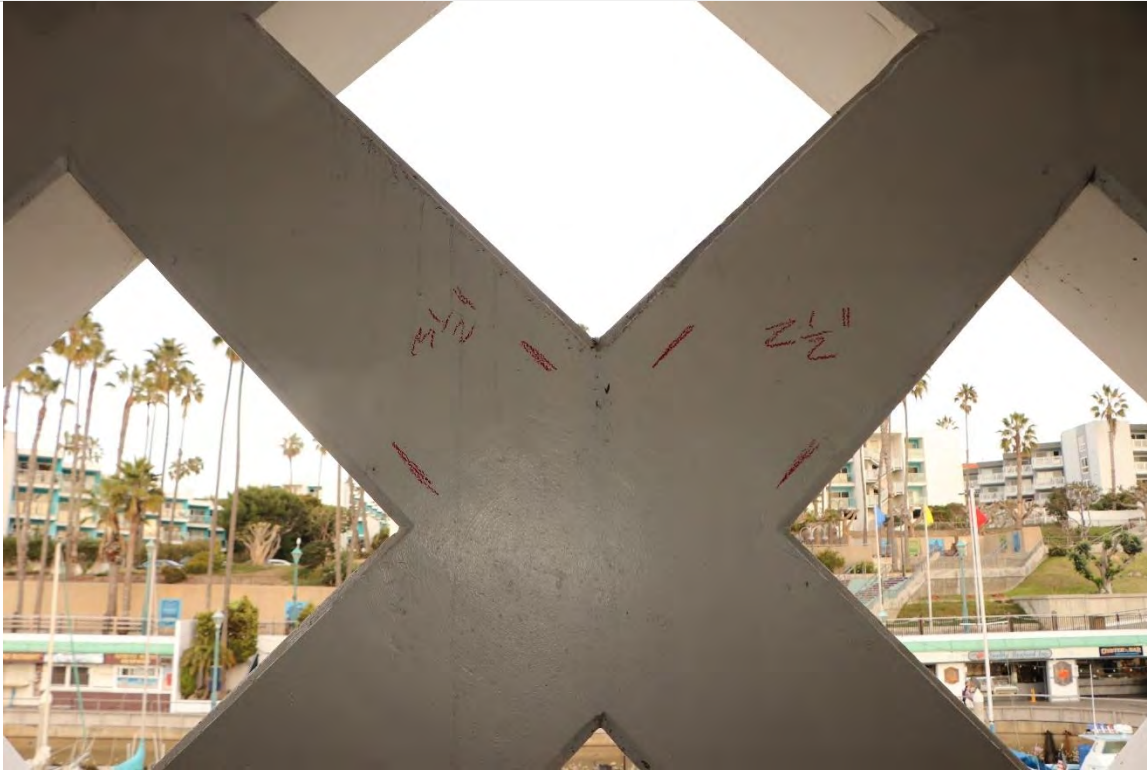
Photo 2.3- Wall steel reinforcement detected using GPR, only longitudinal bar was found, No confinement bar was present, East Wall, 1992 Retrofit – Pier Level (BA2-197)

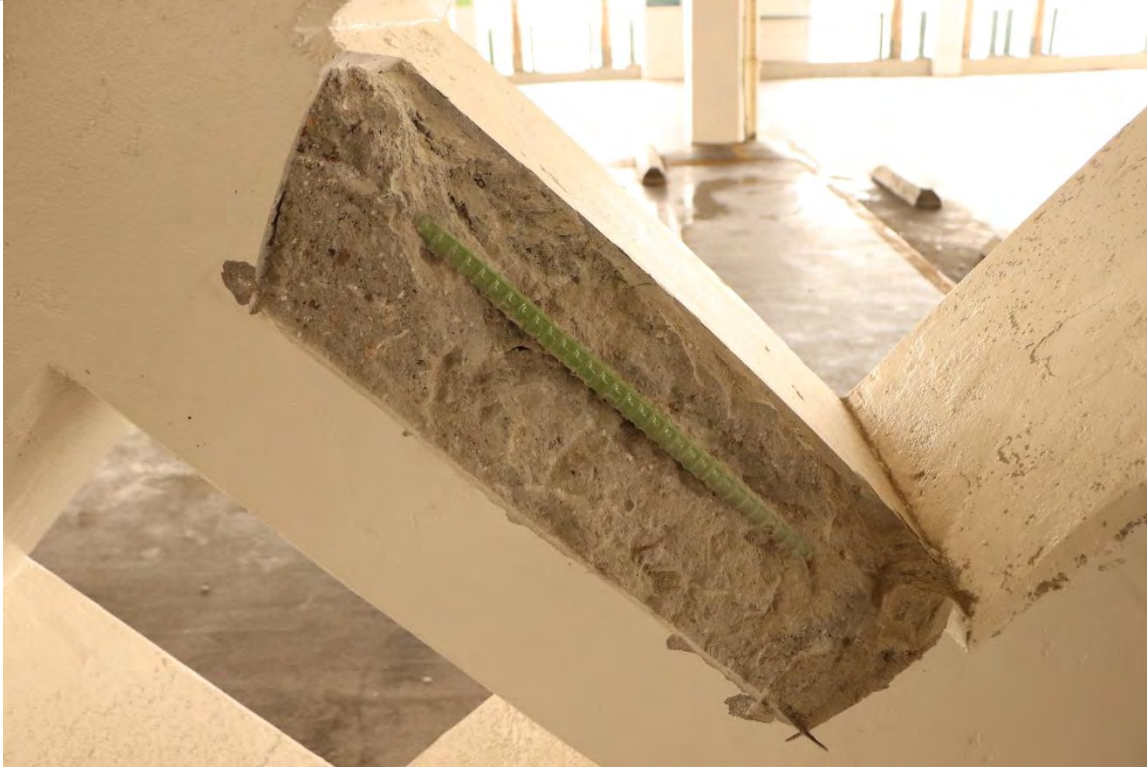
Photo 2.12- Opening of diagonal members on waffle wall, Only # 6 longitudinal bar was found, No confinement bar was present, 1992 Retrofit Wall on Gridline 3— Pier Level (BA2-161)

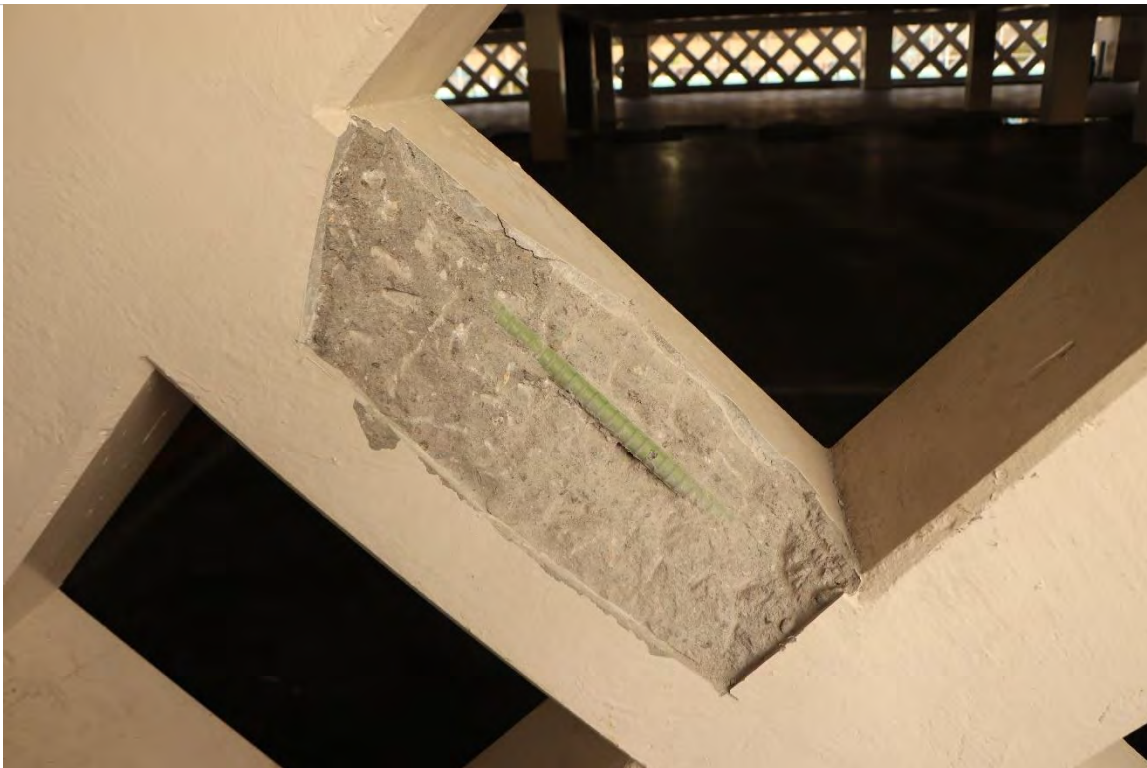
Photo 2.13- Opening of diagonal members on waffle wall, Only # 6 longitudinal bar was found, No confinement bar was present, 1992 Retrofit Wall on Gridline 3— Pier Level (BA2-178)

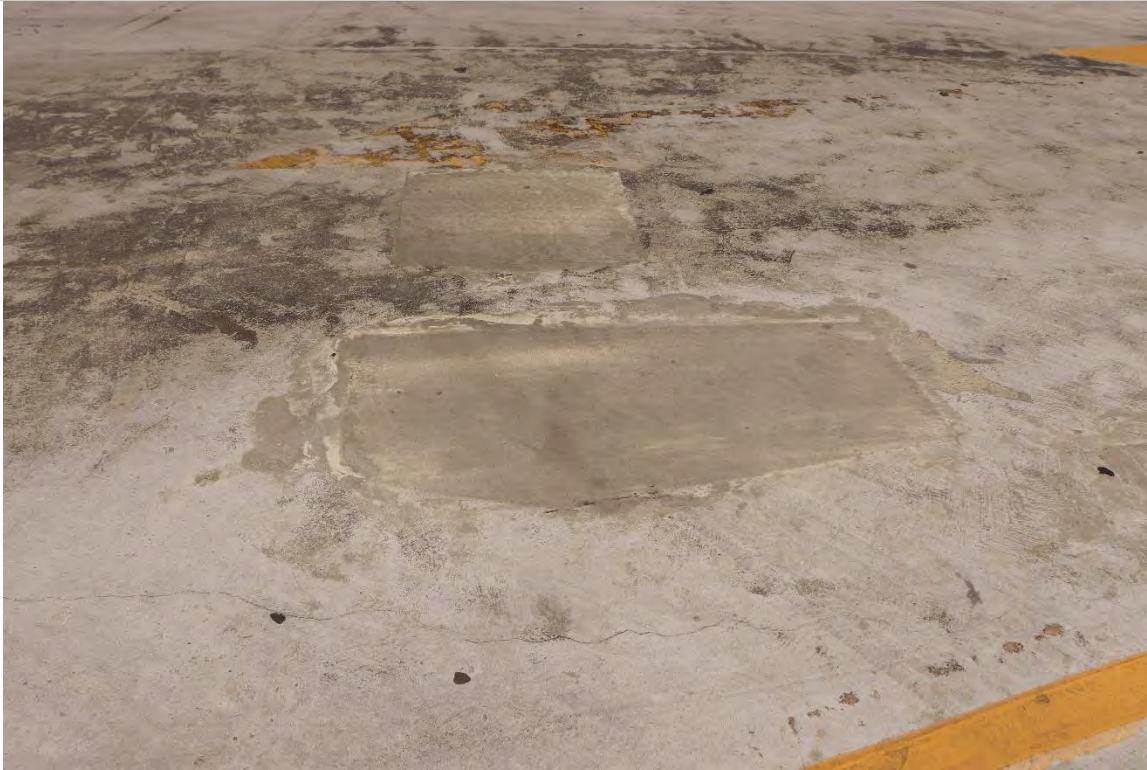
Photo 1.3- Delaminated previous repair, Village level (BA1-111)

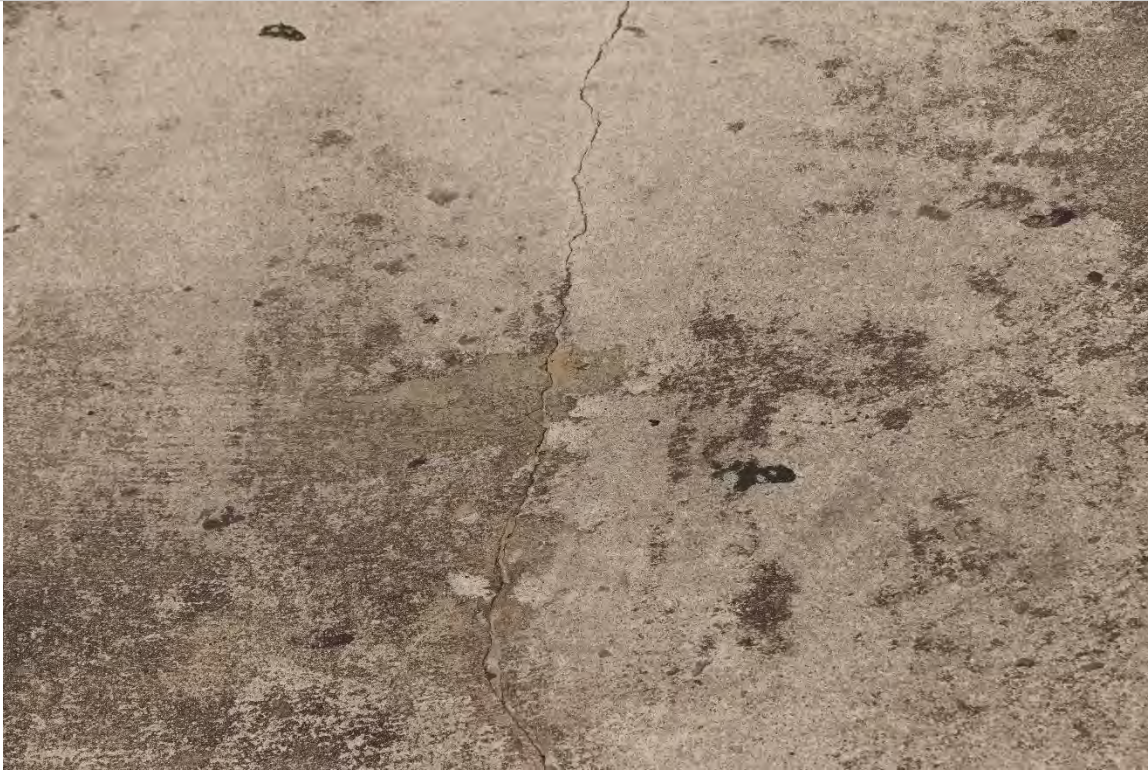
Photo 1.5- Cracks on concrete floor slab, Village level (BA1-80)

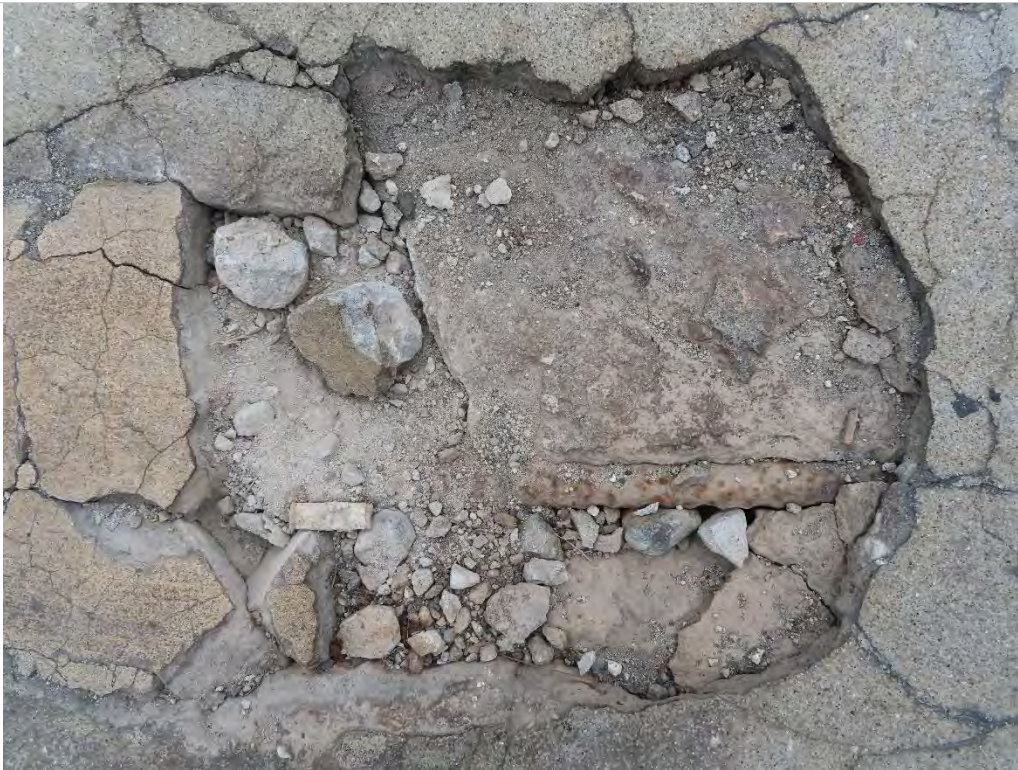
Photo 1.7- Exposed rebar on floor, Village level (SH1-180)

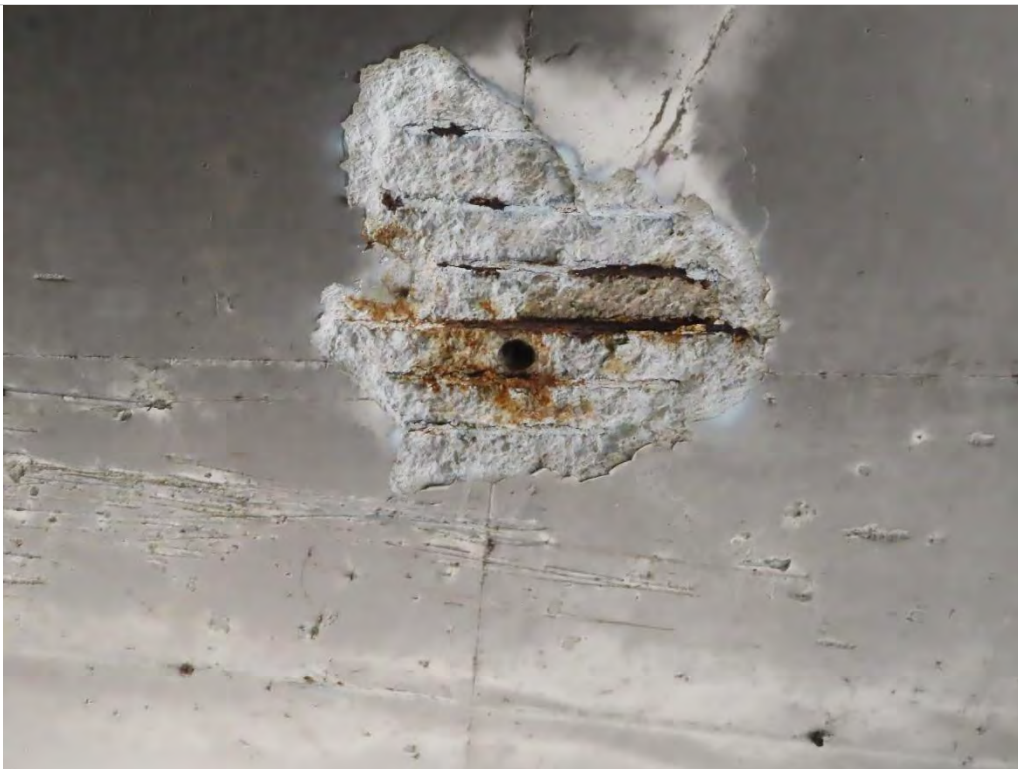
Photo 1.8- Soffit slab deterioration and spalls with exposed reinforcement, Village level (SH1-8)

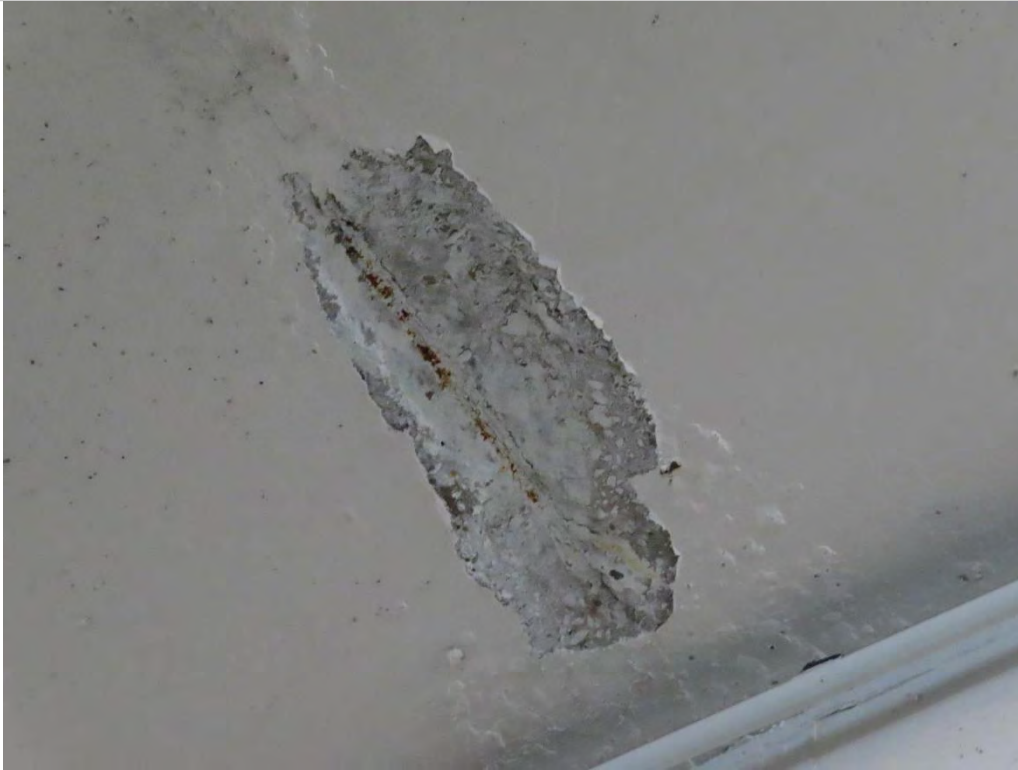
Photo 1.9- Soffit slab deterioration and spalls with exposed reinforcement, Village level (MM1-52)

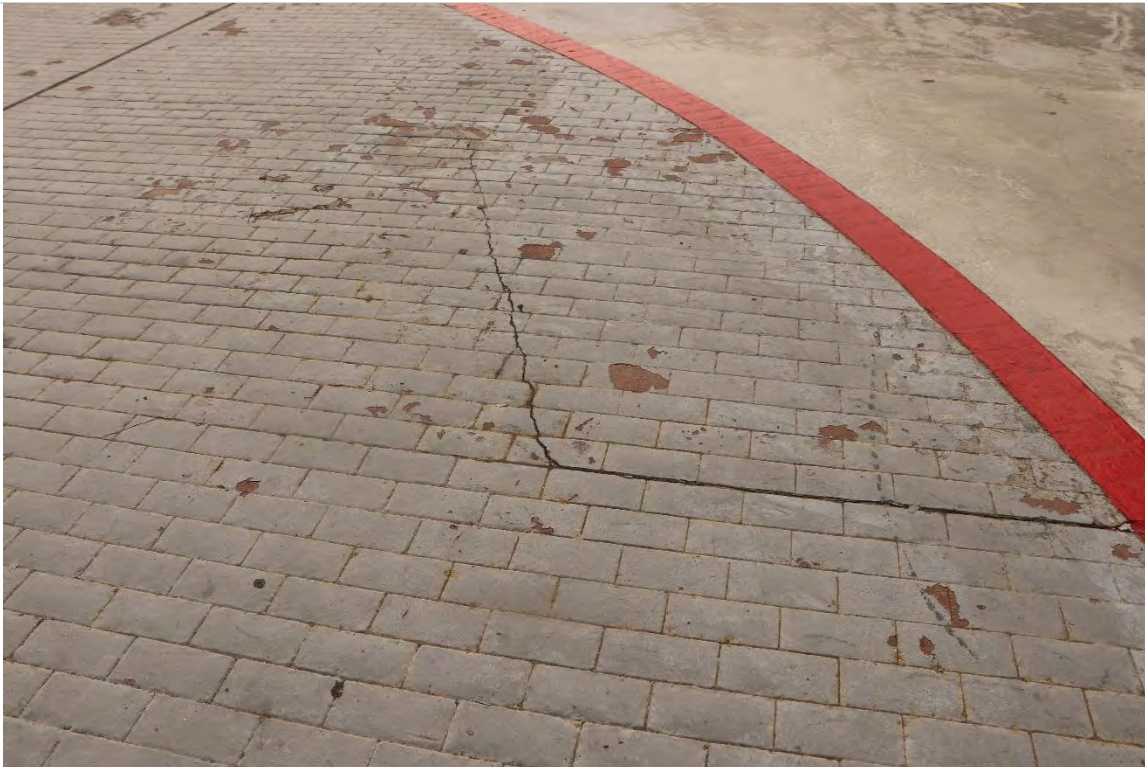
Photo 1.10- Typical spalled and cracked pavers, Village level (BA1-113)

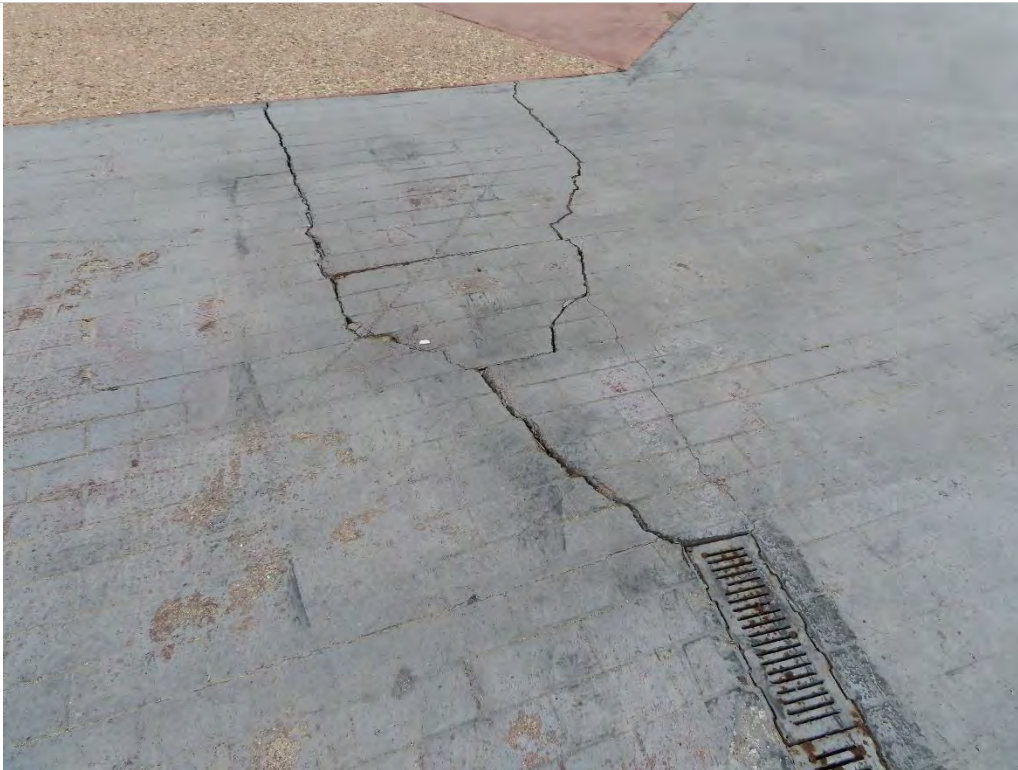
Photo 1.11- Typical spalled and cracked pavers, Village level (SH1-190)
