Re: 2021/22 Pier Parking Structures Condition Assessment

CITY OF REDONDO BEACH NORTH PIER PARKING STRUCTURE 2021-CONDITION ASSESSMENT

CITY OF REDONDO BEACH
Redondo Beach, CA

WALKER
CONSULTANTS

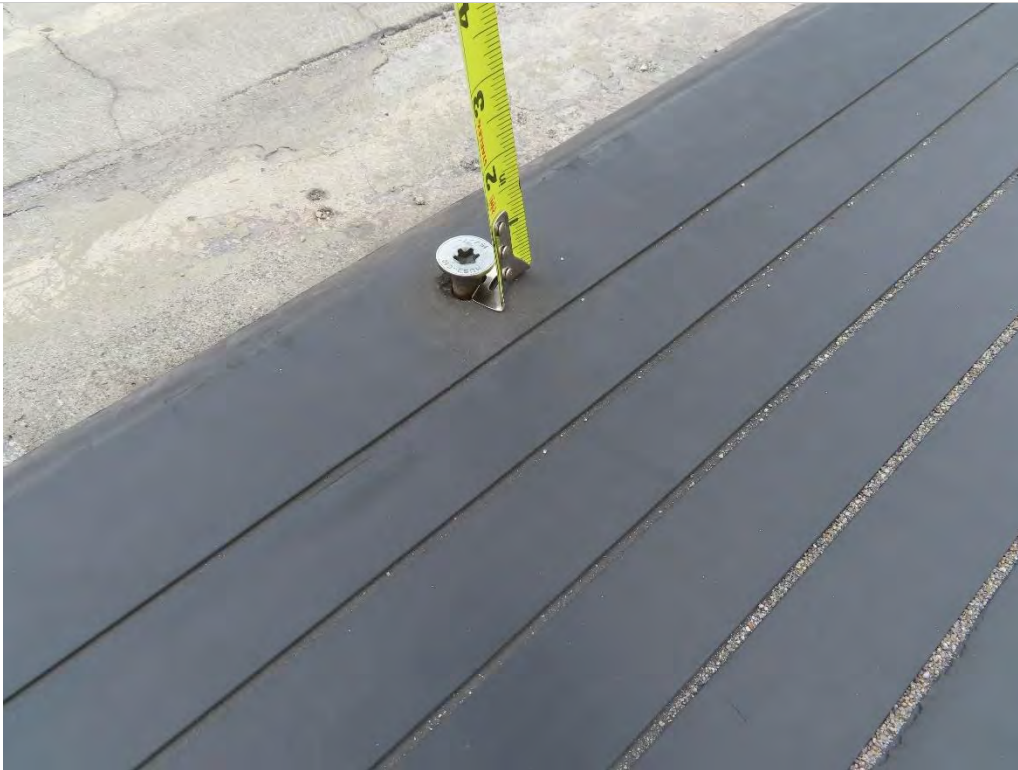
Photo 1.13- Expansion joint cover plate bolts projecting out, Village level (SH1-185)

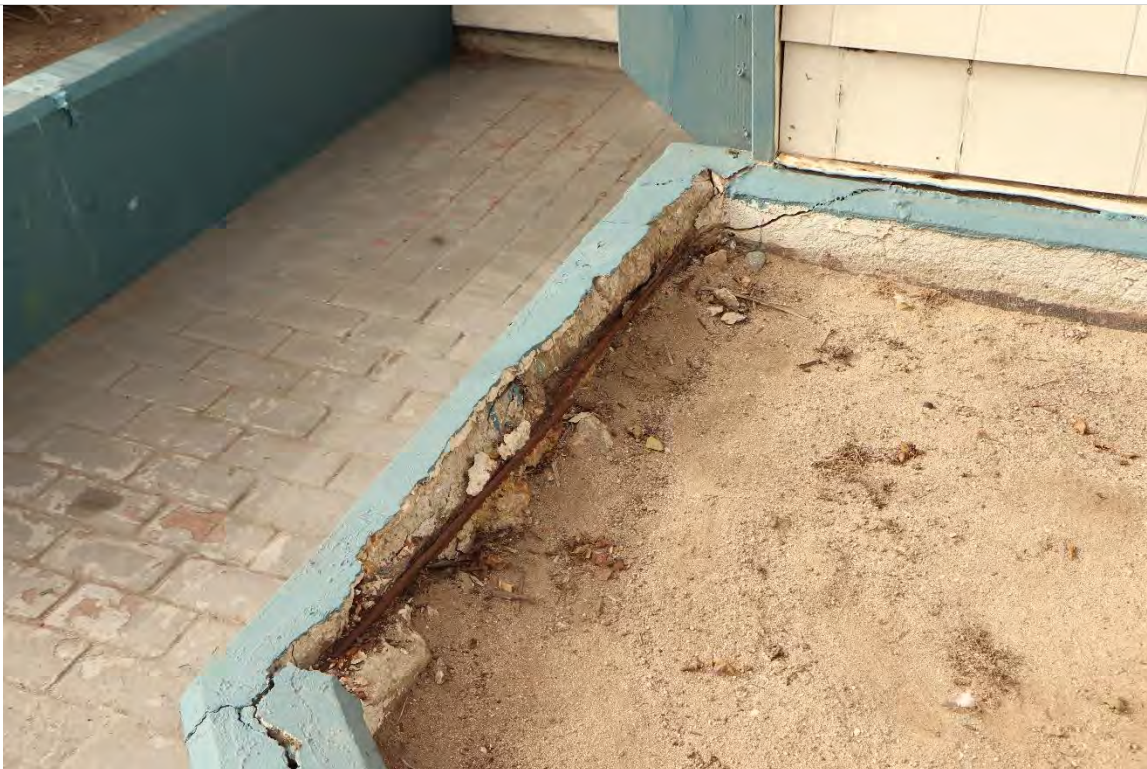
Photo 1.14- Typical spalled concrete planter walls, Village level (BA1-58)

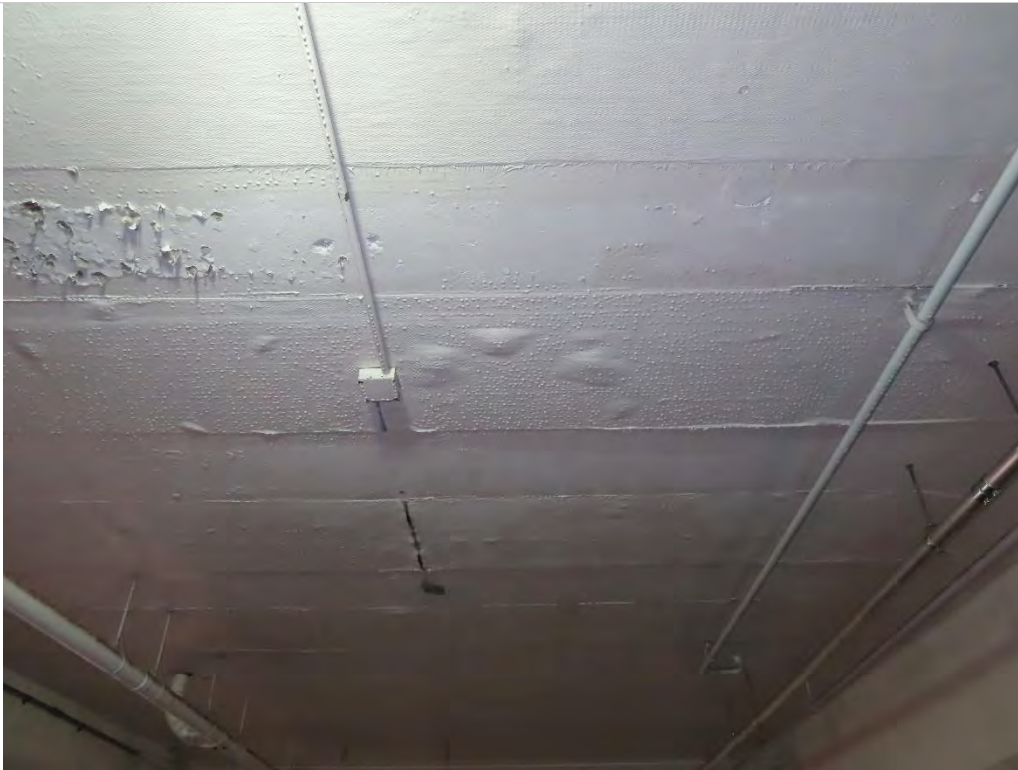
Photo 1.15- Deteriorated fiber reinforcing wrap, Village level (SH1-88)

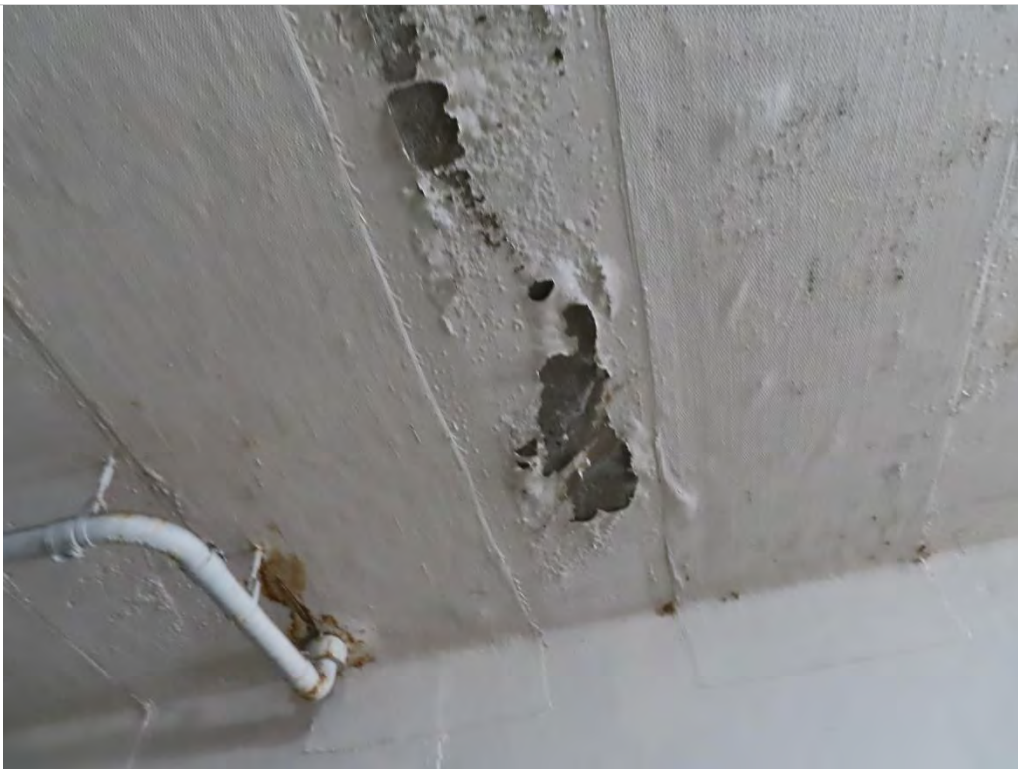
Photo 1.16- Deteriorated fiber reinforcing wrap, Village level (SH1-96)

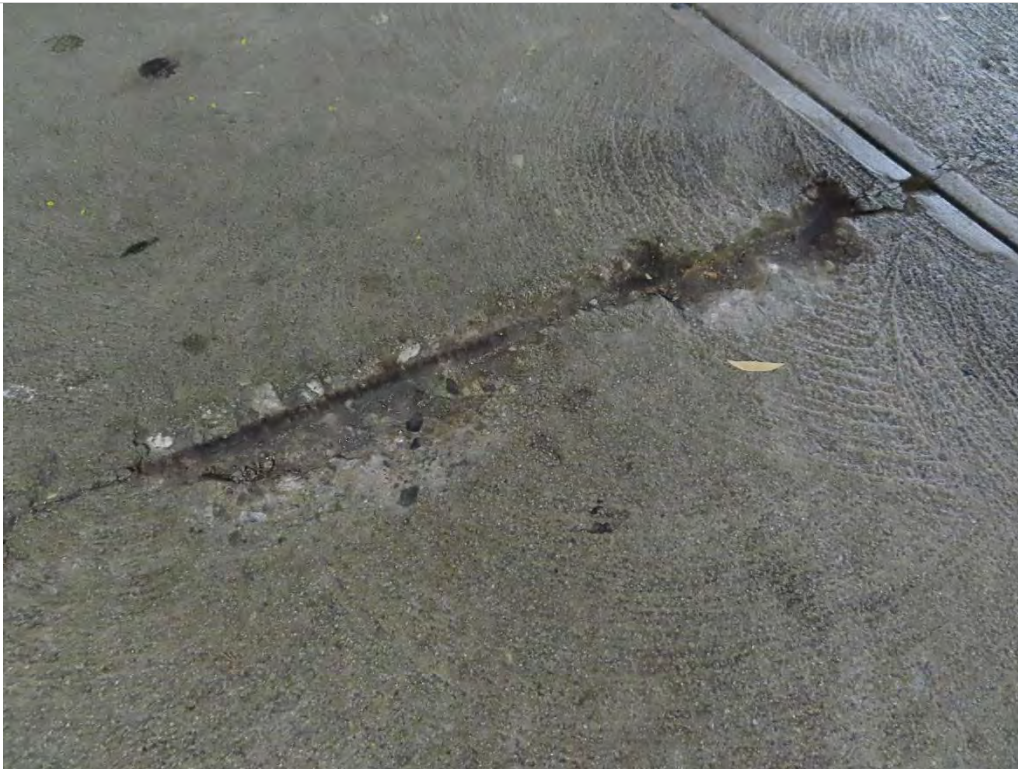
Photo 1.20- Exposed rebar on floor, Pier level (SH2-17)

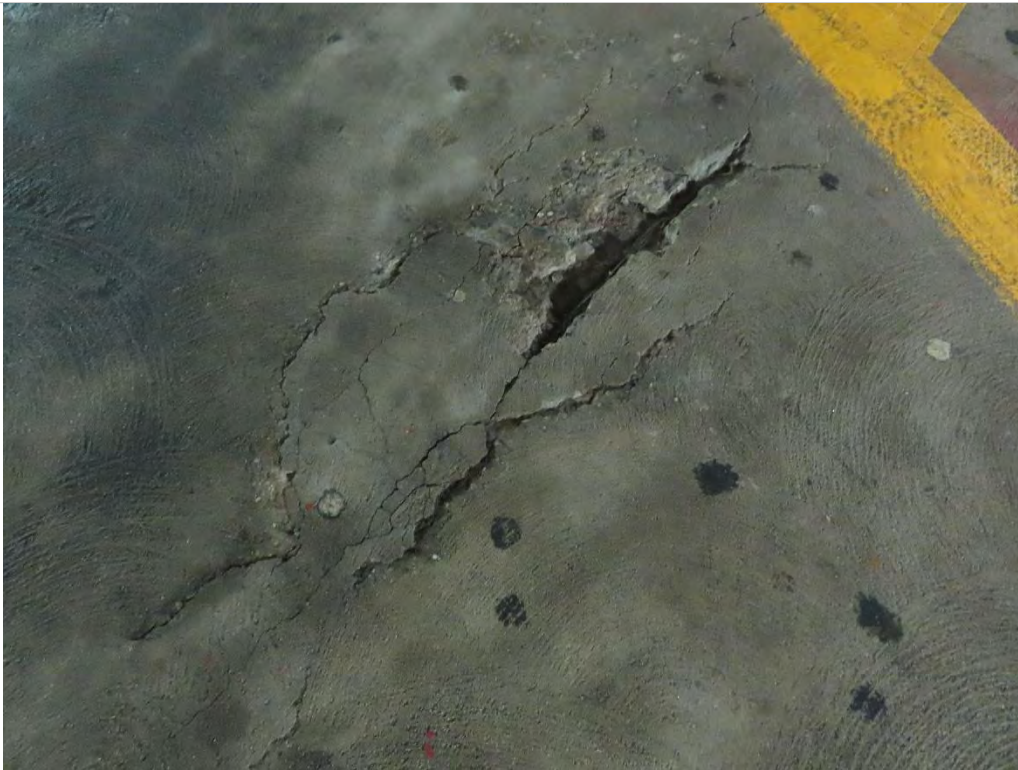
Photo 1.21- Concrete spalling at slabs, Pier level (SH2-10)

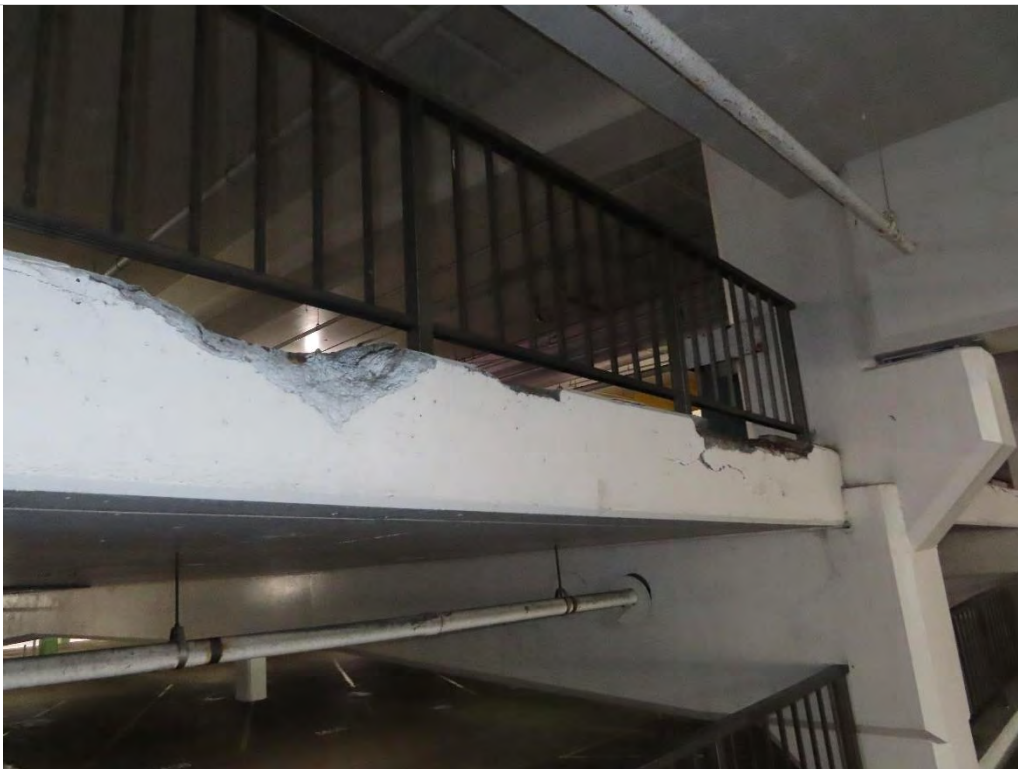
Photo 1.22- Isolated slab edge spall, Pier level (MM1-129)

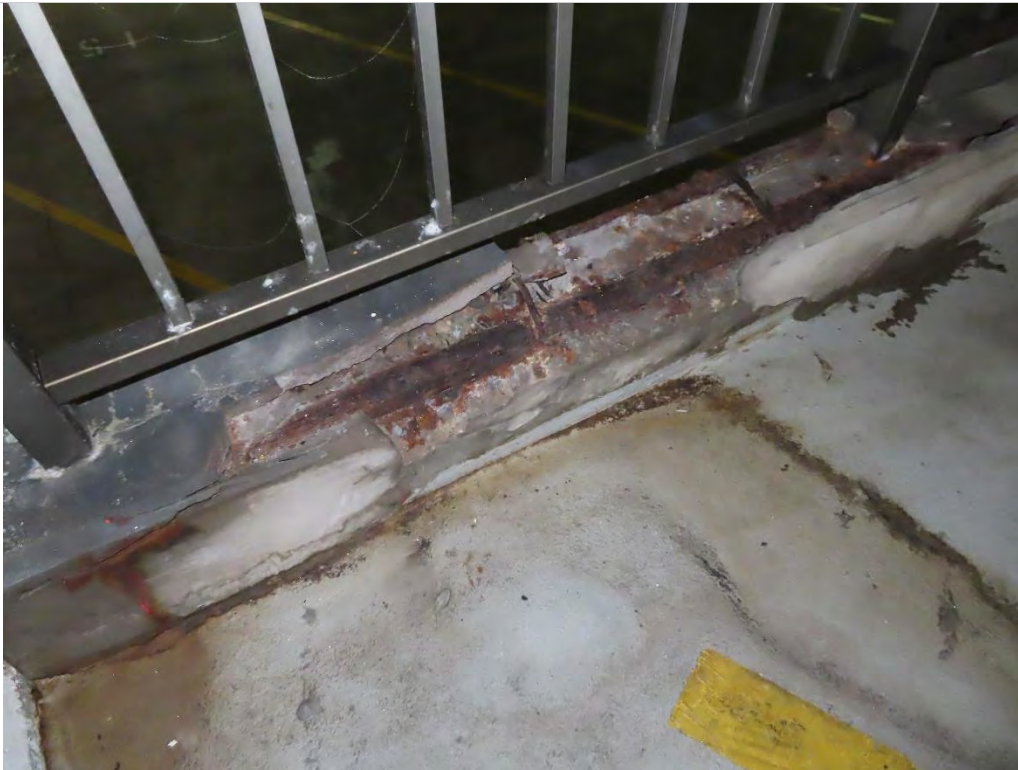
Photo 1.23- Isolated slab edge spall, Pier level (SH1-198)

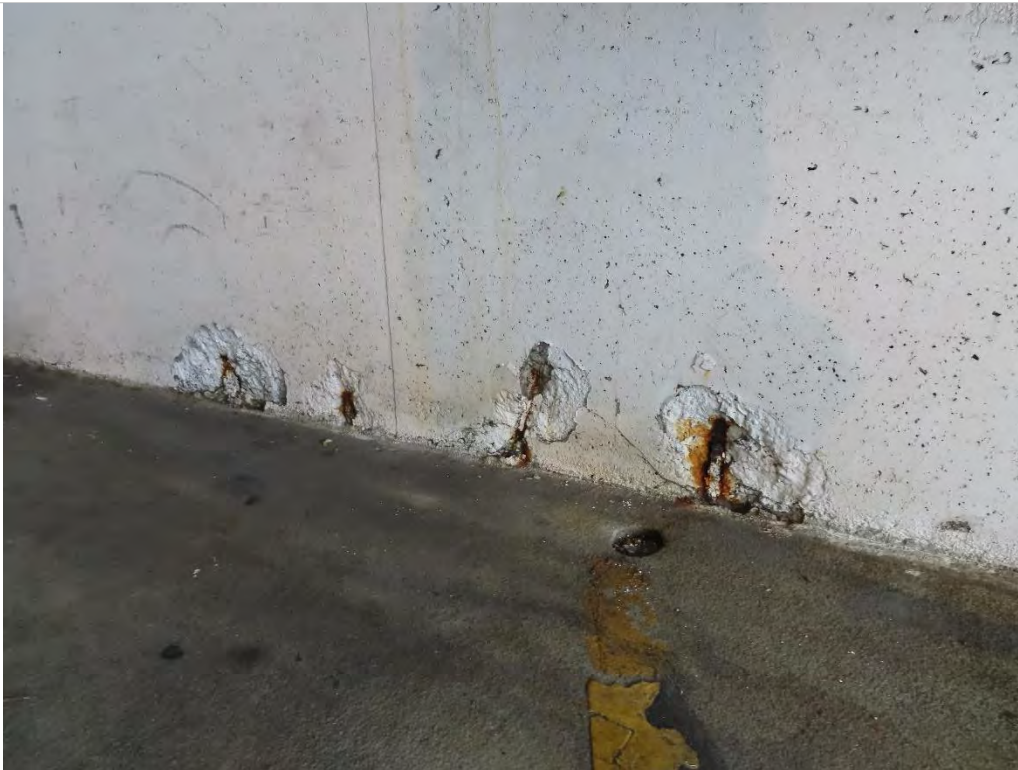
Photo 1.25- Exposed rebar on wall, Pier level (SH1-118)

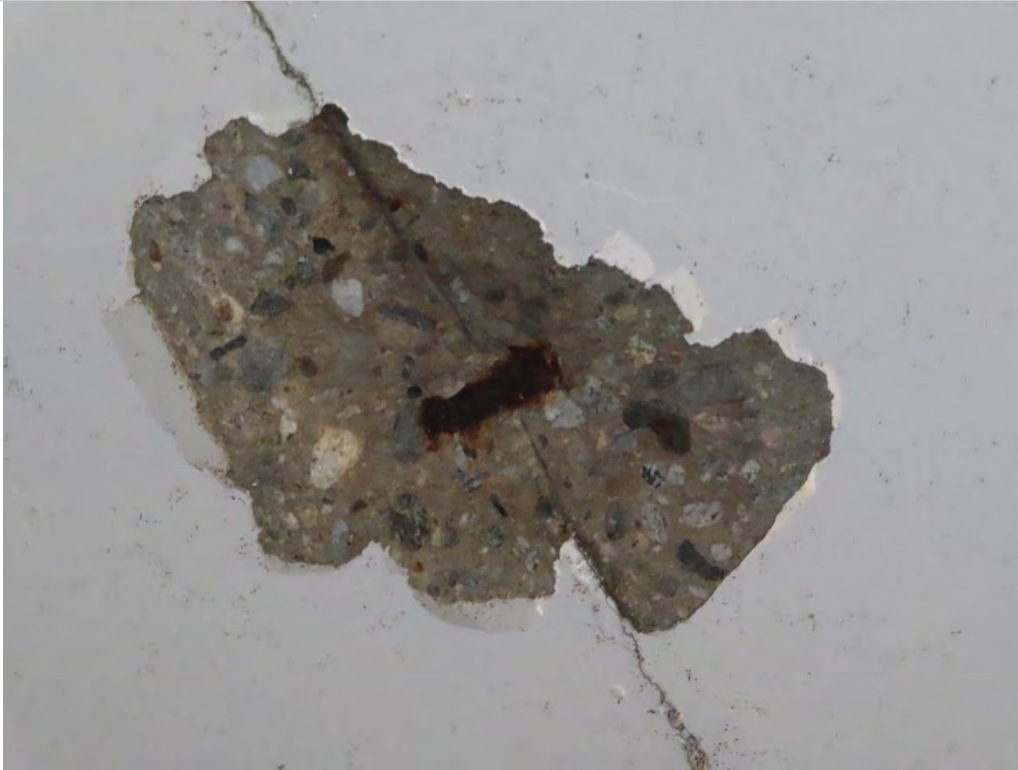
Photo 1.27- Soffit slab deterioration and spalls with exposed reinforcement, Pier level (SH2-58)

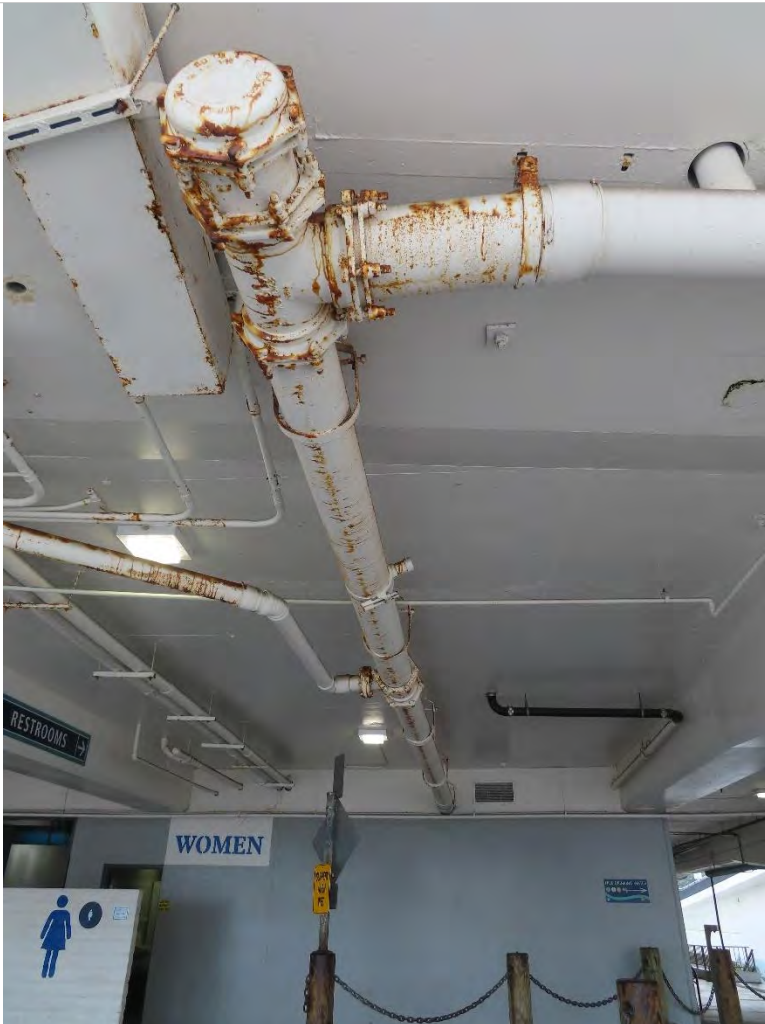
Photo 1.34- Corroded drainpipe, Pier level (MM1-33)

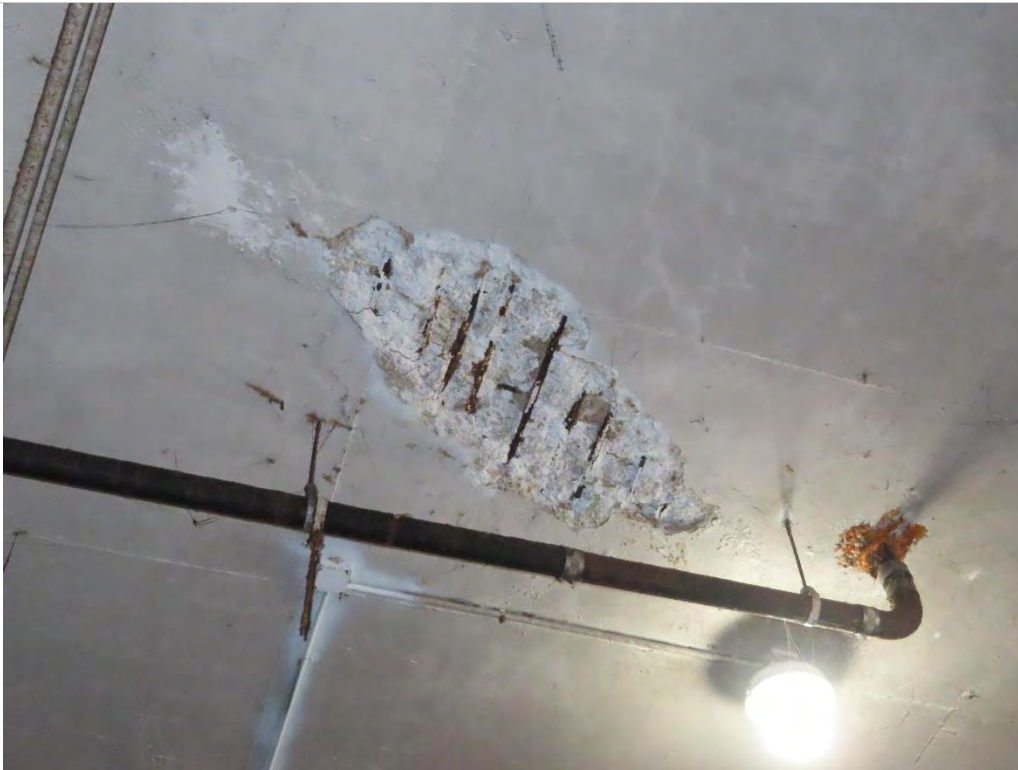
Photo 1.35- Corroded drainpipe, Pier level (MM1-82)

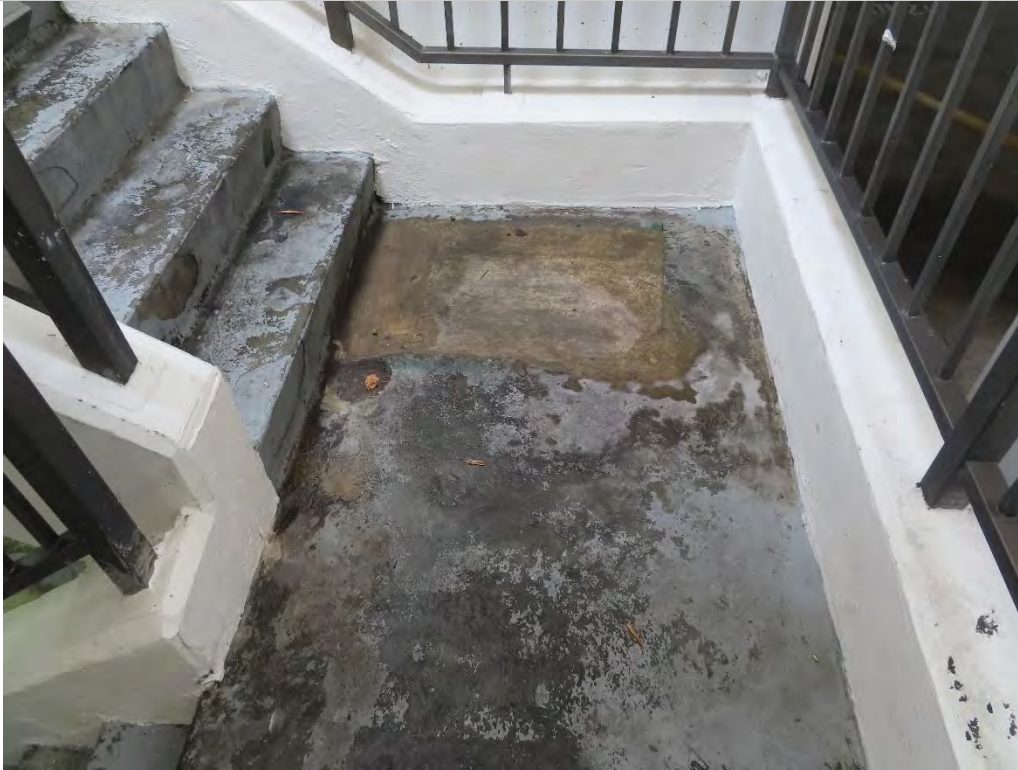
Photo 1.39- Typical stair coating worn off, (SH2-88)

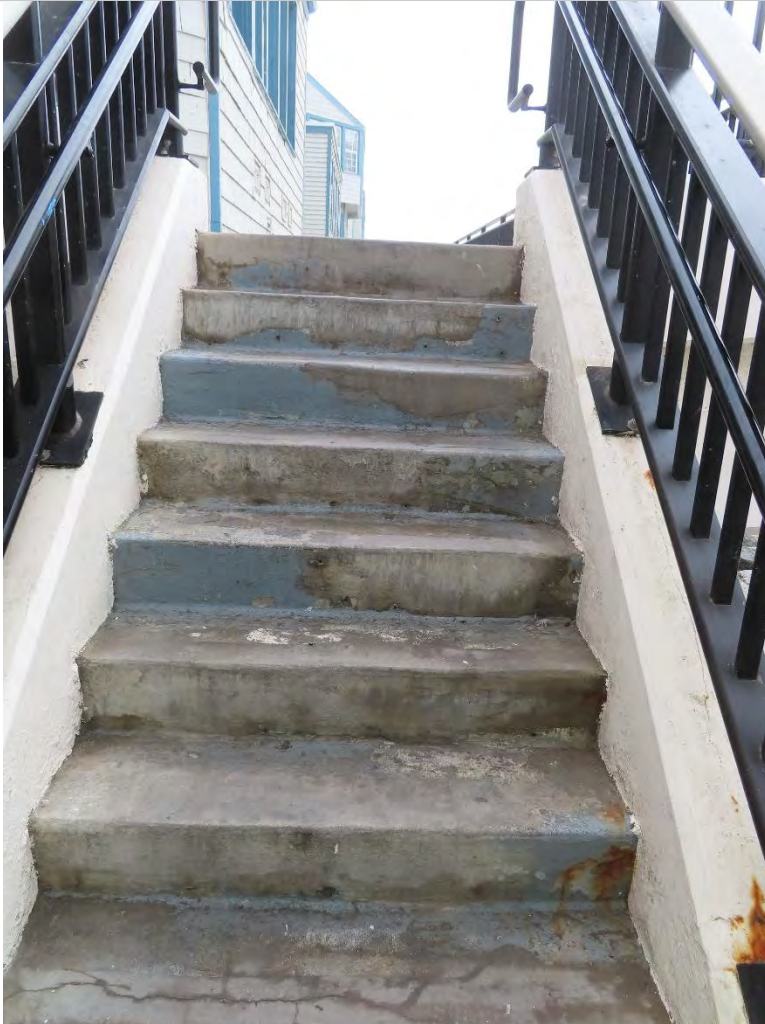
Photo 1.40- Typical stair coating worn off, (SH2-118)

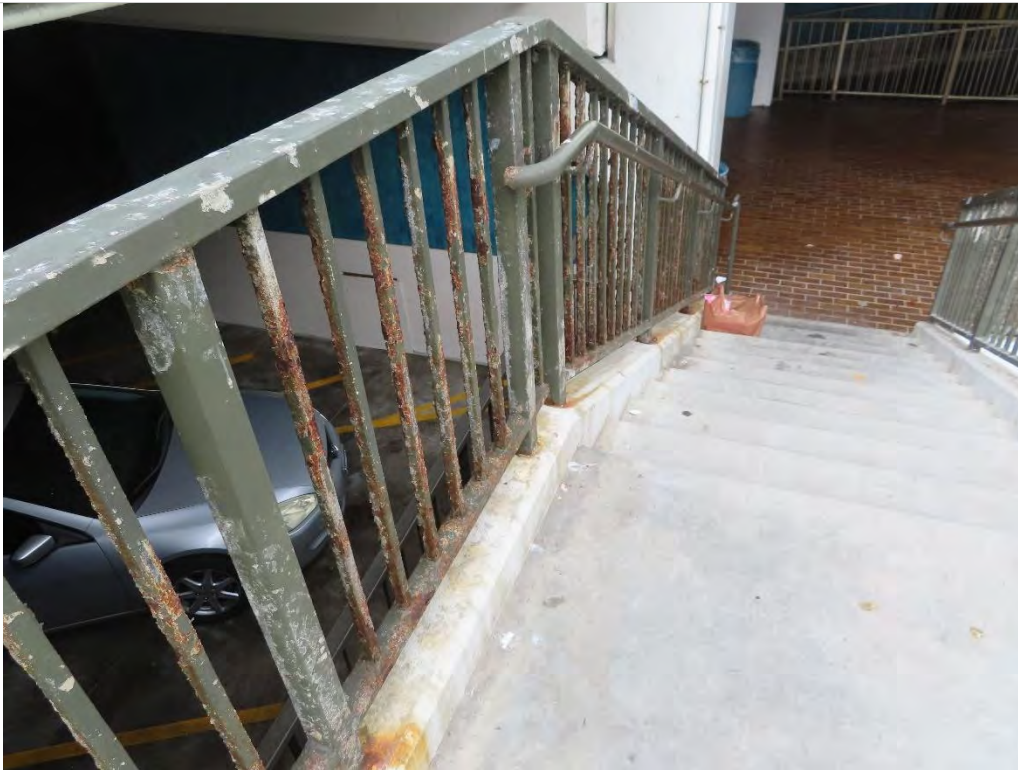
Photo 1.41- Corroded stair railing, (SH2-103)

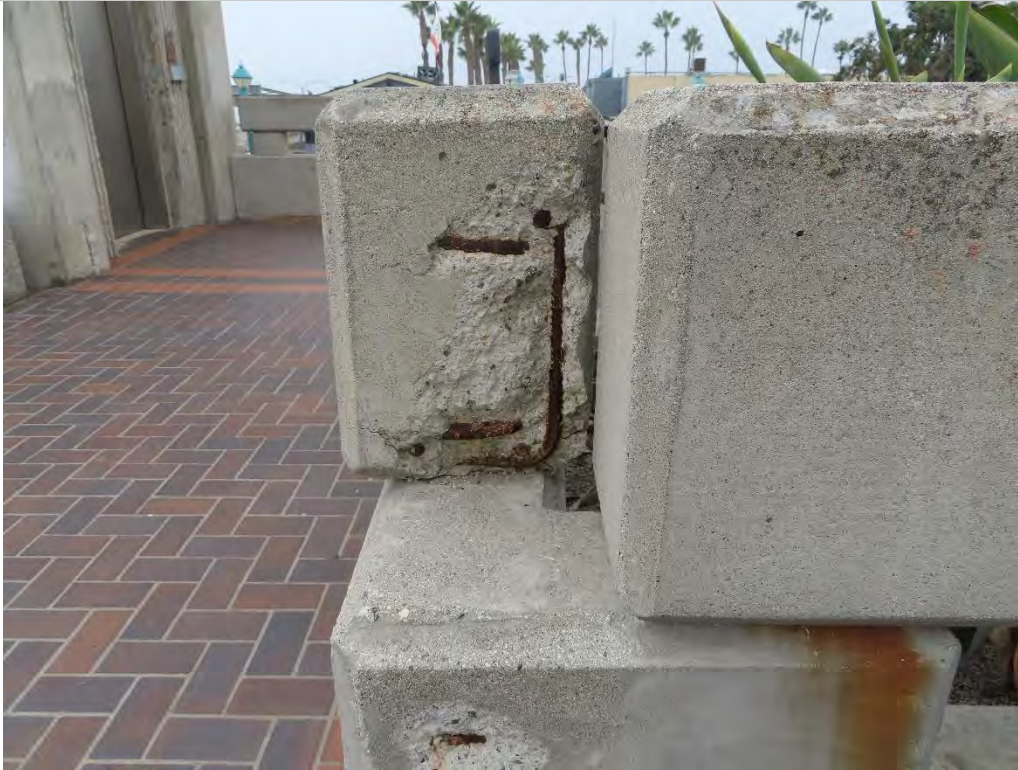
Photo 2.1- Spalled precast concrete spandrel with exposed rebar, Plaza level (SH2-265)

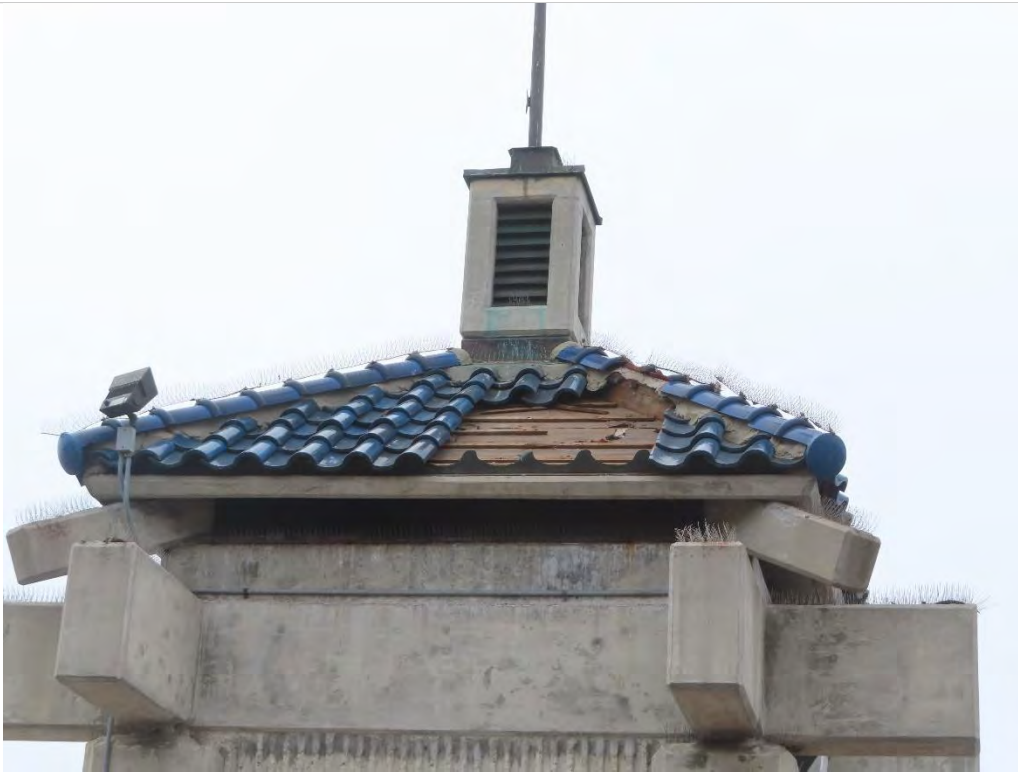
Photo 2.3- Missing roof tiles on the stair tower, Plaza level (SH2-130)

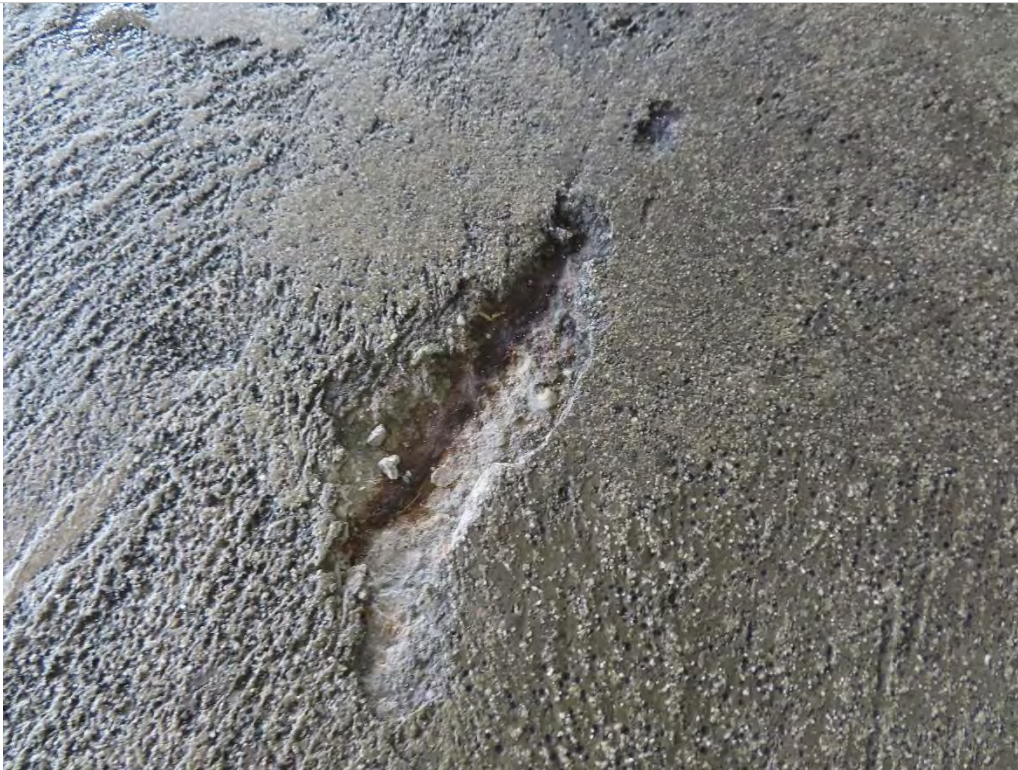
Photo 2.5- Exposed rebar on floor, Pier level (SH2-155)

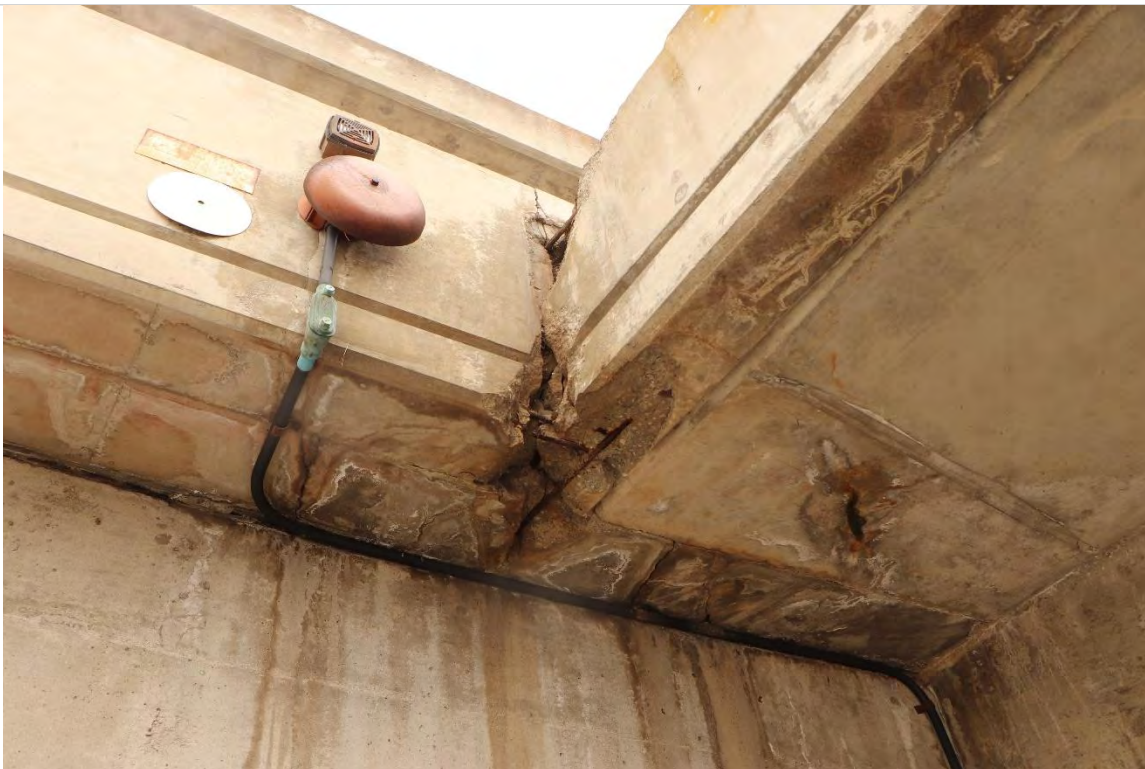
Photo 2.6- Soffit slab deterioration and spalls with exposed reinforcement, Pier level (BA1-326)

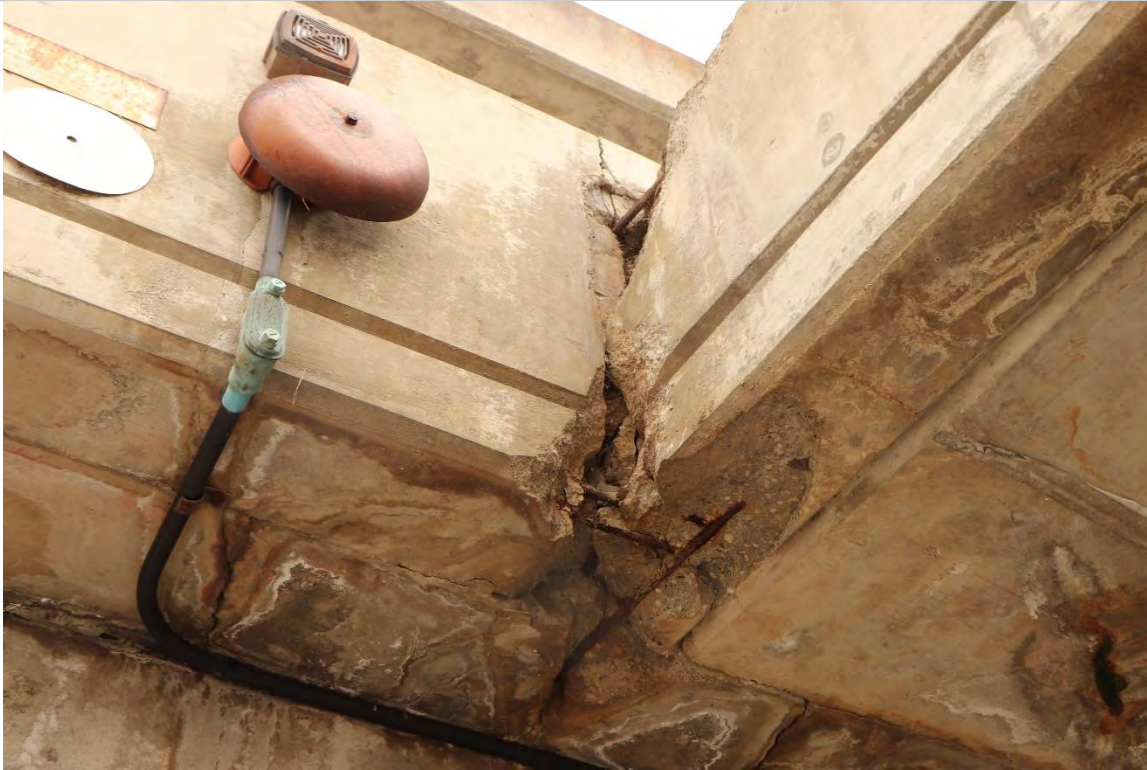
Photo 2.7- Soffit slab deterioration and spalls with exposed reinforcement, Pier level (BA1-327)

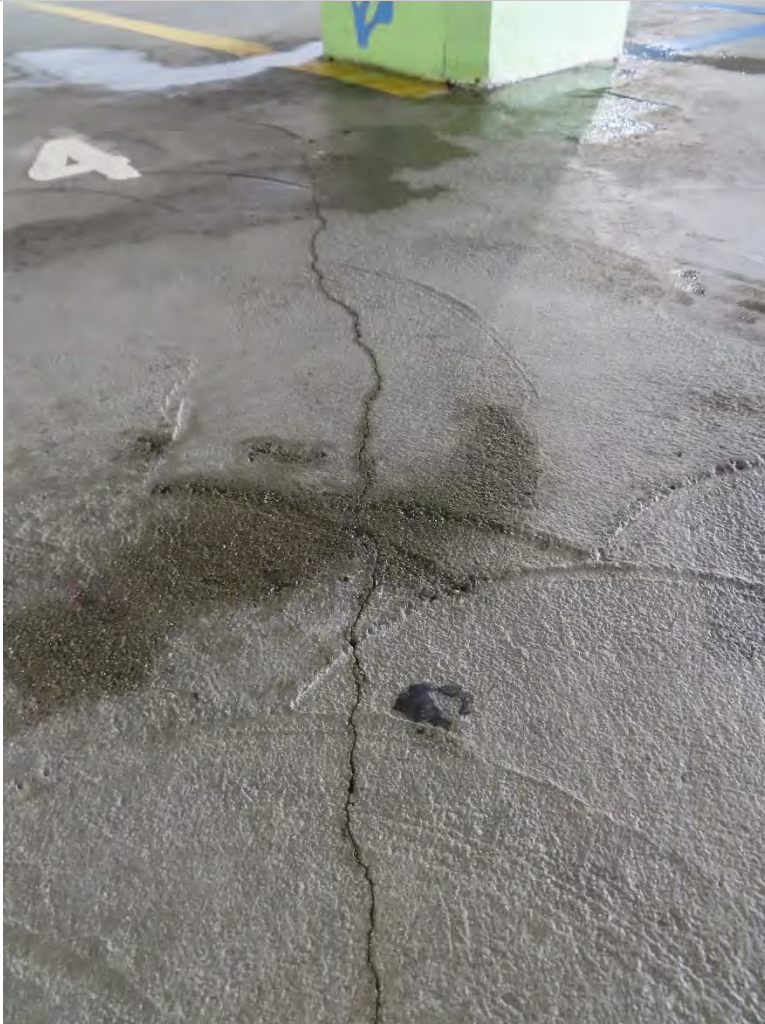
Photo 2.8- Cracks on concrete floor slab, Pier level (SH2-151)

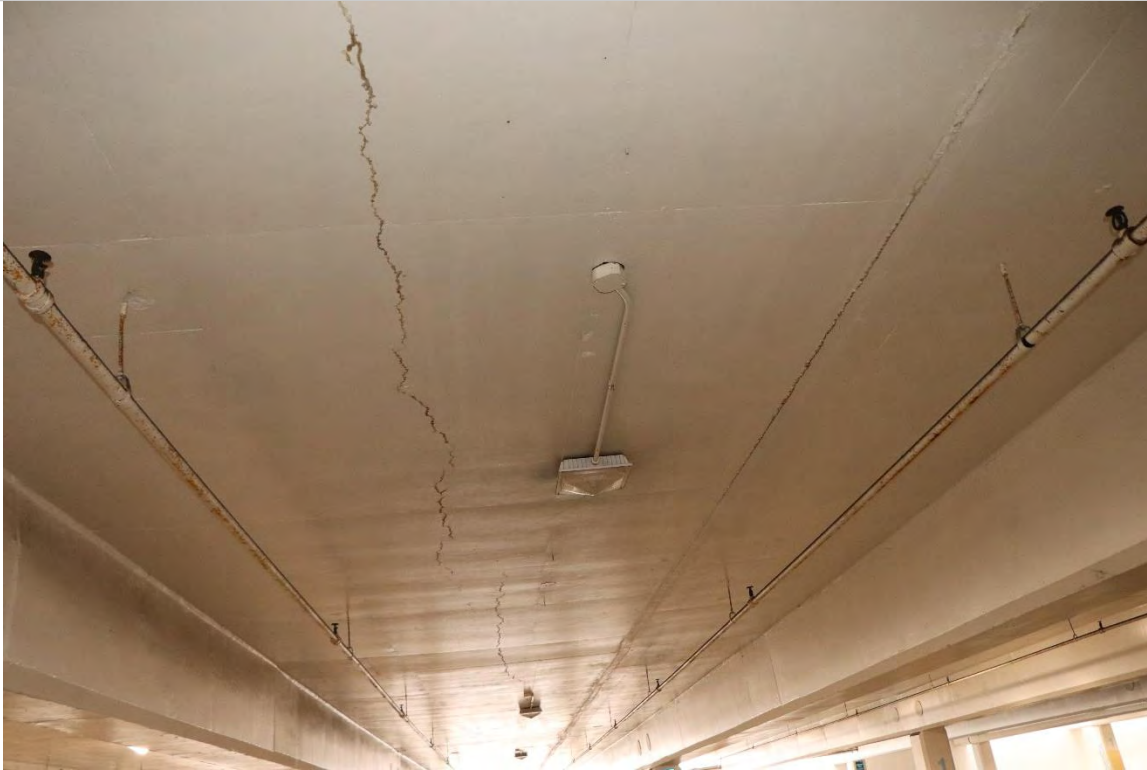
Photo 2.9- Cracks underside of concrete slabs, Pier level (BA1-319)

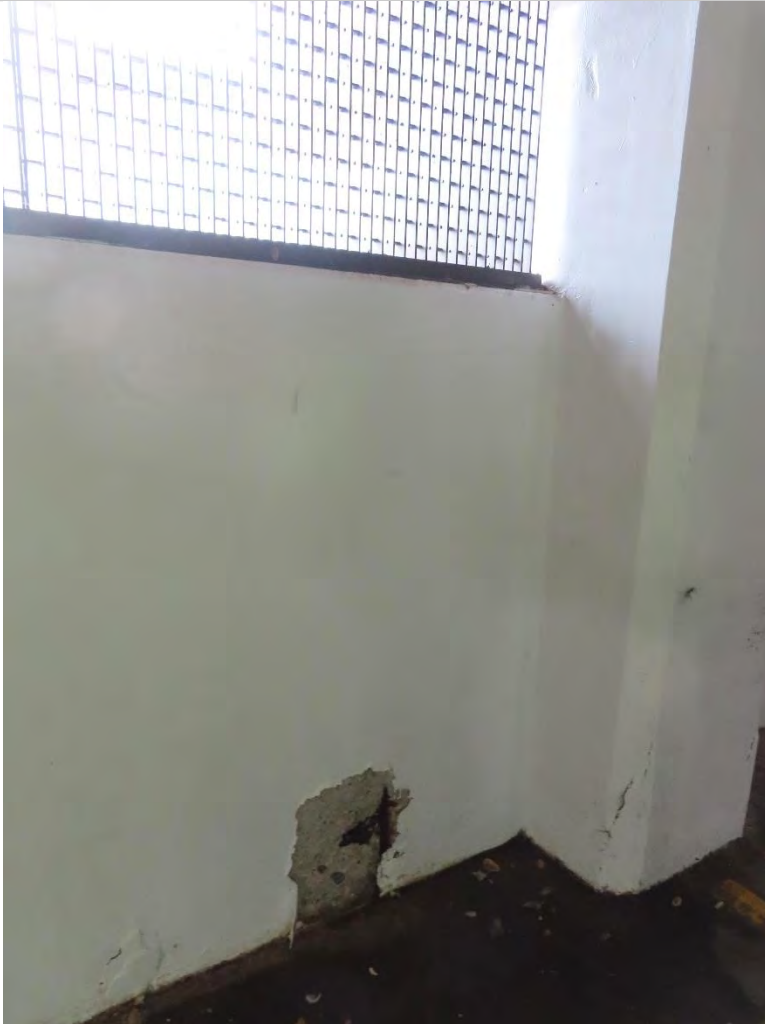
Photo 2.12- Exposed rebar on wall, Basin level (SH2-198)

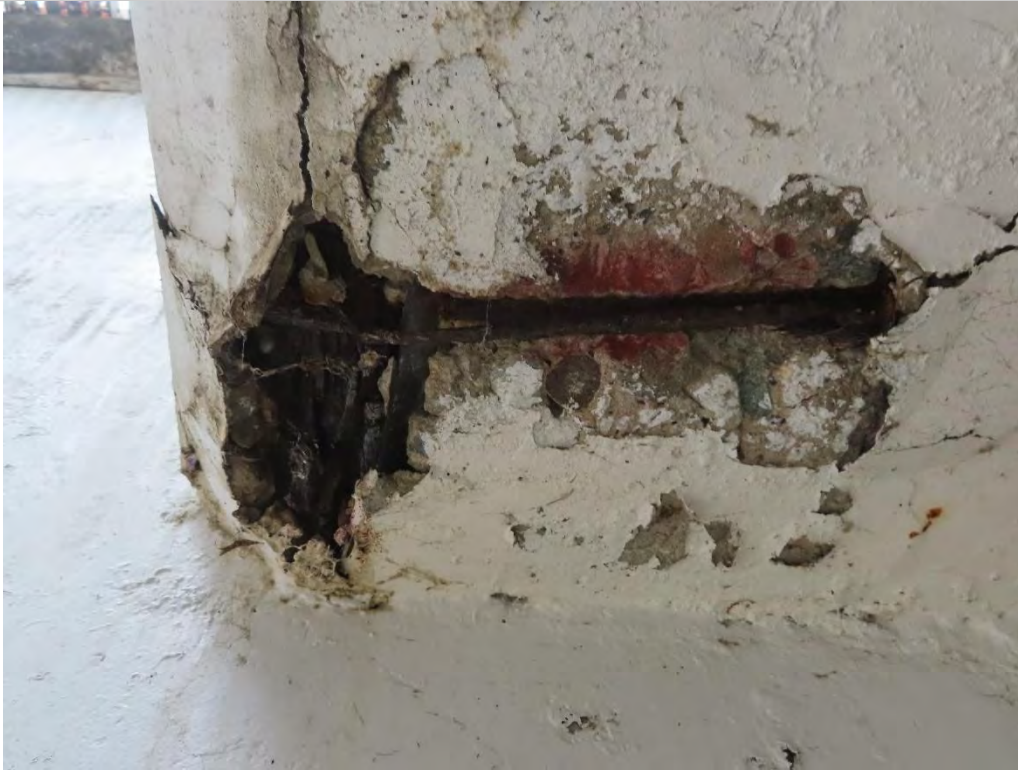
Photo 2.15- Damaged beam P/T rebar, Basin level (SH2-174)
