MEMORANDUM

Re: 2021/22 Pier Parking Structures Condition Assessment

**CITY OF REDONDO BEACH
NORTH PIER PARKING
STRUCTURE
2021-CONDITION ASSESSMENT**
CITY OF REDONDO BEACH
Redondo Beach, CA

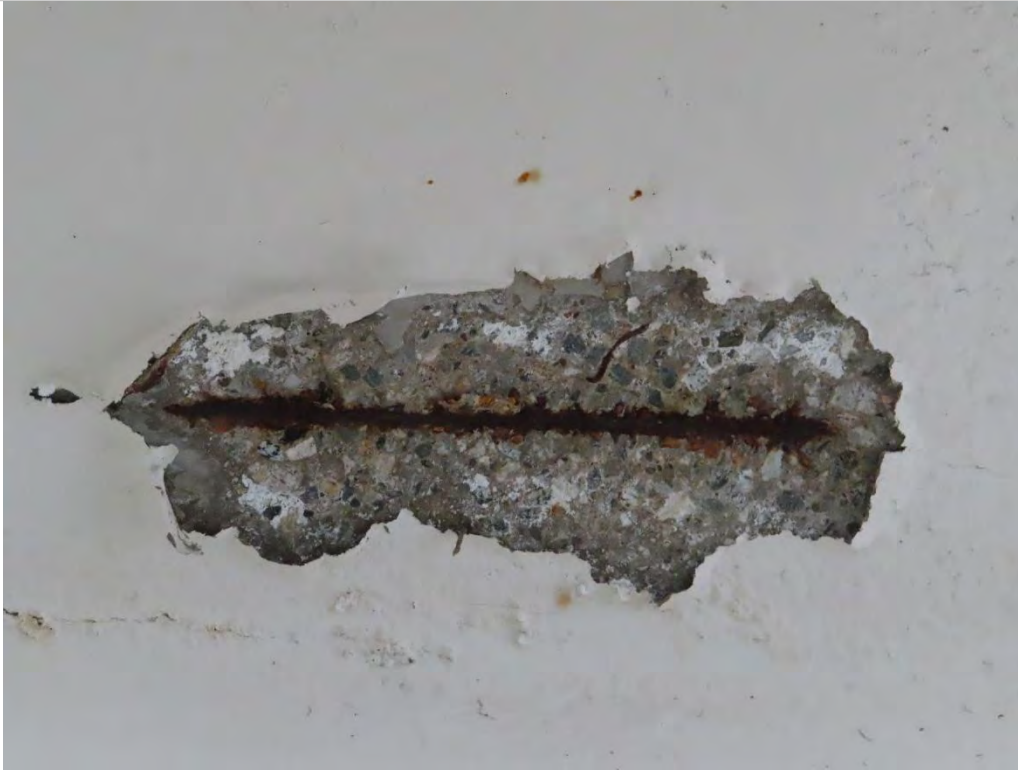
Photo 1.1- Soffit slab deterioration and spall with exposed reinforcement, Village Level (SH3-79)

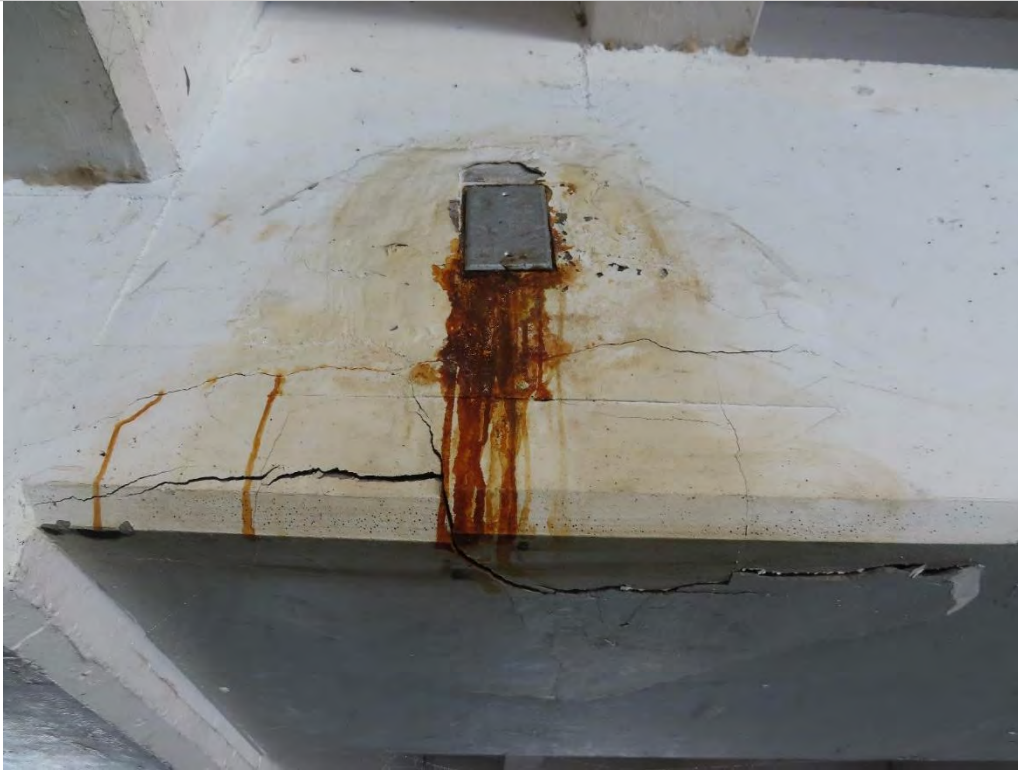
Photo 1.10- Concrete beam spall, Pier Level (SH3-201)

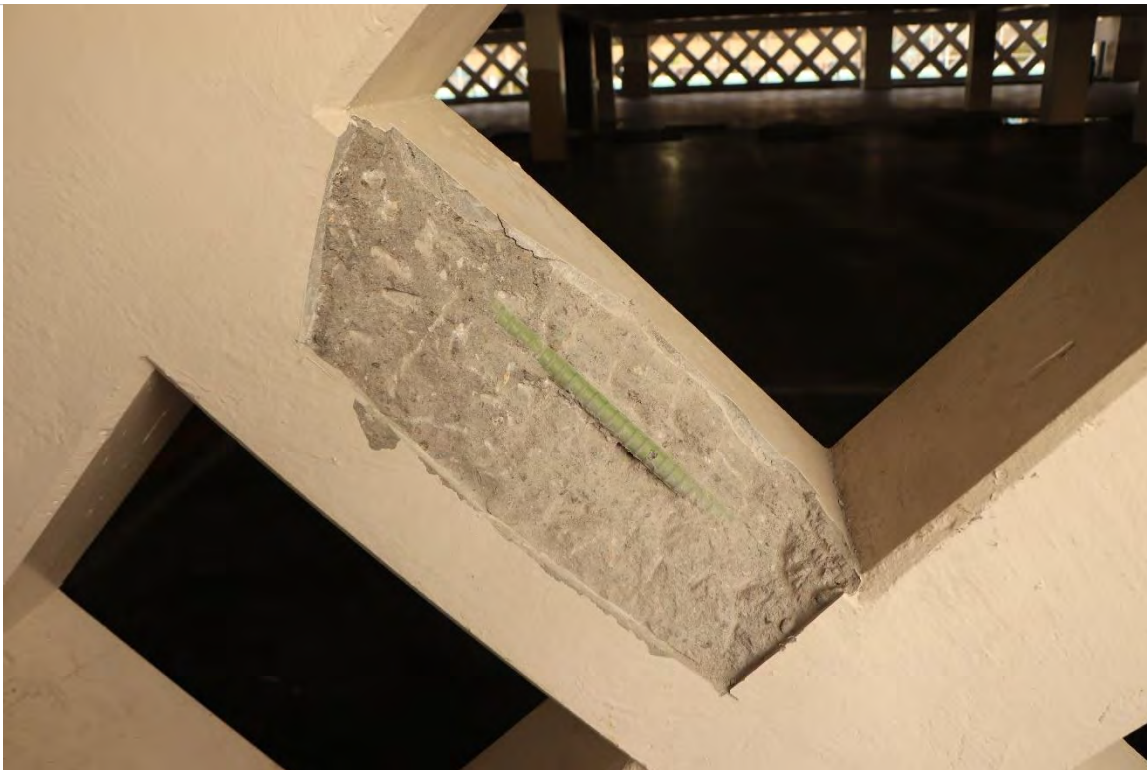
Photo 2.13- Opening of diagonal members on waffle wall, Only # 6 longitudinal bar was found, No confinement bar was present, 1992 Retrofit Wall on Gridline 3— Pier Level (BA2-178)

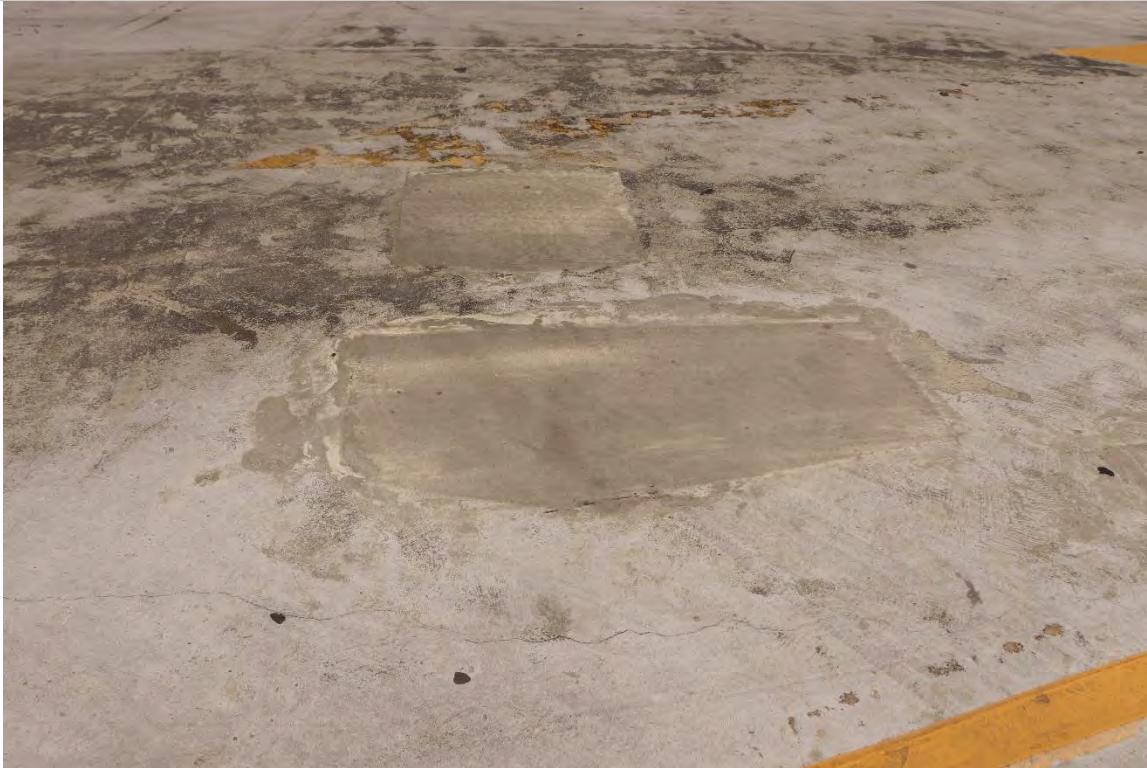
Photo 1.3- Delaminated previous repair, Village level (BA1-111)

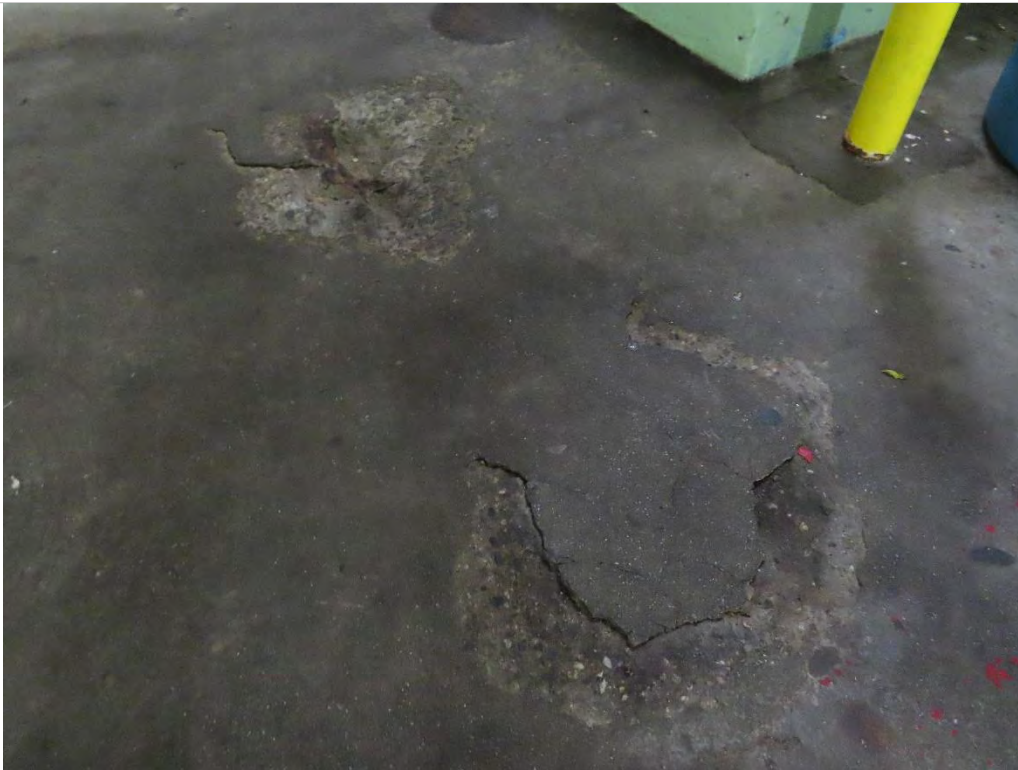
Photo 1.37- Deteriorated slab on grade, Basin level (SH2-48)

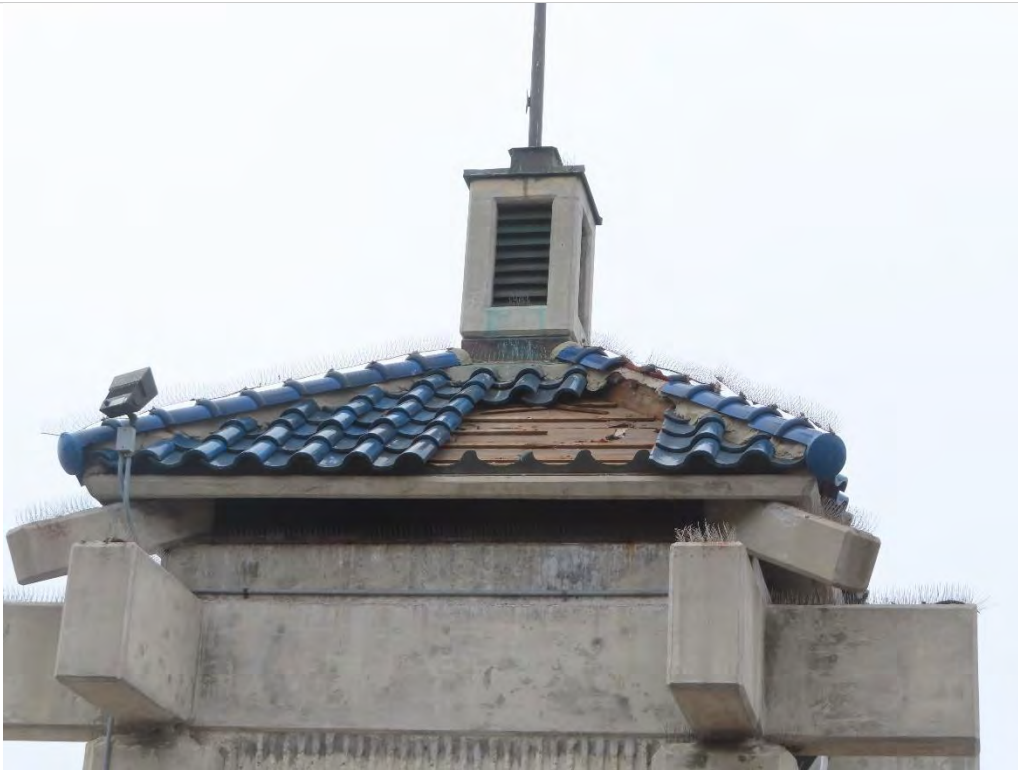
Photo 2.3- Missing roof tiles on the stair tower, Plaza level (SH2-130)
