| Project Name | Aviation Park Soccer Field ASTM F1936 Gmax Impact Evaluation | | |
| Client Info | AFE SPORTS 2683 Lime Ave, Signal Hill, CA 90755 | Site Info | 1935 Manhattan Beach Blvd, Redondo Beach, CA 90278 |
| Report Date | 09/10/2021 | Test Date | 09/09/2021 |

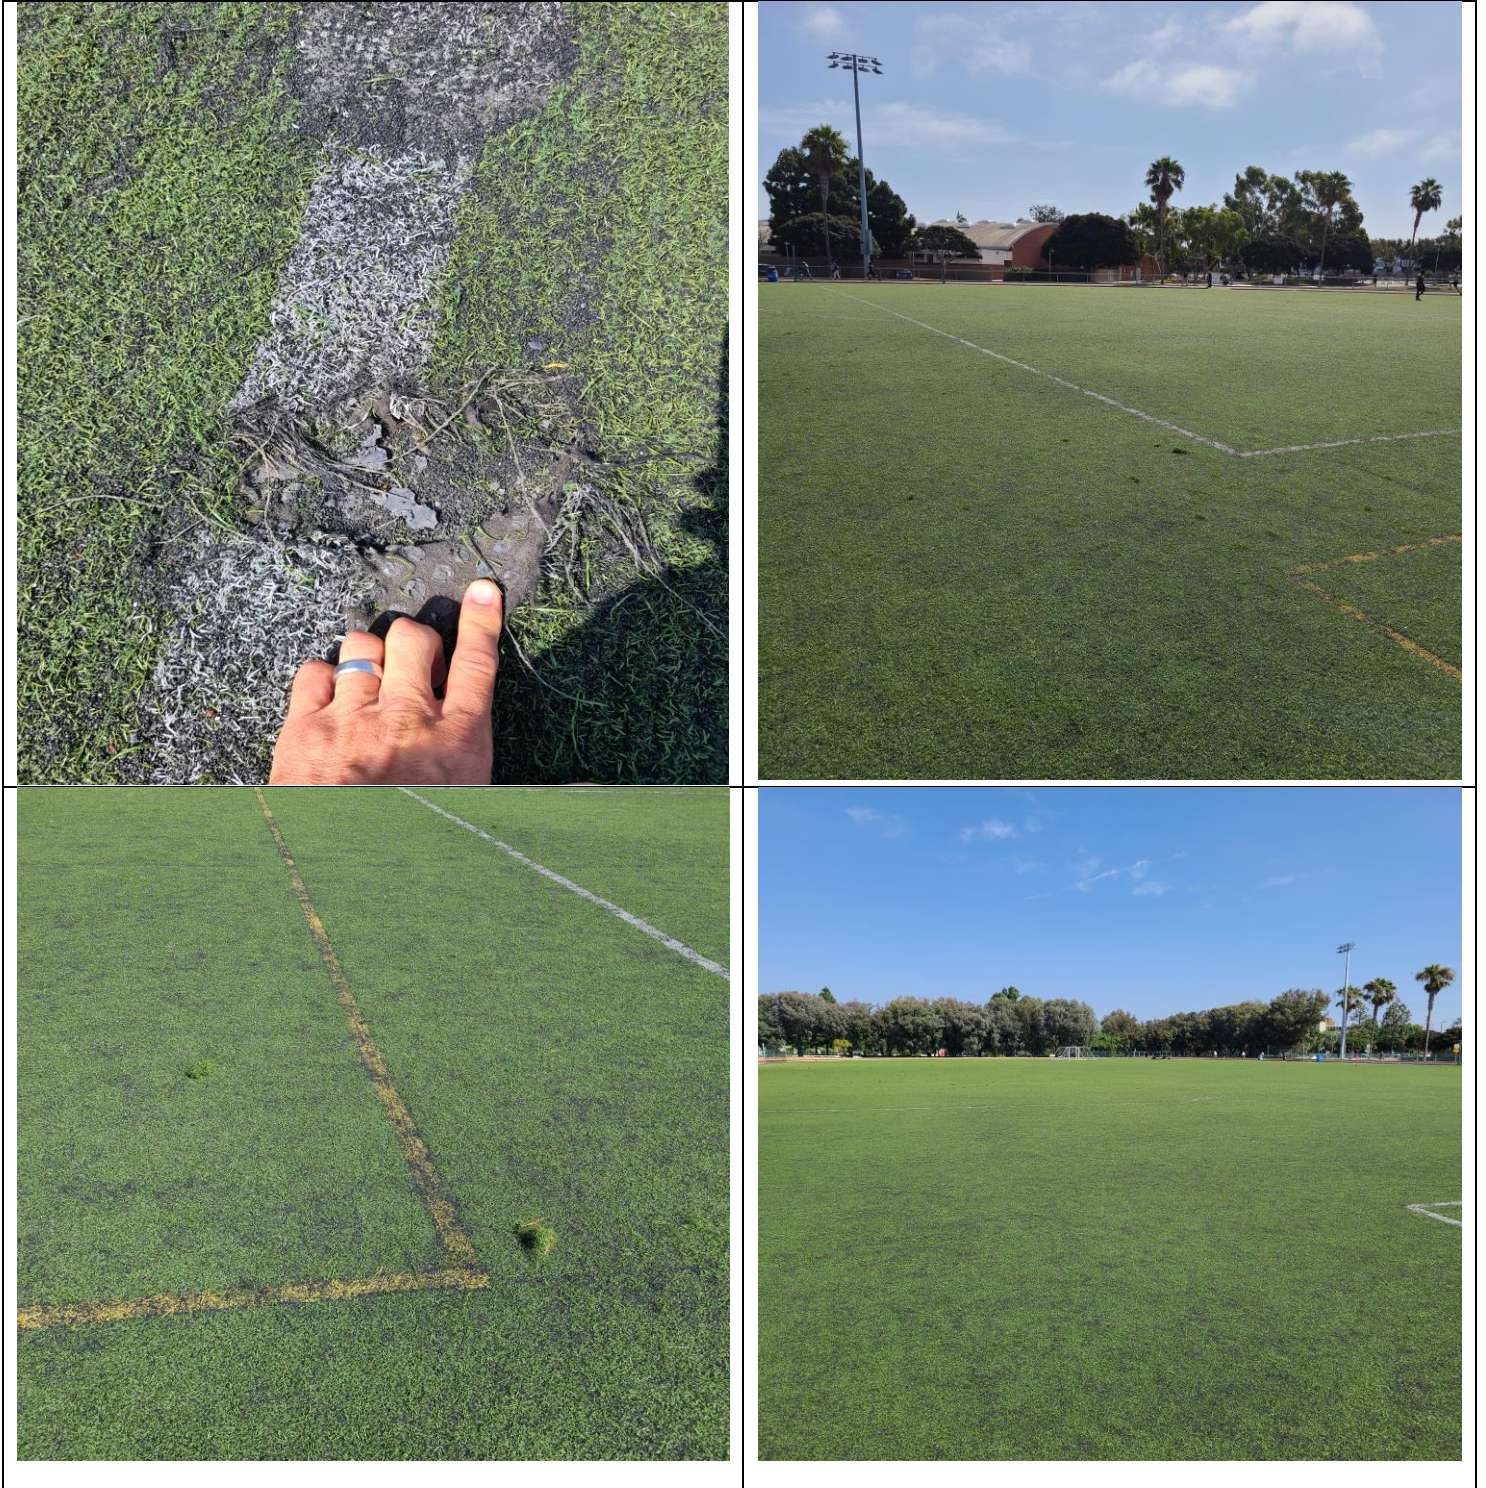
Site Photos:

1. There are locations in the goal mouths of the small sided soccer that are exposing the underlayment and destroying the integrity of the product below. These areas fall outside of our testing locations per ASTM requirements but would fail or come close to failing for safety. These locations need to be repaired immediately.

2. The surface has lost significant yarn and has lots of SBR rubber on the surface that players are interfacing with and playing directly upon. This can create a slicker surface for players creating more player to surface interaction than a field with uniform yarn heights.

5. There is a tremendous amount of loose yarn all over the surface and around the site. With the site containment becoming a growing concern for field owners in respect to the impact it has on the storm water runoff and carrying plastic to the ocean overtime. This being an older field the lead levels of the yarn maybe exceeding the 50 – 100 PPM that most design and Municipality Owners require the yarns to comply with when purchasing new fields today. The lead and other chemicals in the yarn were not of high concern at the time this field was installed at its estimated date of 2007. The growing concern of the PFAS materials (plastic and rubber) leading to the ocean and storm water system in relation to this field, I would suggest that the field and site be cleaned of the yarn and excess rubber on the surface to ensure a better containment of the plastic fibers and rubber leaving the site. My concern would be with rubber removal to only happen around the site, as removing any surface rubber from this field will only increase the hardness at this point in time of the field's life.

7. The field estimated installation date is 2007. The age would be close to 14 years old. From our observations in testing fields and building fields in California this product has seen its time and I would suggest that replacement of the surface be completed sooner than later at this time.
