APPLICATION FOR CERTIFICATE OF APPROPRIATENESS

132 N. Catalina Avenue

132 N. Catalina Avenue (1905/1930)

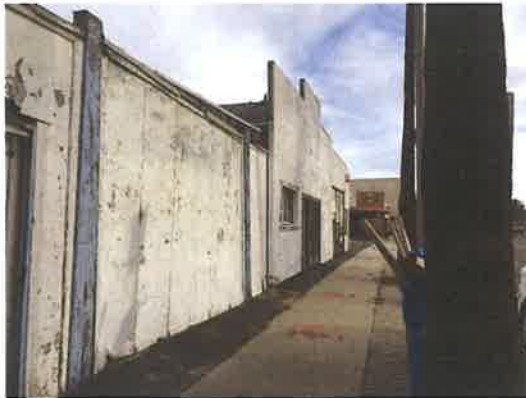
Initial investigation found unfinished vertical wood siding that is in poor condition behind the metal panels. The wood framing of the wall behind the woodwork appears to be of relatively recent construction. At the front façade of the north portion, the woodwork at the columns and wall is in extremely poor condition. The enclosed north area has a low sloping roof that spans across the space but leaves a gap along the side property line. This structure may require removal or re-construction.

Façade at north end needs substantial Rehabilitation. Pilasters can be re-created

One method of restoration/rehabilitation would be use of new vertical wood for the front façade. The central entryway and parapet extension above should be retained as part of the building rehabilitation as they represent an early building form for small town commercial structures and industrial workshops. The north addition to the building can be demolished or reconstructed. Retaining the two columns at the frontage as a portal to the space would preserve a historic characteristic of the site.

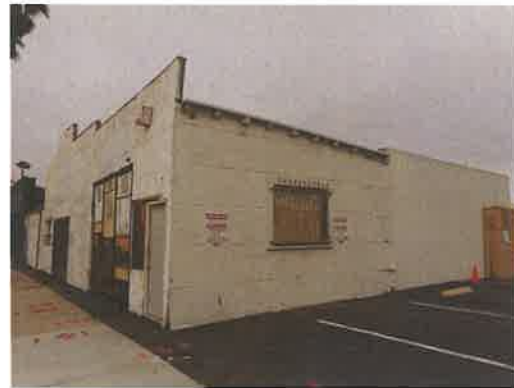
All openings should be rehabilitated

The front entry to main building should be maintained as well as the horizontal window to the north of the doors although the existing aluminum sash within the opening could be replaced with a more compatible window type. The large door at the street frontage of the south addition could also be replaced while

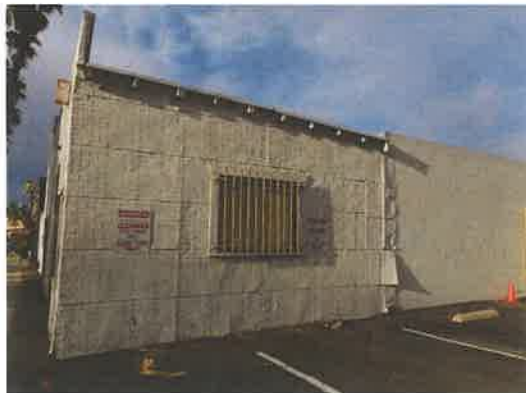
Much of the roof structure from the interior appears updated with plywood sheathing although some lumber looks older with true dimensions and square corners. The current main façade appears to have been constructed around WWII. The assessor indicates changes in 1930 which may relate to the additions to the building. One possibility is that there may have been a masonry façade that collapsed in the Long Beach Earthquake. Alternatively, the building may have had a vertical wood façade that was eventually covered with the metal siding although it is unusual that a wood façade would be unfinished. The current condition is that the wood façade behind the metal panels appears heavily deteriorated. The metal panels have also been applied in a haphazard process with a mix of nails and screws and metal panels were bent around the corner to extend along the south facade.

South façade with metal panel wrap to end of original wall

maintaining the large opening. The south wall of the south addition is covered with the metal panels partway and would be reconstructed with vertical wood to look similar to design for the front façade. The front portion of the south wall may extend to the original back corner for the angled rear façade that appears in early photos and maps, while the continuation of that wall is an addition to the building dating possibly to the 1950s. Openings can be created on the south façade but they should be setback from the street as far as possible. The rear of the building is not a significant part of the feature and can be partially cut back if necessary for overall project.

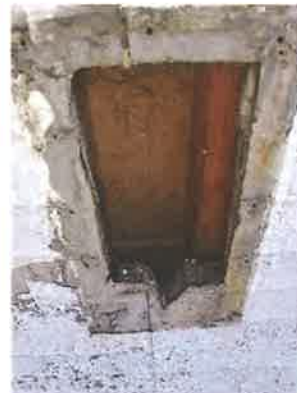
Façade investigation

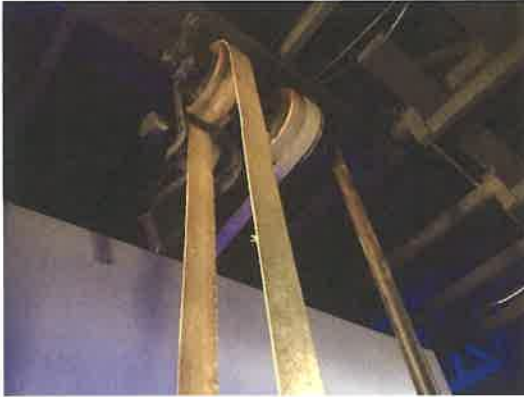
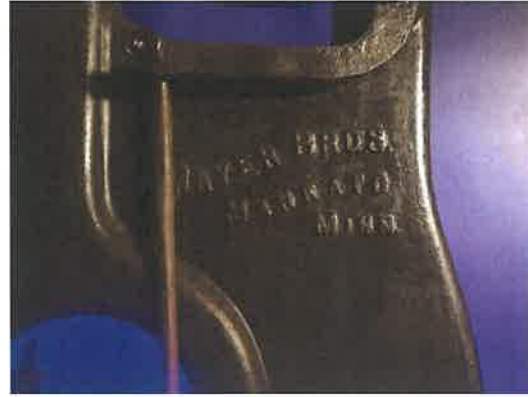
Large pulleys in the ceiling at the back of the main building connect a series of machines with a single motor. The assembly of machine elements is a historic feature of the space.

Interior features include metal work equipment
