Project Description by Noble Consultants, Inc.

PROJECT DESCRIPTION

KING HARBOR MAINTENANCE DREDGING PROJECT

July 10, 2020

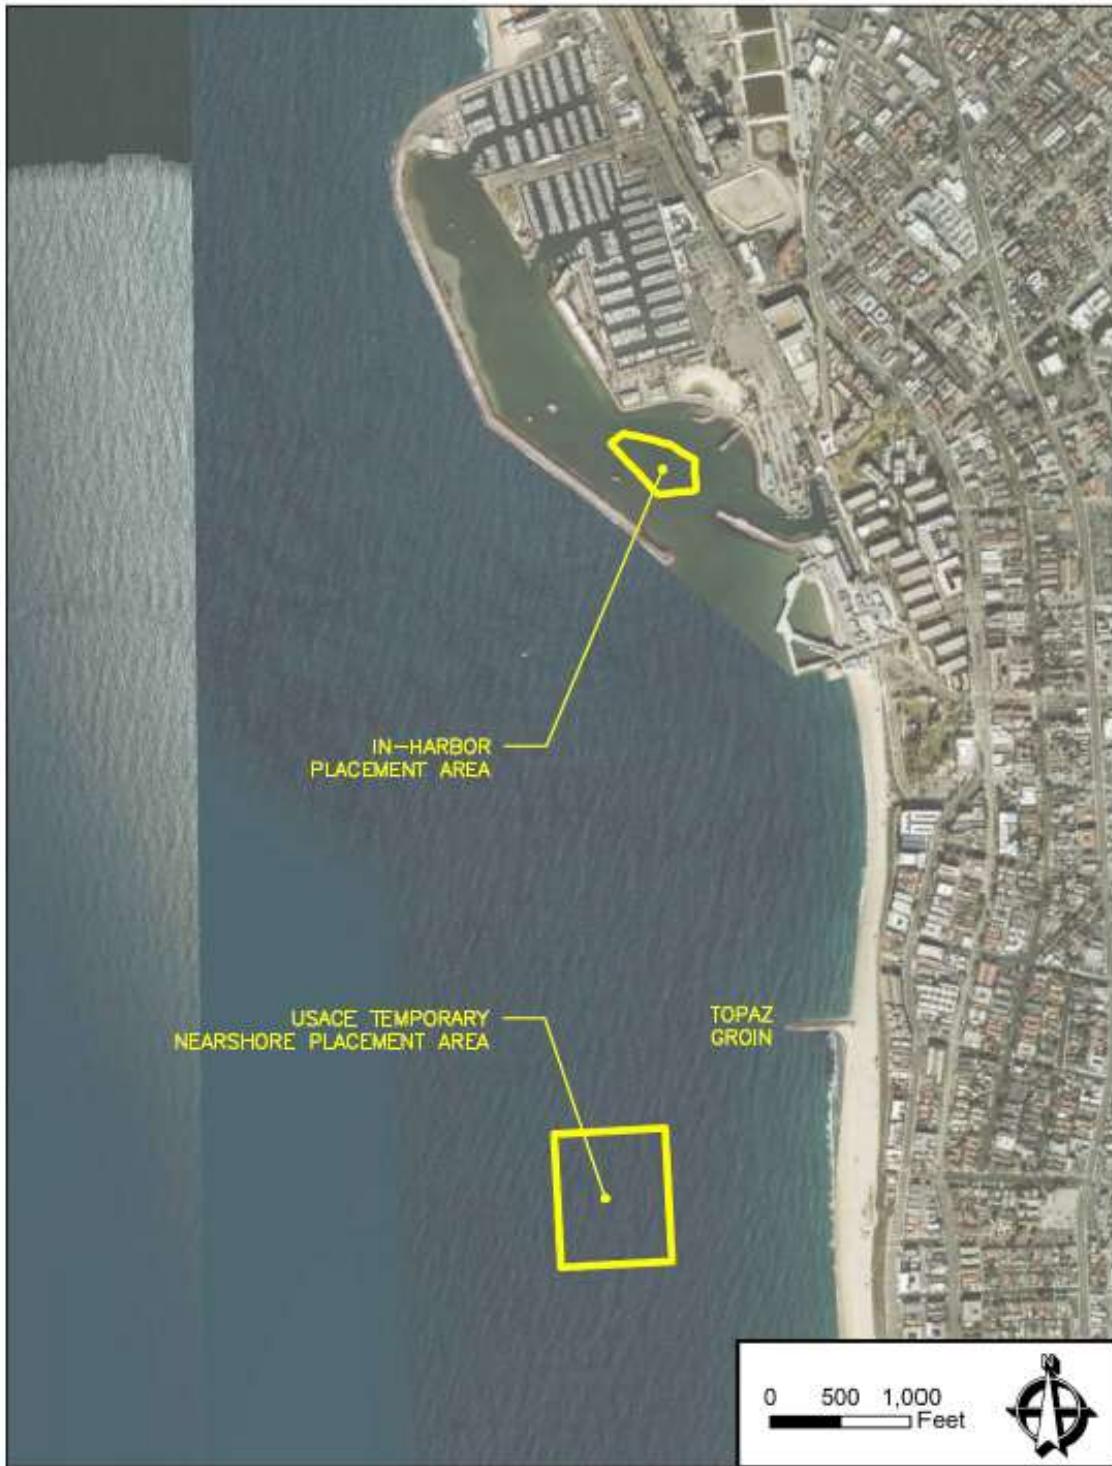
Figure 4. Plan View of Dredged Material Placement Areas

The In-harbor placement site will act as a sediment sink in which the dredged material will fill in a depressed harbor entrance bottom area that currently has a deeper water depth. While the surficial samples collected in the In-harbor placement area are finer than the samples collected in the dredging areas, deeper sediments at this location are expected to be coarser and more like those collected within the dredged area. Although the dredged material may not physically be compatible with the surface sediments at the in-harbor placement site, the placement of the dredged material will prevent further scour and help maintain a more even depth in this area. In addition, sediment chemistry for the In-harbor placement site does contain elevated levels of DDT’s and PCB congeners, which is similar to the dredged materials from the south portion of Dredging Area I. This indicates that the dredged materials at the south portion of Dredging Area I are more suitable for the In-harbor placement site. The location of this placement area is shown in Figure 4.

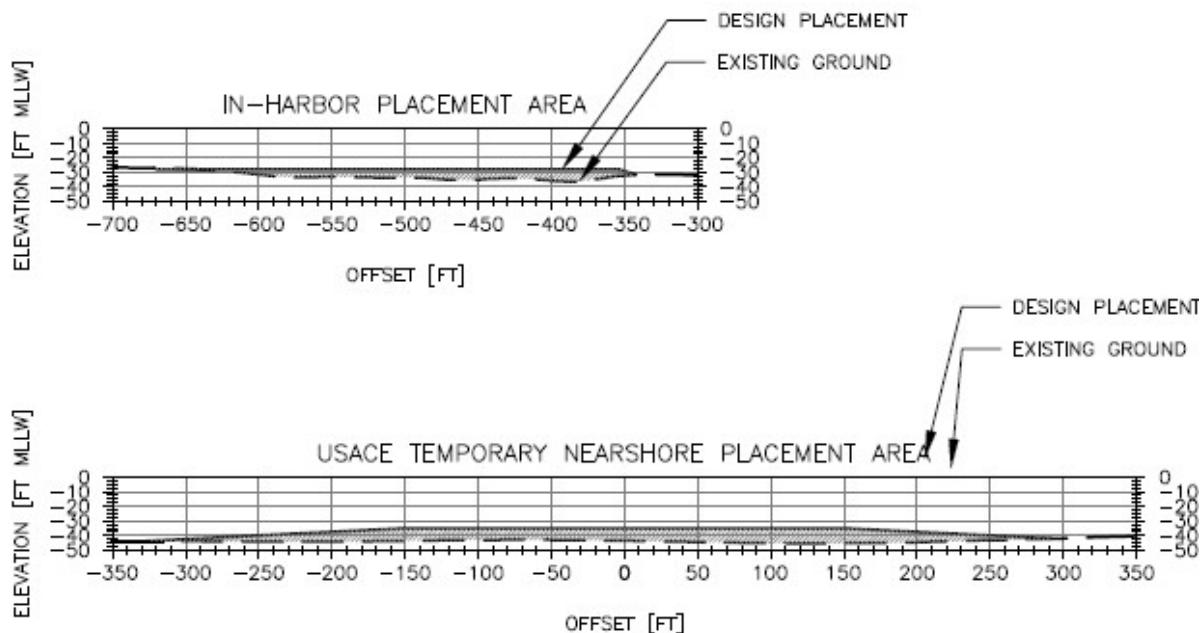
Figure 5. Typical Dredged Material Placement Cross-Sections

It is proposed to place up to approximately 29,000 cy of the material dredged from the south portion of Dredging Area I (composite areas OH-C and OH-D as defined in SAPR) within the In-harbor placement site, and approximately 33,000 cy of the dredged material (comprised the north portion of Dredging Area I and Dredging Area II) within the USACE's temporary nearshore placement site. These final placement locations for the dredged materials were presented to the SC-DMMT at their May 27, 2020 meeting with no objections. The plan view of the dredged material placement areas is shown in Figure 4. The typical placement cross-sections are shown in Figure 5.

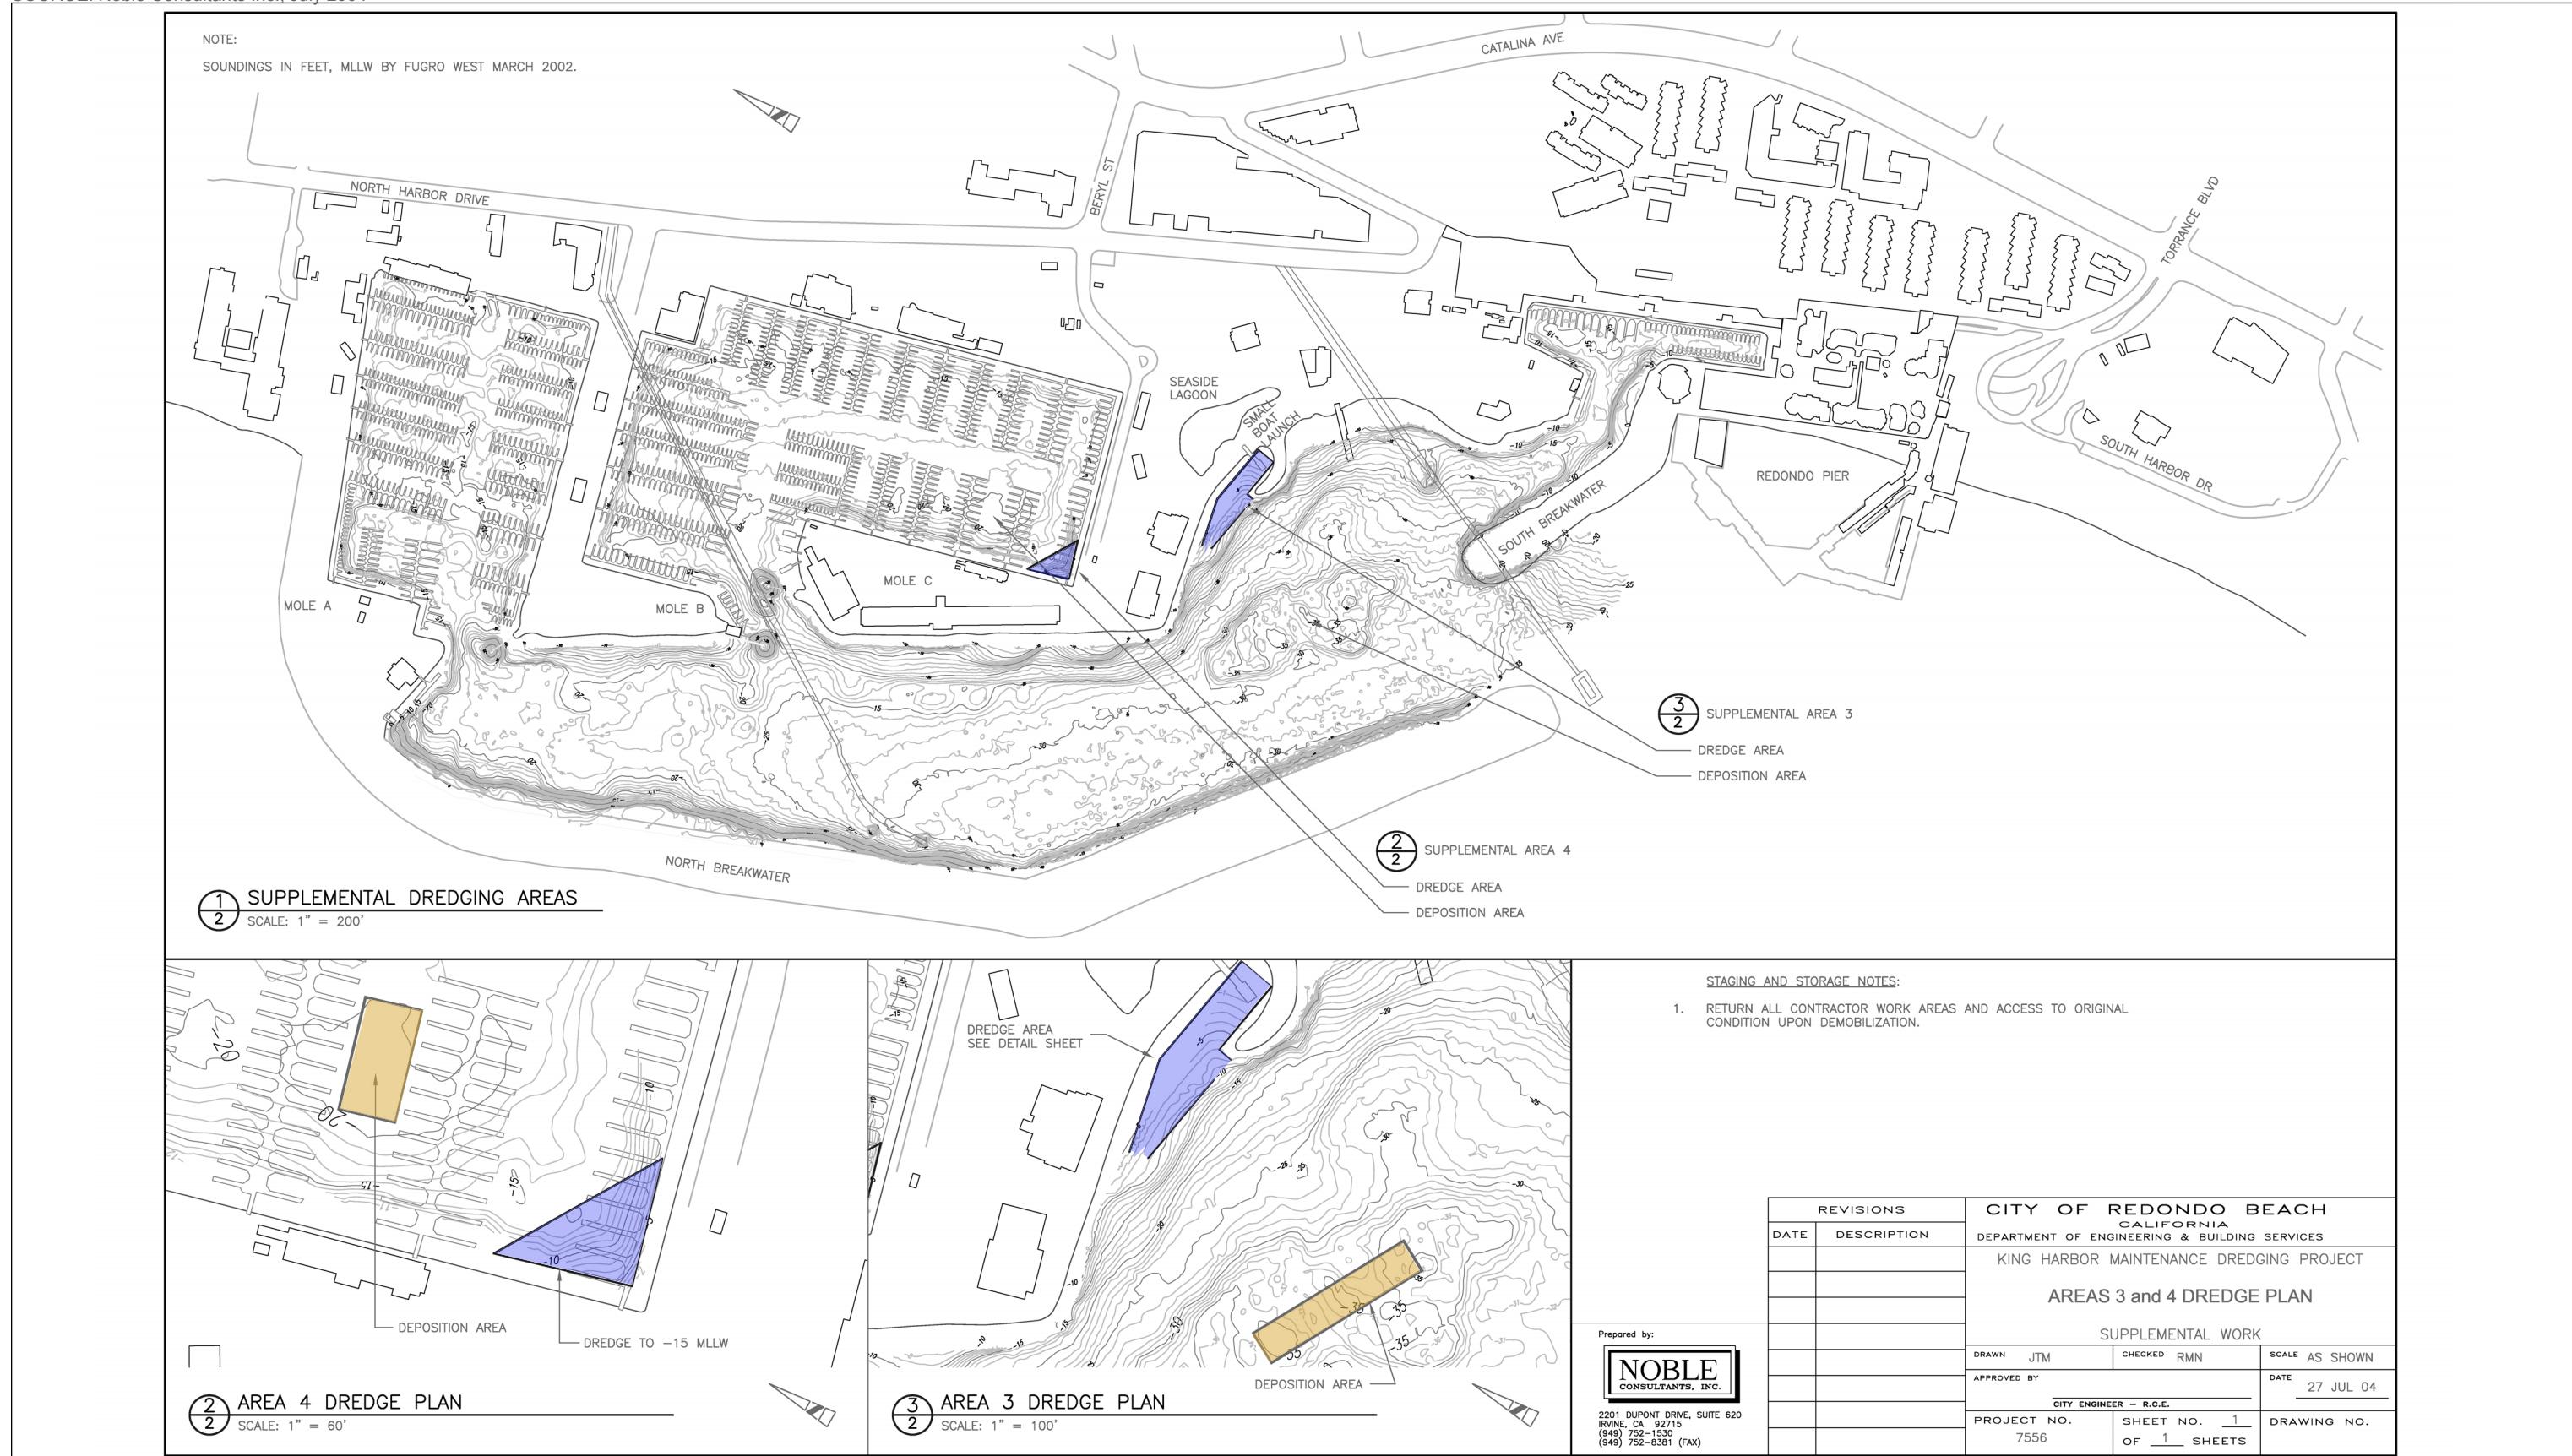
King Harbor Historical Dredging & Placement Sites (2004)
King Harbor, Redondo Beach

Although proposed and permitted for dredging in 2004, only material from Dredge Area I (the Basin 3 entrance channel) and a small volume from Dredge Area II was completed (Figure 2-1a). Dredging from Dredge Area II was incomplete in 2004 due to the presence of stone intermixed with the shoal material. The stone originated from the USACE breakwater road repair base material that was placed on the North Breakwater crest during their 1990's breakwater renovation project that raised crest elevation. The hydraulic dredge could not pump the sand/stone mix to

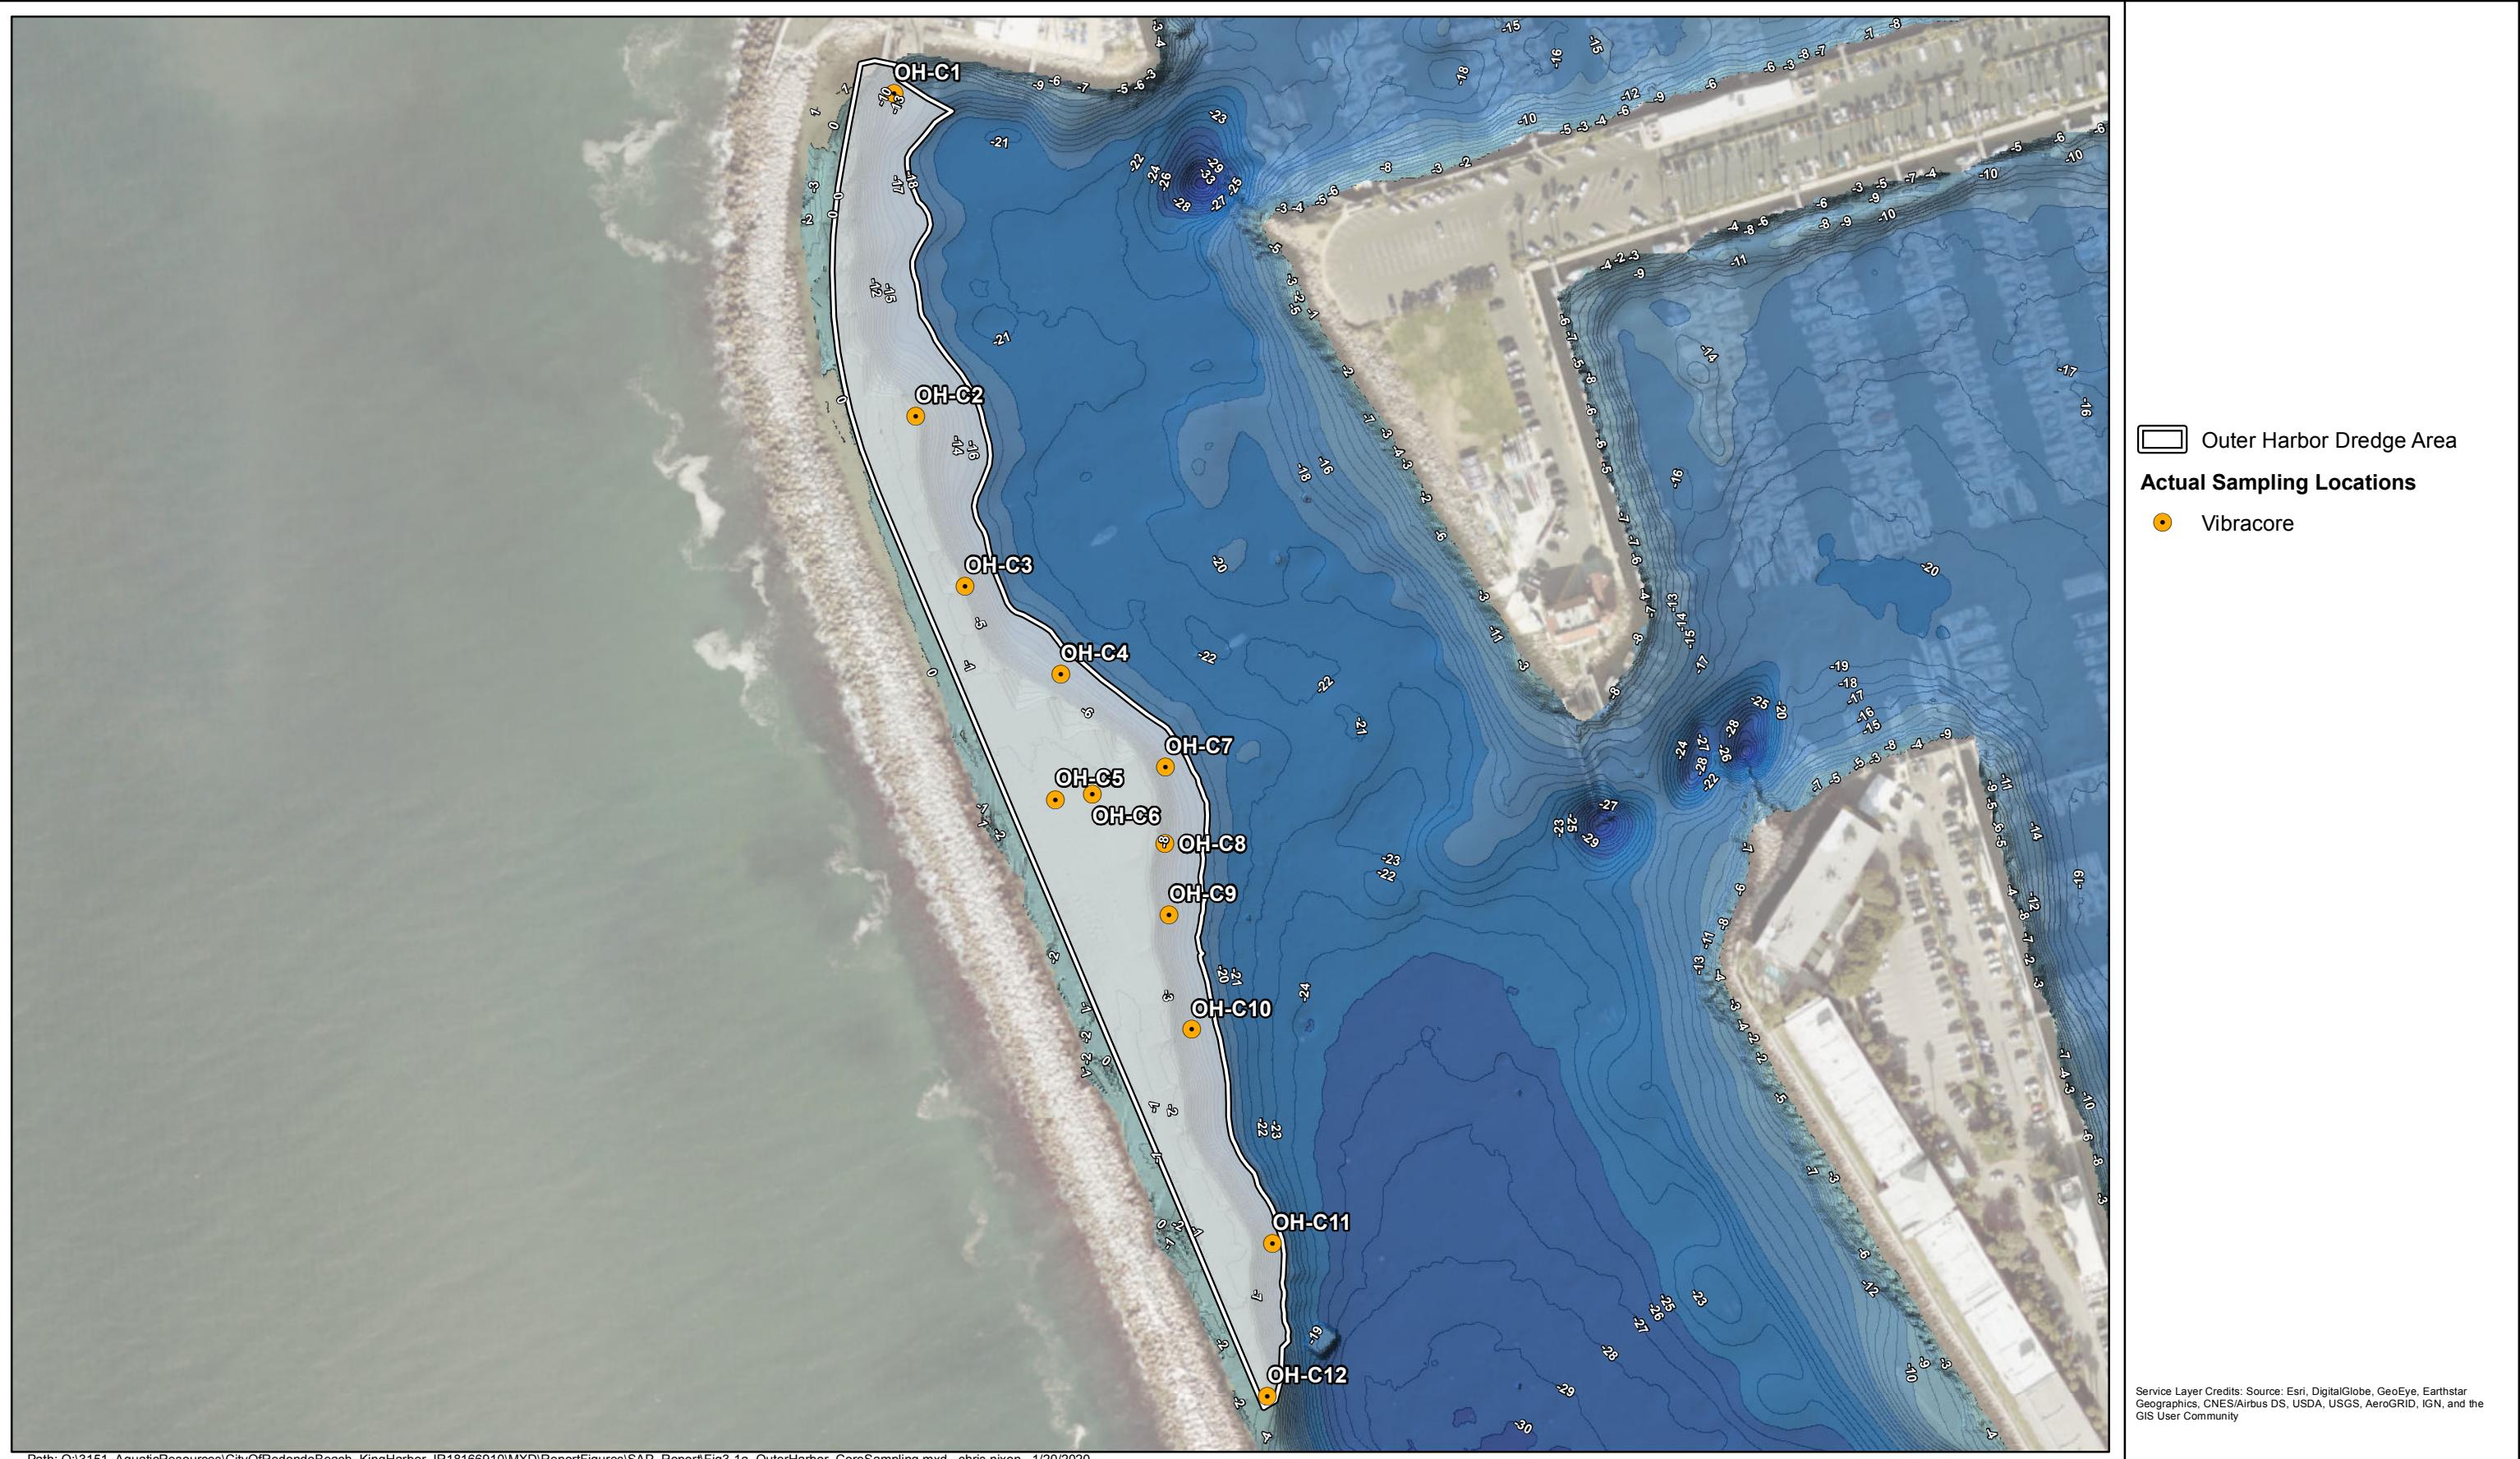
Actual Sampling Locations
Outer Harbor Core Sampling Locations
Redondo Beach, California

Vibracore and grab samples were collected at King Harbor between October 14 and October 17, 2019 (Table 3-2a and Table 3-2b). Coring locations were positioned as close to the proposed sites as possible, only relocating to avoid rip-rap, rocks, or dangerous sampling conditions

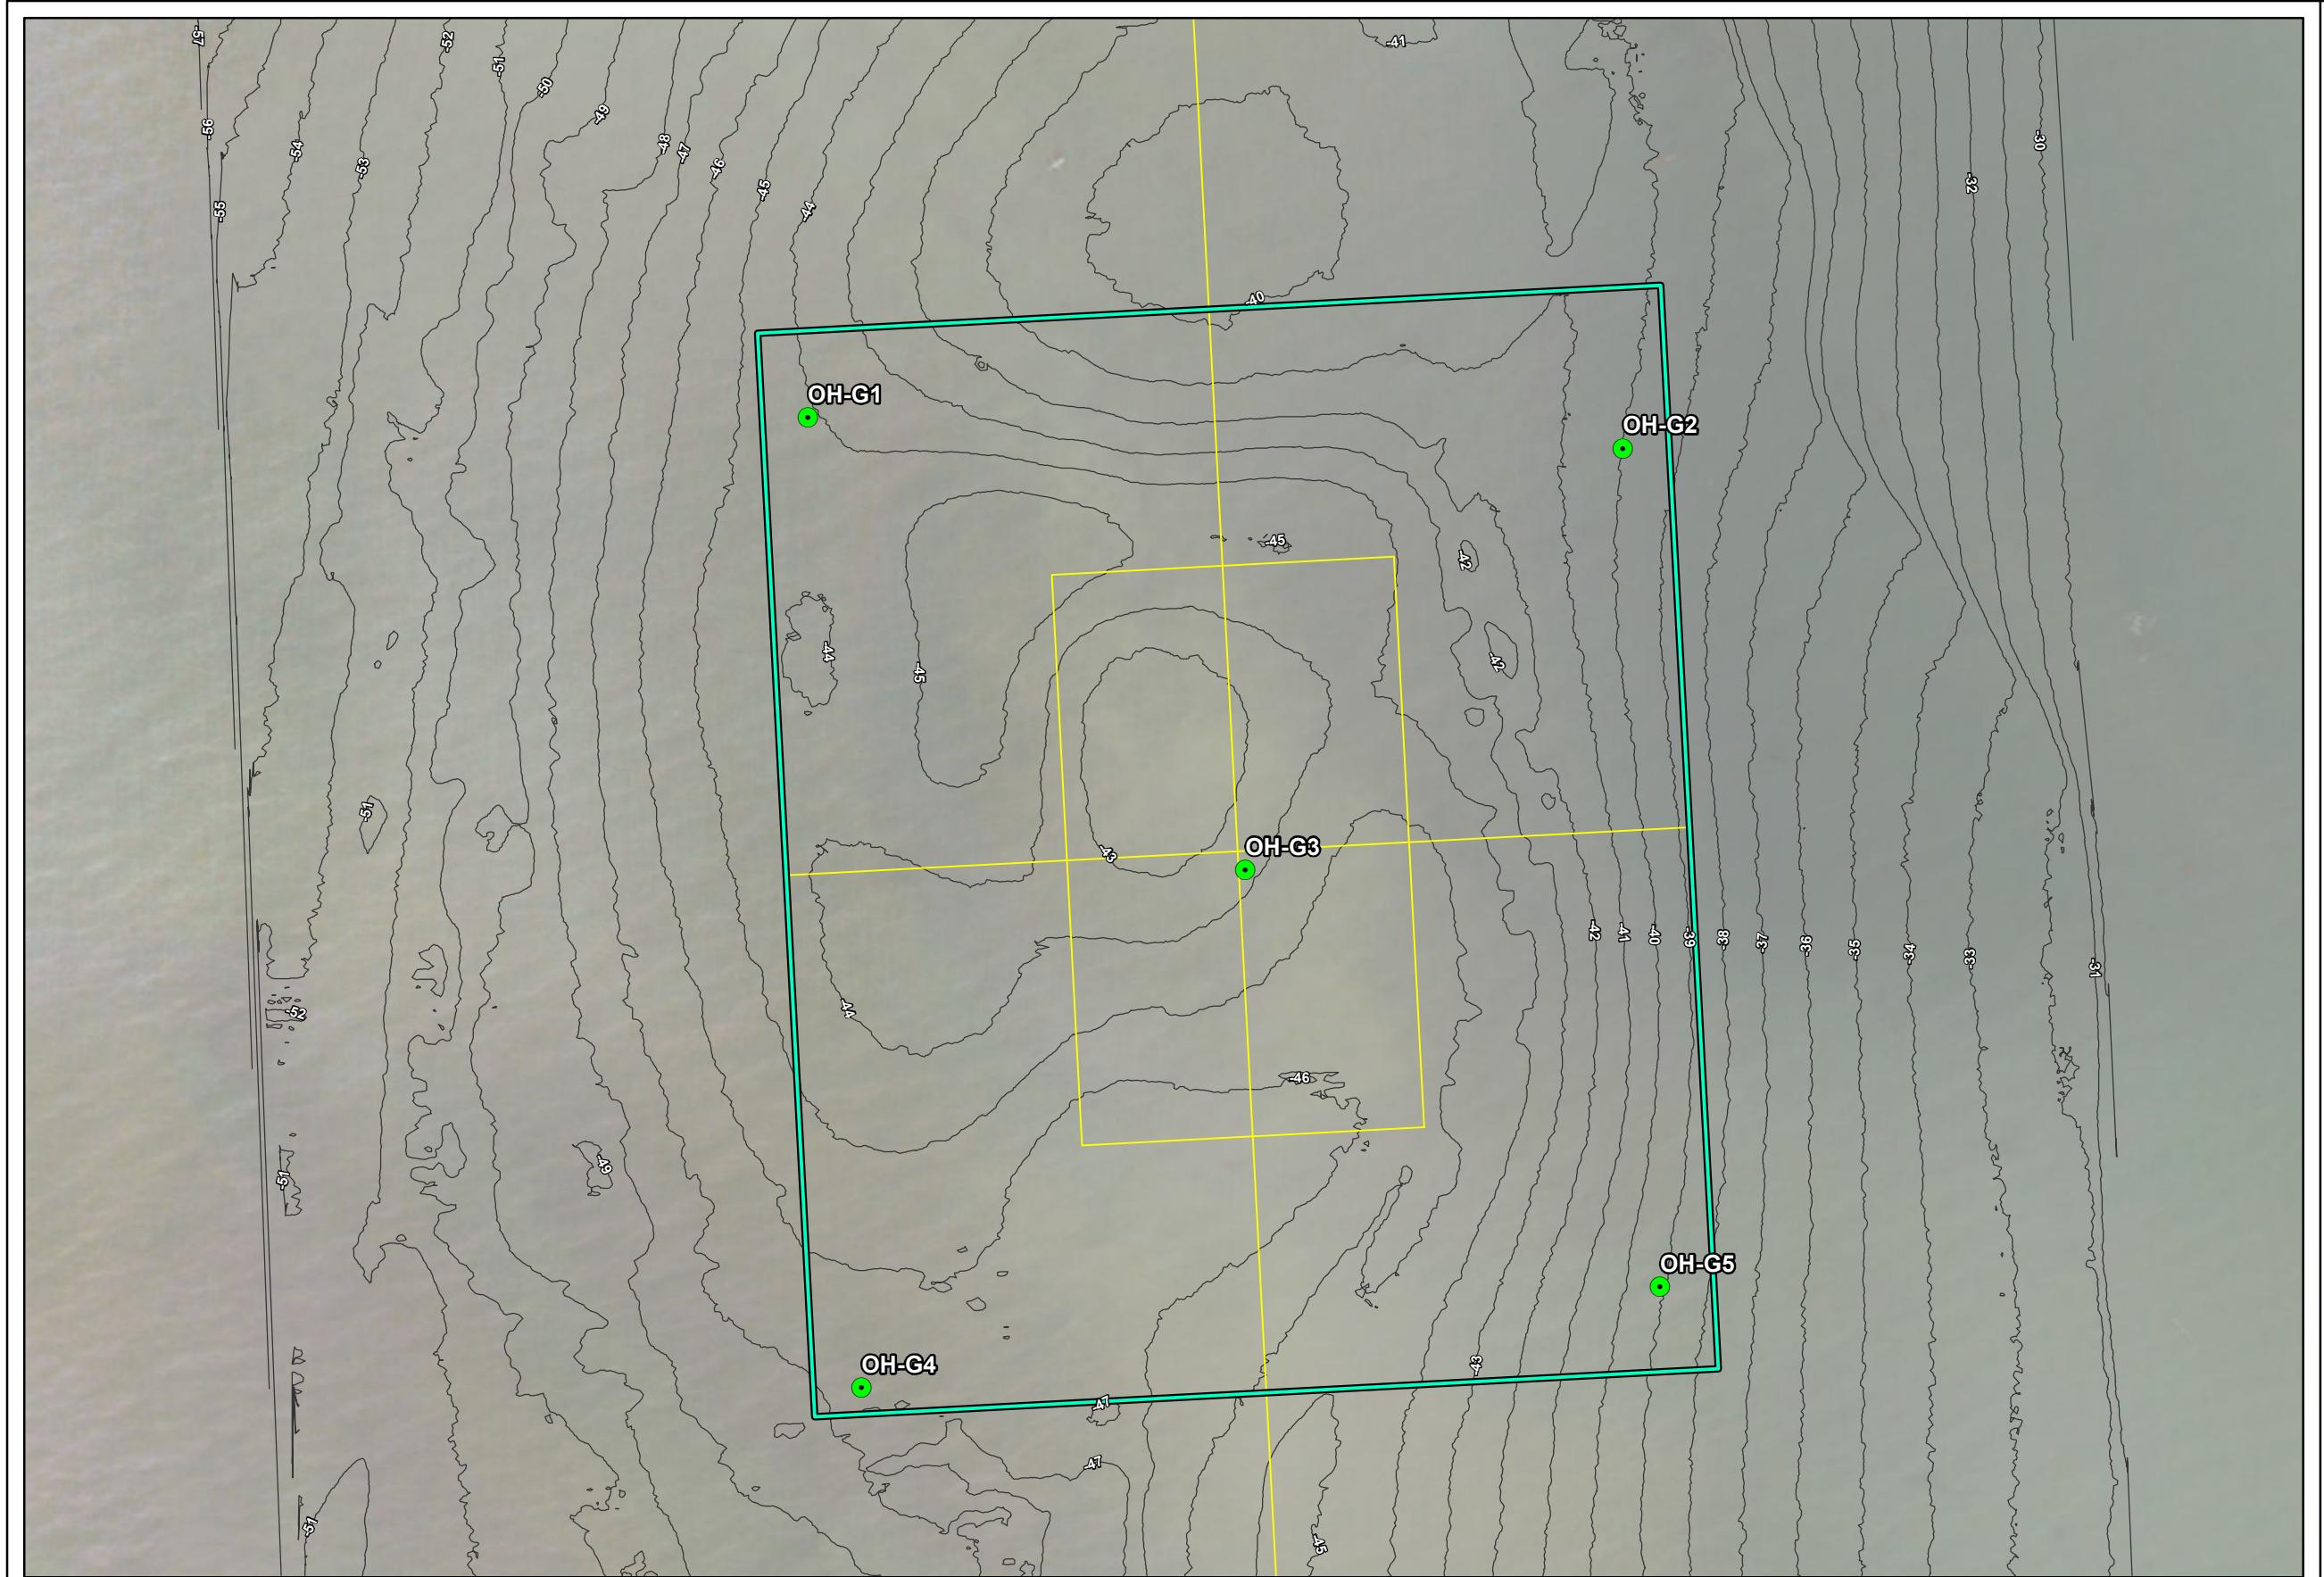
Actual Sampling Locations

Sample ID	Reason for relocating
OH-C1	Proposed sampling location obstructed by vessel, moved 10' east.
OH-C2	Shifted sampling location 10' east due to visible submerged riprap.
OH-C4	Sample location relocated approximately 10'.
OH-C5	Sample relocated approximately 15' east due to submerged riprap and inadequate water depth to collect sample.
OH-C6	Sample relocated about 15' east due to submerged riprap and inadequate water depth to collect.
OH-C7	Sample relocated 15' east due to submerged riprap.
OH-C8	Site too shallow to sample safely, moved sampling location approximately 10' west.
B3-C1	Sample location moved approximately 5' out because proximity to riprap too precarious to 3 point anchor.
B3-C3	Sample relocated to avoid shoal buoy with anchor.

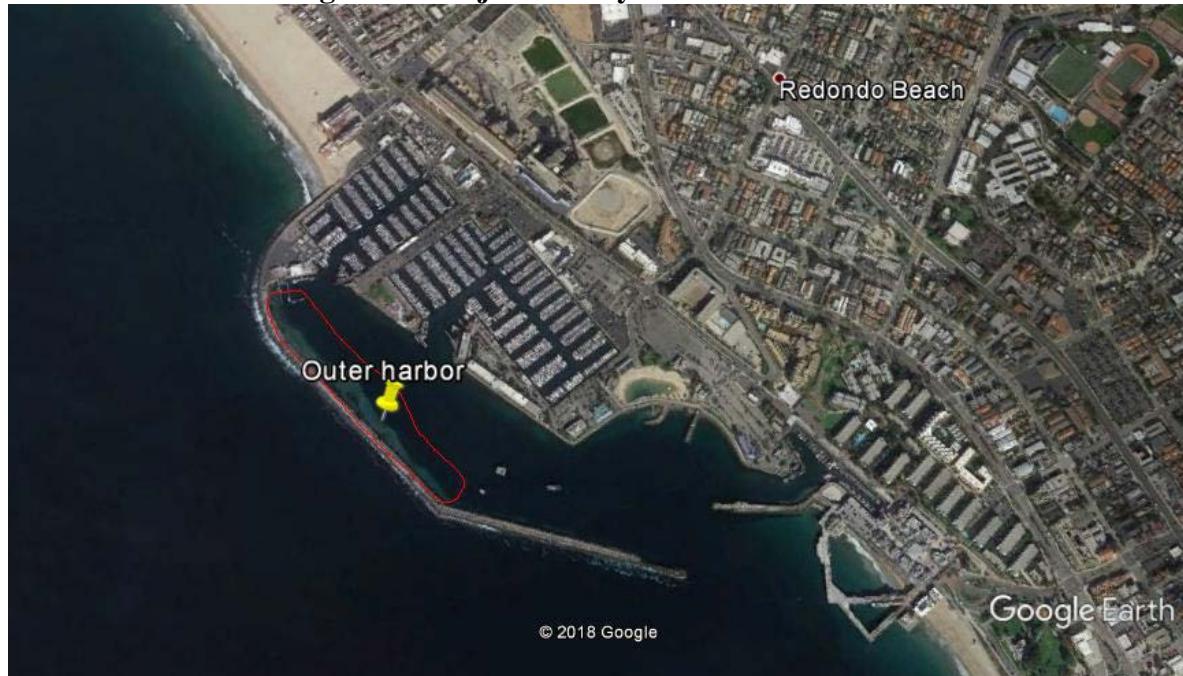
Figure 4. Project Survey Area: Outer Harbor

The project area was comprised of four distinct survey areas based on the project footprints in each zone of the Harbor (Figures 4-7). These survey zones included the Outer Harbor dredge area (Figure 4), Basin 3 Channel and alternative site (Figure 5), the Harbor Placement Site (Figure 6) and the Offshore Placement Area (Figure 7).

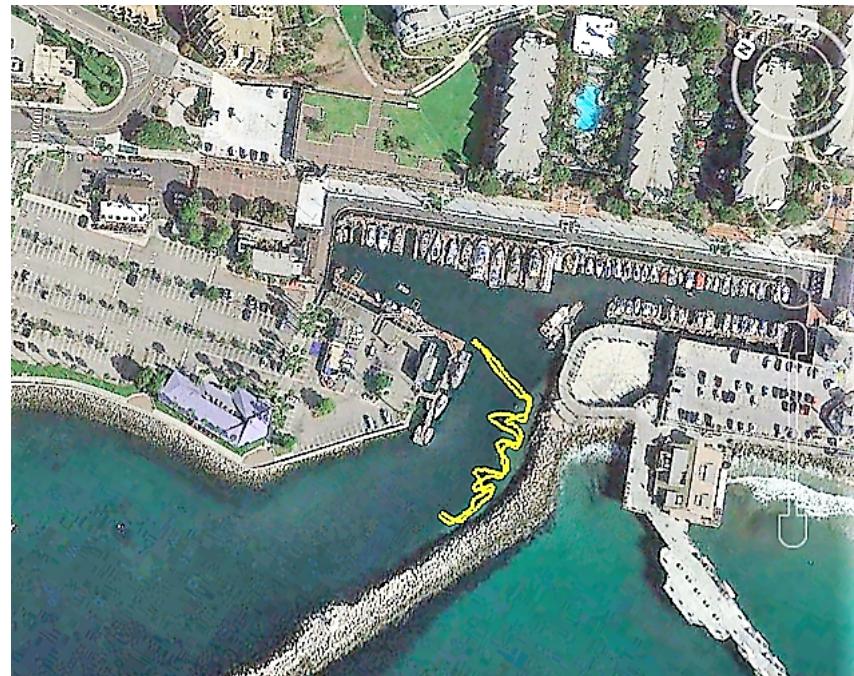
**Figure 2. Project Survey Area and Diver
Transects**

Site Name: Site Name	Basin 3 Channel Area, King Harbor, California. See Figure 1
Survey Contact: Survey Contact	<p>Mike Anghera, Senior Marine Biologist, Anghera Environmental. (805) 698 1004 mikeanghera@gmail.com</p> <p>Client Contact: Lisa Louie Chambers Group, Inc. 949.261.5414 x7289</p>
Permit Reference: Permit Reference	TBD
Hydrographic System: Hydrographic System	King Harbor, Los Angeles County, California. See Figure 1
Specific Location: Specific Location	33.84179° N 118.39200° W to 33.84151° N 118.39279° W NAD 83. Accuracy within 1 meter. See Figure 1
Was Eelgrass Detected:	NO, Eelgrass was not found at this site.
Description of Permitted Work: Description of Permitted Work	<p>Maintenance Dredging Project Source: Lisa Louie Chambers Group, Inc. 949.261.5414 x7289</p>

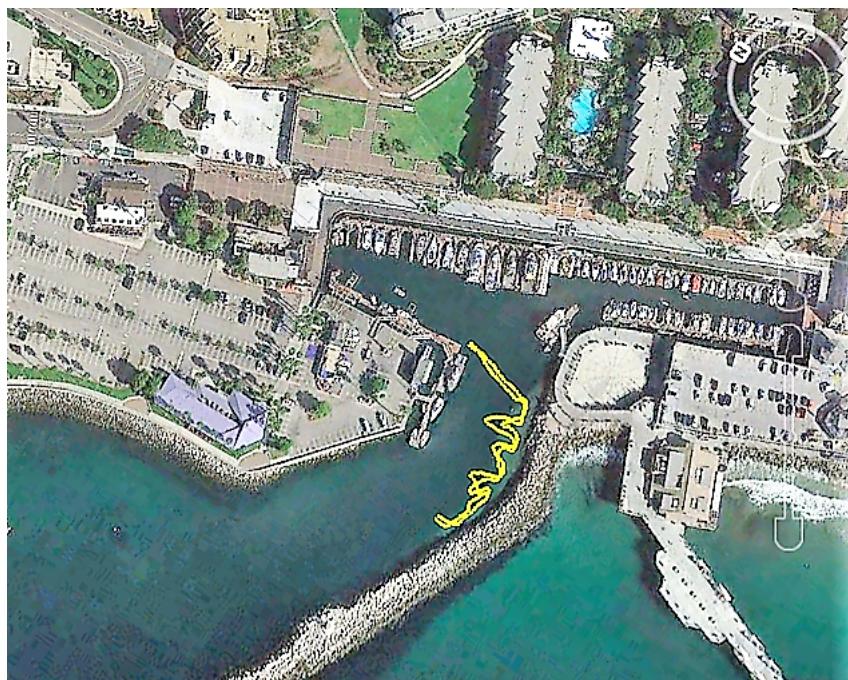
**Figure 2. Project Survey Area
and Diver Transects**

Report Date:	October 10, 2018
Name of bay, estuary, lagoon, or harbor:	King Harbor, Los Angeles County, California. See Figure 1
Specific Location Name:	Basin 3 Channel, King Harbor, California. See Figure 1
Site Coordinates: (UTM, Lat./Long., datum, accuracy level, and an electronic survey area map or hard copy of the map must be included).	33. 84179° N 118. 39200° W to 33. 84151° N 118. 39279° W NAD 83. Accuracy within 1 meter. See Figure 1
Survey Contact: (name, phone, e-mail)	Mike Anghera, Senior Marine Biologist, Anghera Environmental (805) 698-1004 mikeanghera@gmail.com Client Contact: Lisa Louie Chambers Group, Inc. 949.261.5414 x7289
Personnel Conducting Survey (if other than above): name, phone, email	Mr. Mike Anghera (certified <i>Caulerpa</i> surveyor) Dr. Kimo Morris (certified <i>Caulerpa</i> surveyor)
Permit Reference: (ACOE Permit No., RWQCB Order or Cert. No.)	TBD
Is this the first or second survey for this project?	First

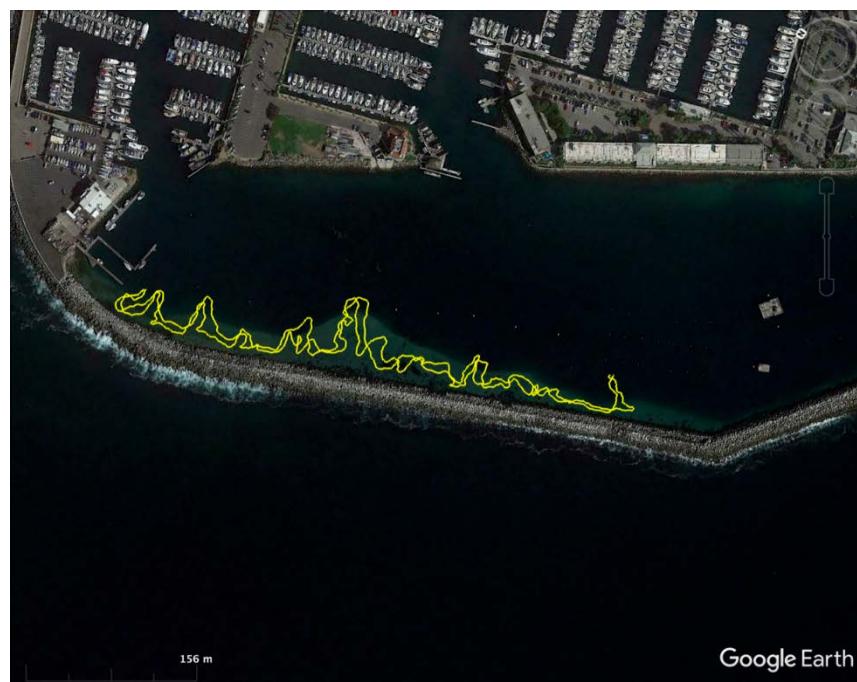
Figure 2. Project Survey Area and Diver Transects

Report Date:	October 10, 2018
Name of bay, estuary, lagoon, or harbor:	King Harbor, Los Angeles County, California. See Figure 1
Specific Location Name:	Outer Harbor Dredging Site, King Harbor, California. See Figure 1
Site Coordinates: (UTM, Lat./Long., datum, accuracy level, and an electronic survey area map or hard copy of the map must be included).	33° 50' 55.94" N 118° 24' 05.51" W to 33° 50' 37.21" N 118° 23' 56.73" W NAD 83. Accuracy within 1 meter. See Figure 1
Survey Contact: (name, phone, e-mail)	Mike Anghera, Senior Marine Biologist, Anghera Environmental (805) 698-1004 mikeanghera@gmail.com Client Contact: Lisa Louie Chambers Group, Inc. 949.261.5414 x7289
Personnel Conducting Survey (if other than above): name, phone, email	Mr. Mike Anghera (certified <i>Caulerpa</i> surveyor) Dr. Kimo Morris (certified <i>Caulerpa</i> surveyor)
Permit Reference: (ACOE Permit No., RWQCB Order or Cert. No.)	TBD
