**100-132 N. Catalina Avenue
Redondo Beach, California
Historic Resource Evaluation**

November 20, 2020

100 – 132 N. Catalina Avenue
Historic Preservation Plan
Redondo Beach, California

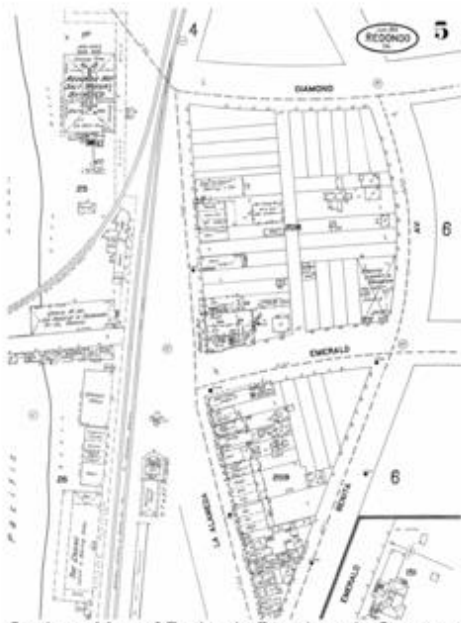
Sanborn Map of Redondo Beach early Commercial District, 1904

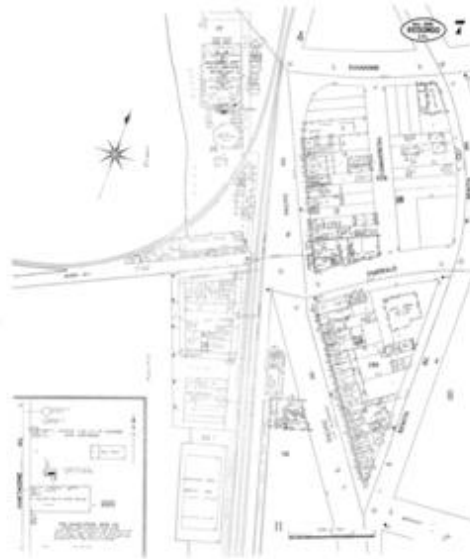
Sanborn Map of Redondo Beach early Commercial District 1908

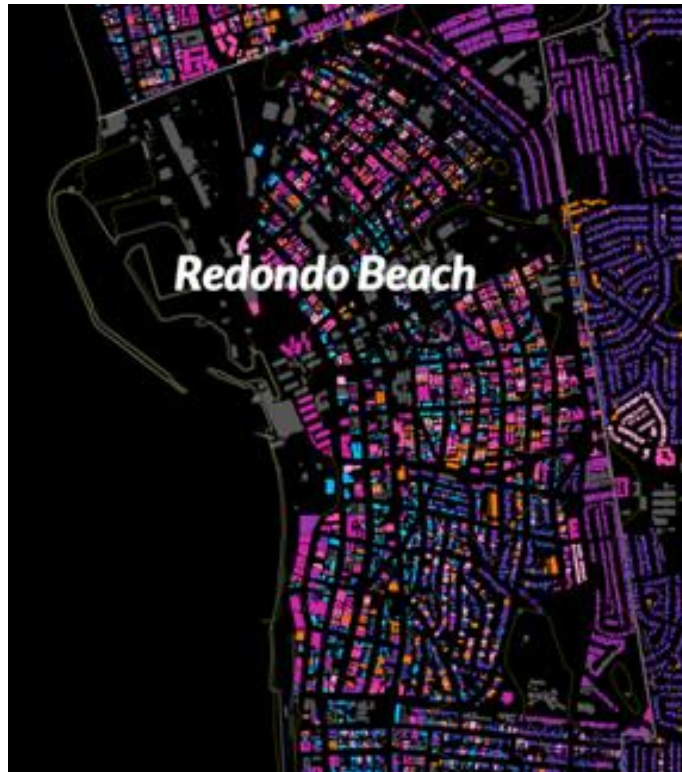
The Built: LA Building Age Interactive Map, a visual development history database, shows the age of many buildings in Redondo Beach. Buildings are color coded based on the decade of their construction with a color for each decade from 1920 to 2000 and a “1909 and earlier” category. Although the data is incomplete (some buildings are not colored), the map shows the general development history of the original townsite and environs.

The map shows a concentration of early 20th century residential buildings on the 300 block of N. Gertruda Avenue, the Original Townsite Residential Historic District. In most other residential areas, the map shows that bursts of development occurred in the 1950s, 1970s and 1980s.

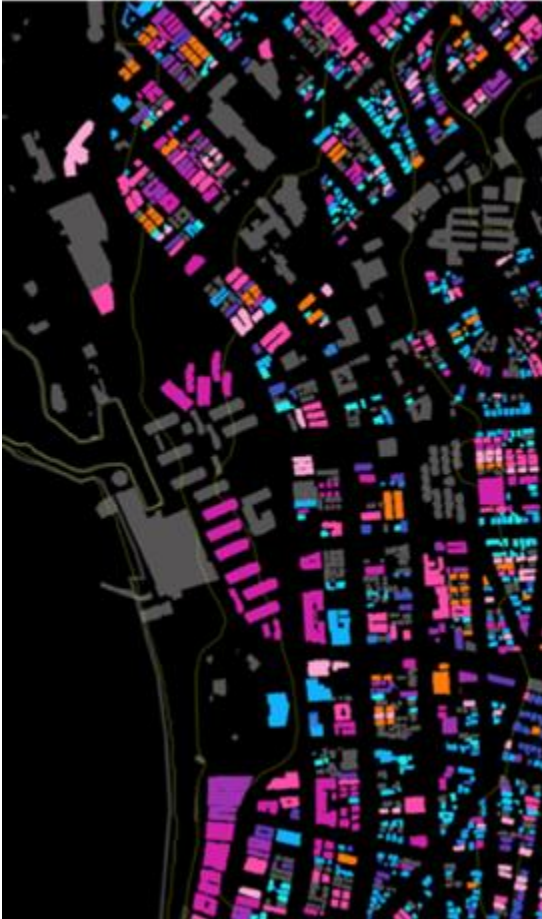
Commercial areas of the City running along the 400 block of N. Catalina Avenue and 200 block of Broadway show redevelopment of that area took place in the 1960s and 1970s. Across from the subject buildings on the west side of the 100 block of N. Catalina Avenue are large multi-family residential buildings of “The Village” which were constructed in the late 1970s. While a few early 20th Century buildings remain, including the landmark Redondo Van and Storage Diamond Apartment Building (321 Diamond Avenue), many of those remaining have been substantially altered. Commercial areas on the 200-400 South blocks of Catalina Avenue show the majority of buildings were constructed in the 1970s and 1980s.

Area around subject block

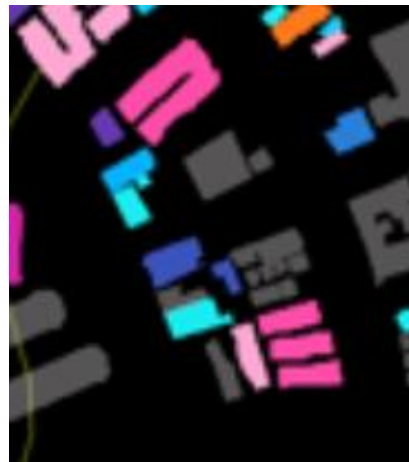
100 block of N. Catalina Avenue

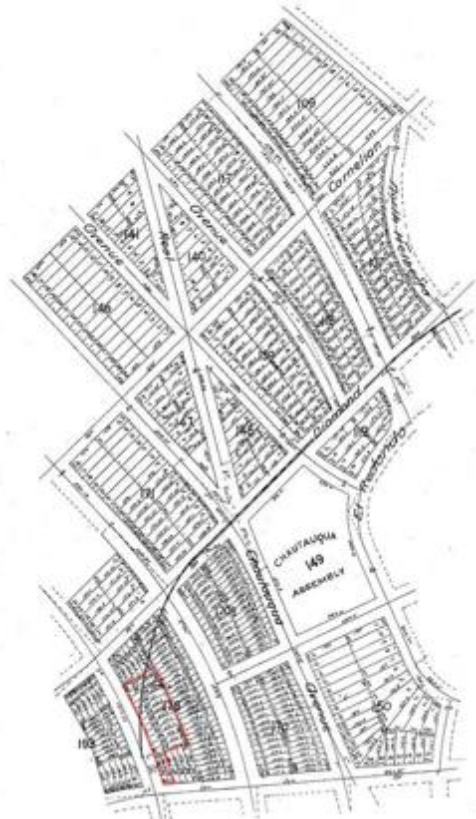
Tract Map of Redondo Beach Original Townsite and page with subject parcels

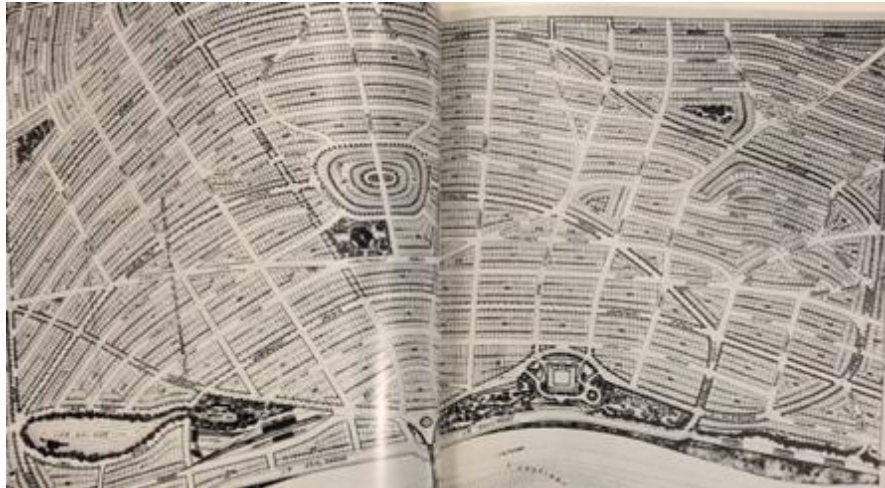
Map of Original Townsite

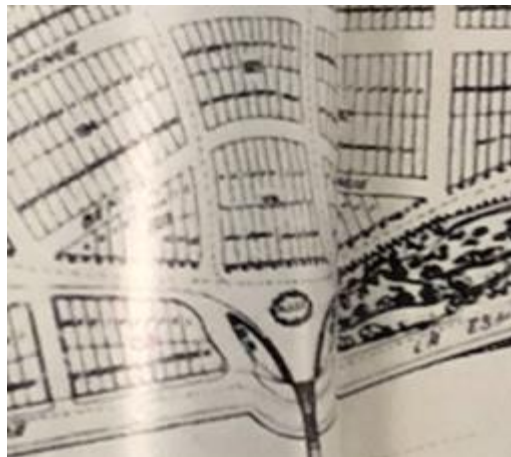
Excerpt of Original Townsite Map showing area
around 100 block of N. Catalina Avenue

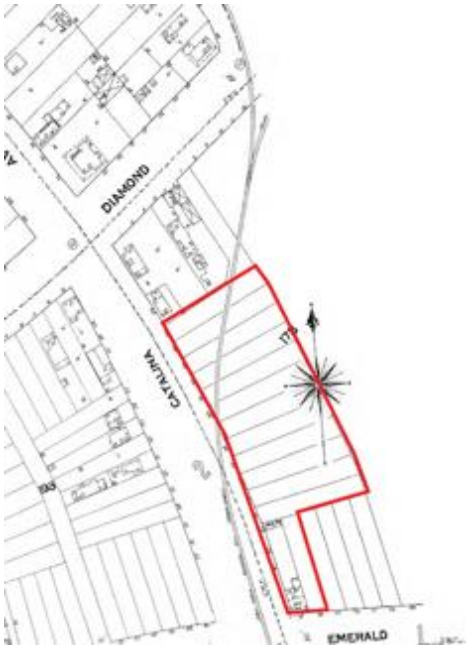
Sanborn Maps and aerial images show the development of the 100 block of North Catalina Avenue between 1895 and 1964. The block was sub-divided into two larger corner parcels and 12 long, narrow parcels; these parcels were later reconfigured and consolidated to create the eight parcels that exist today.

Sanborn Map Excerpts – 100 Block of N. Catalina Avenue

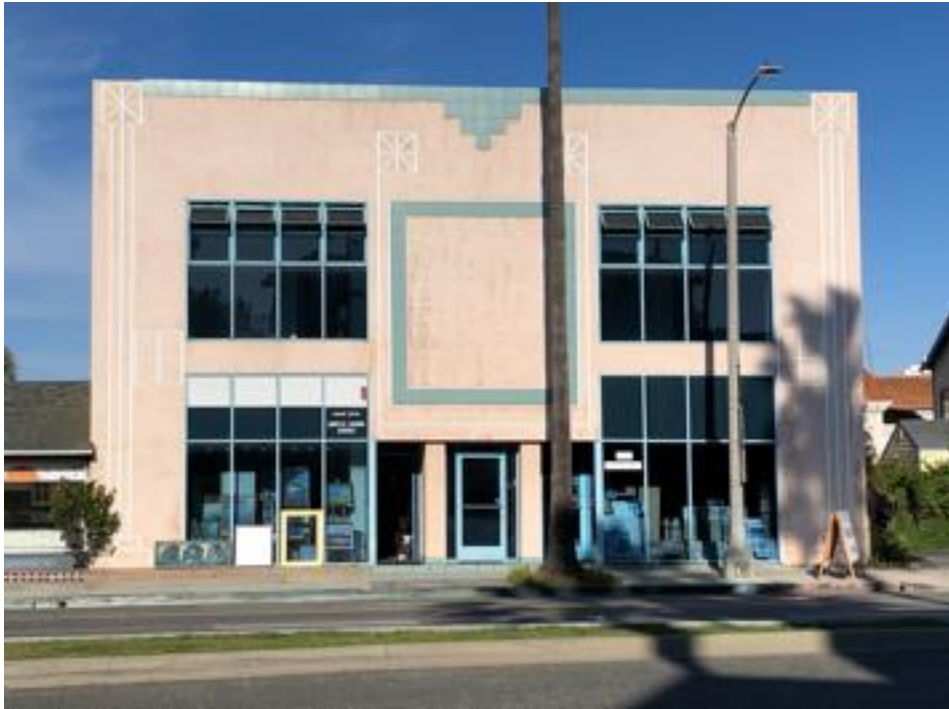
112 N. Catalina Avenue, front (west) elevation

The 112 N. Catalina Avenue building is a two-story vernacular commercial building containing 9,200 square feet. The building is rectangular in plan with a flat roof behind a parapet. It is a masonry structure with plaster façade. The building is on a mid-block parcel and has no side setbacks. It is likely that aspirations anticipated additional development of commercial buildings on the block would abut this two-story building, thus rendering at least most of the side walls unviewable.

The building exterior is in relatively good condition although the front façade is a dated design with minimal references to the original building design. Along with fading, the textured plaster has accumulated dirt creating an uneven appearance. Aluminum mullions for windows and doors have faded but otherwise the window assemblies appear in satisfactory condition.

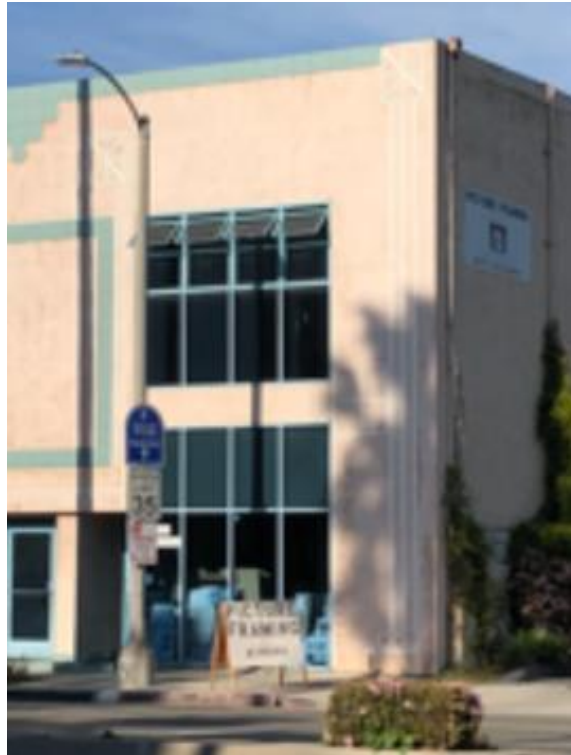
South end of west elevation, 2019

The original building exterior was re-plastered, and the original windows were removed and replaced. The photograph of the building from 1993 shows a defined horizontal cornice panel at the top of the building. The photograph also shows that there was a window centered along the upper elevation which has been enclosed; the other window openings are in the original locations of windows and generally of the same size. There was a horizontal band above a storefront with a recessed entry. There is an exposed original cornerstone setback at the northwest corner of the building.

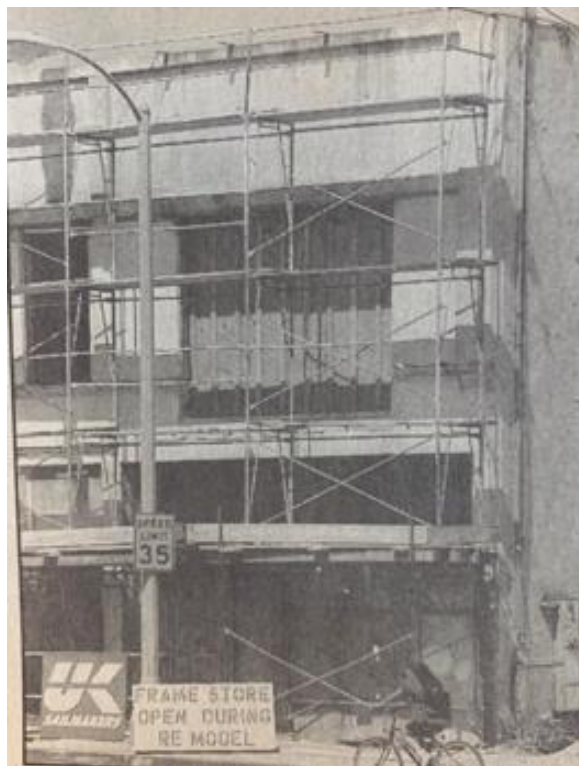
South end of west elevation, c1992

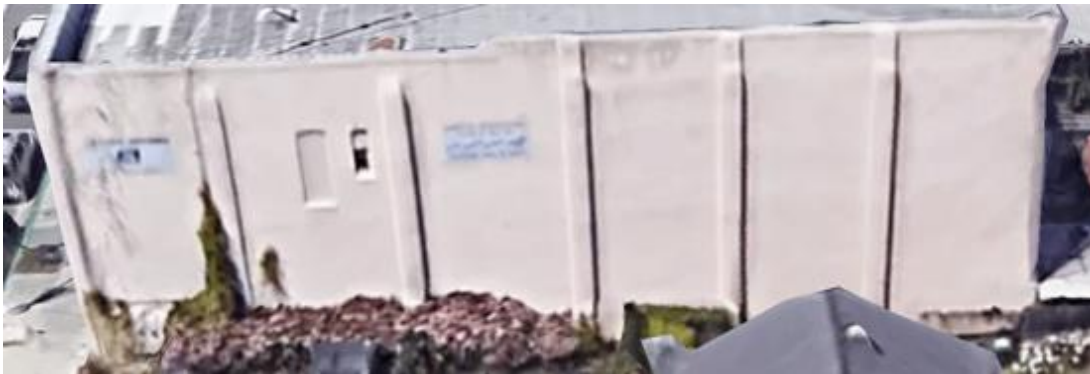
North (side) elevation of 112 N. Catalina Avenue (Google Earth, c2019)

The long side elevations are broken up by a series of vertical pilasters that stop short of reaching the parapet. The side walls are windowless except for one large and one small window. There are arched brick headers in the second bay from the front on both sides and infilled openings in the first and third bays on the south side. There are no architectural details other than the pilasters on the side elevations. The lack of fenestration and architectural details on the side elevations was likely due to aspirations and anticipation of adjacent development which would obscure views of these elevations.

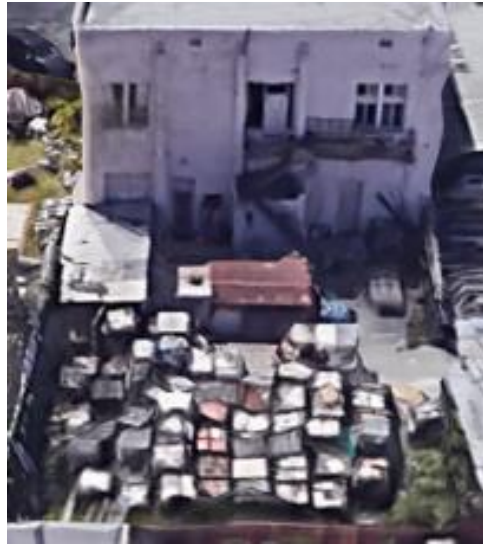
The rear elevation has three arched opening on the upper floor and an exterior metal stair. There are storage sheds and surface parking at the rear of the parcel.

112 N. Catalina Avenue, east (rear) elevation, Google Earth, c2019

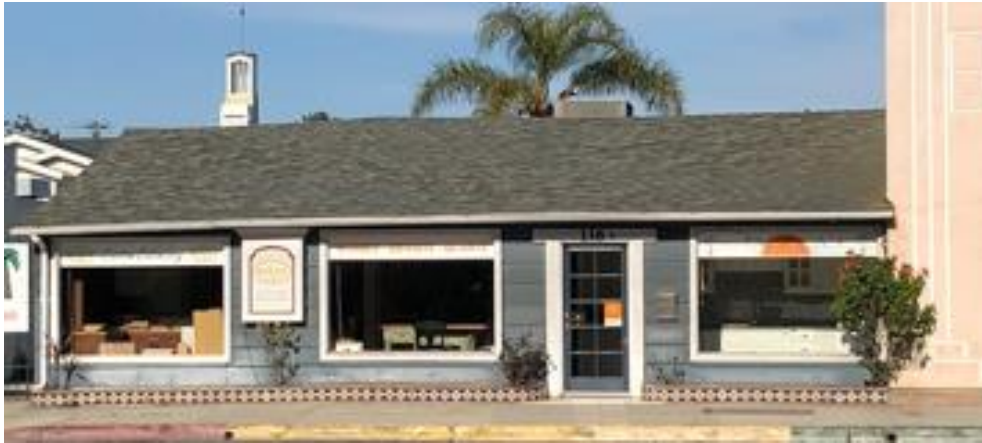
116 N. Catalina Avenue, front (west) elevation

The building is one-story with 1, 601 square feet. It has a side-gable roof and is clad in wide wood plank siding. Very limited areas retain original narrow siding and are visible only on some areas of the rear elevation. Rear additions to the building were constructed in a somewhat haphazard process and with a mix of exterior appearances. The rear sections of the building have flat roofs. The front (west) street facing facade contains three very large plate glass windows with wood frames that take up much of the area of this elevation. All evidence of the 1925 residential building has been removed and what was left of what had been a residential building now has a large plate glass display window. The three large plate glass windows, were installed in the 1990s and are not original. There is a single entry door located to the north of the southernmost window creating an asymmetrically balanced front façade. There is a low planter that runs along the west elevation. A driveway is located on the north side of the parcel leading to a paved rear parking area which also contains a storage structure and storage area.

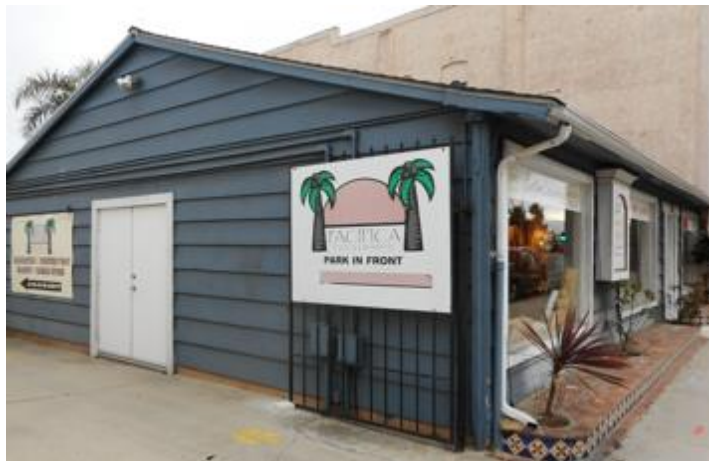
The building is a commercial building constructed in 1921. In 1925 a duplex dwelling was added onto the building. Later a portion of the duplex, on the north side, was demolished to create a driveway to provide vehicular access to the rear of the parcel. The remaining portion of the dwelling was converted to commercial uses. The building has served as a carpentry shop and cabinet shop for several decades.

116 N. Catalina Avenue, north elevation

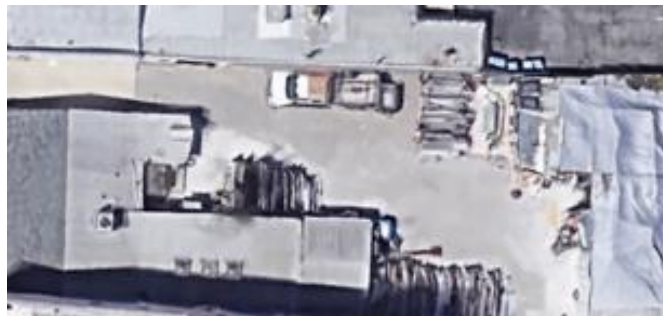
Plan view showing driveway in upper left where a section of the duplex was removed for driveway

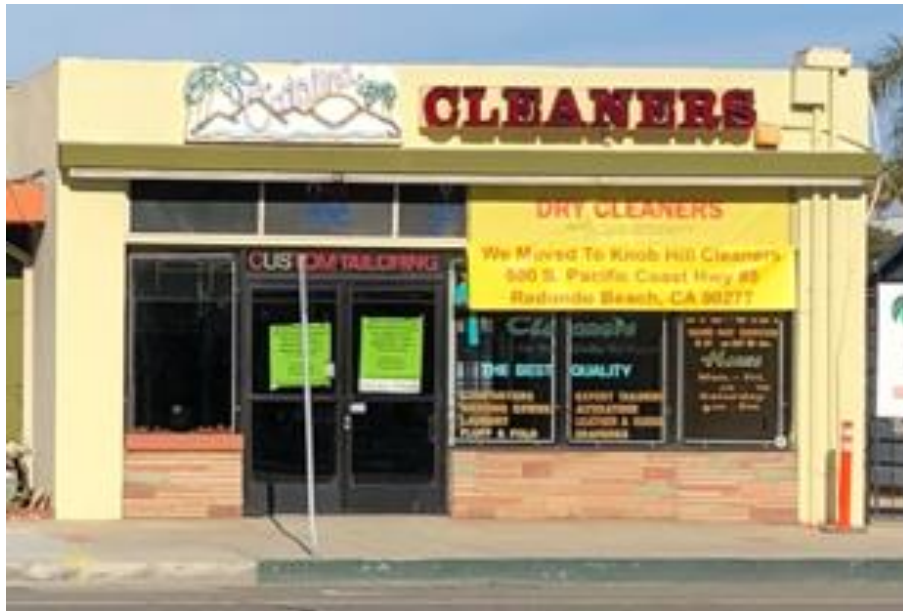
124 N. Catalina Avenue, west (front) elevation

The building has a flat roof with parapet. The exterior is clad in smooth cement plaster. The front elevation, the retail portion of the building, consists of an enframed storefront assembly. The front façade retains the original configuration of the storefront opening including the horizontal mullion that separates the upper transom windows. The composition of the front façade is asymmetrical with the entry door offset from the center of the building to the north. The original entry doors were two separate doors which was changed to a single double-door entry around 1995. Windows include plate glass windows with a horizontal mullion that separates the upper transom windows. The window sash and storefront has been changed to dark finished aluminum. There is a decorative pattern of masonry at the bulkhead that may be original. Existing signage is not original.

The façade is generally in satisfactory condition. There have been unattractive modifications to the front façade mostly from exposed electrical service and outdoor lighting applied to the building that impacts the historic quality of the building. The horizontal wood mullion separating the transom windows should be refurbished.

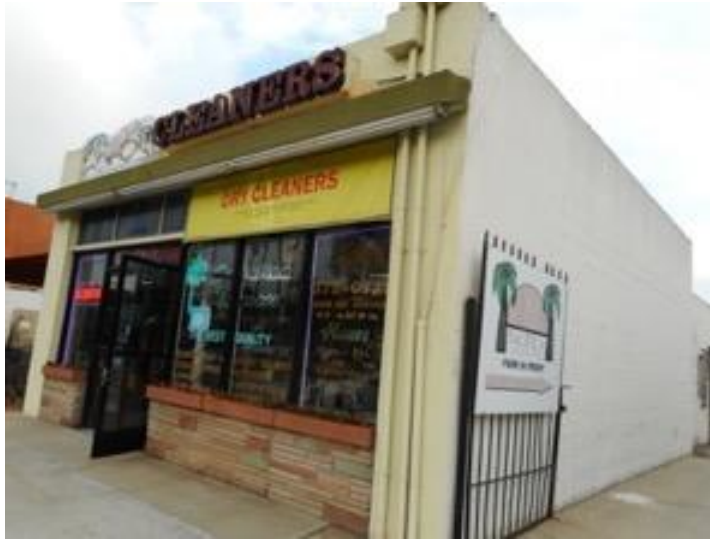
The front retail section of the one-story building is rectangular in plan with simple massing. The north side of the building is adjacent to the neighboring building. The south elevation of the building faces a driveway that leads to surface parking at the rear of the parcel. A long rear section of the building contains the industrial dry cleaning plant. Between 1946 and 1959 the rear was extended.

124 N. Catalina Avenue, west and south elevation

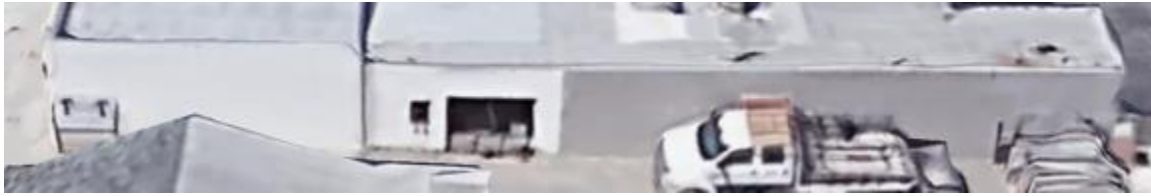
124 N. Catalina Avenue, south elevation (Google Earth, c2019)

The south side elevation of the retail building is plain without any architectural details. The north side elevation abuts the neighboring building. The far rear of the building contained the industrial cleaning operations. There is a garage door opening on the south elevation towards the front of the rear industrial (cleaning) wing of the building. There is no architectural detailing on the side elevation.

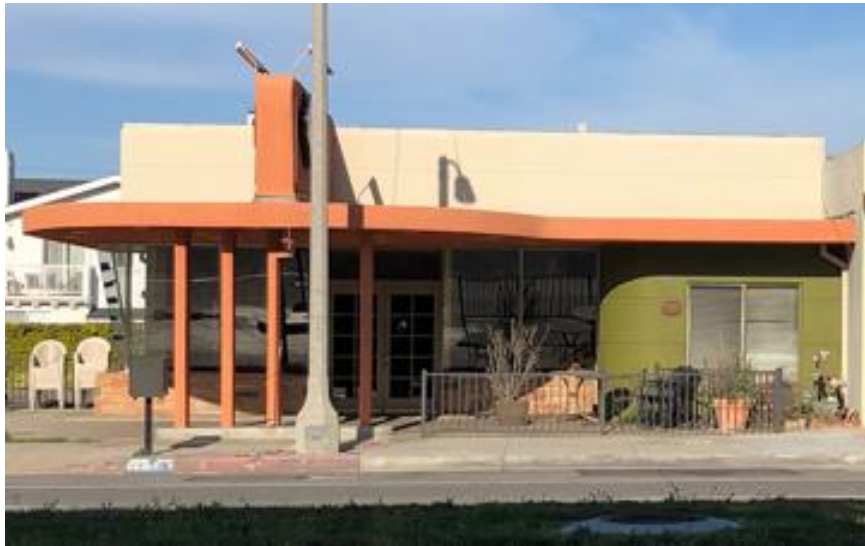
This building was constructed in 1949 in the Mid-century Modern architectural style featuring an early Modernist flair with expressive front entry covering and angled support. There is no architect or contractor listed on the building permit. The building functioned as a drive-in facility for Wardrobe Cleaners as well as service as its dry-cleaning plant. Based on a Palos Verdes Peninsula News article from January 1950, the new plant was “next door to the Wardrobe Cleaners former quarters.”⁷

126 N. Catalina Avenue, west (front) elevation

The coffee shop front façade is generally in good condition with stylistic architectural elements intact. The glazed storefront including the corner without mullions will need further assessment to ensure longevity. The pair of front entry

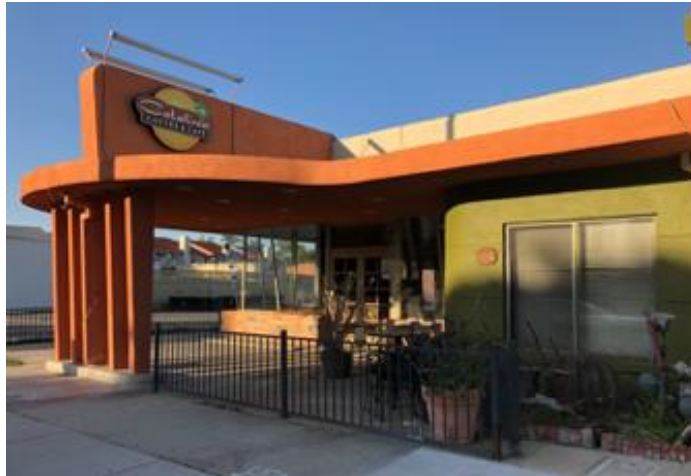
The building is setback from the front property line and features a patio area. The building has a canopy that covers the patio. The canopy is a slightly projecting band along the front wing of the elevation but where the building is recessed at its north end, the canopy juts out to create a semi-circular roof and is supported by a series of tapered posts. The angles of the front windows and the tapered columns align with the curve of the canopy giving the building a dynamic aesthetic. Adding to that dynamism is the projecting sign, integral to the canopy, that sits atop the canopy.

126 N. Catalina Avenue, west elevation and canopy

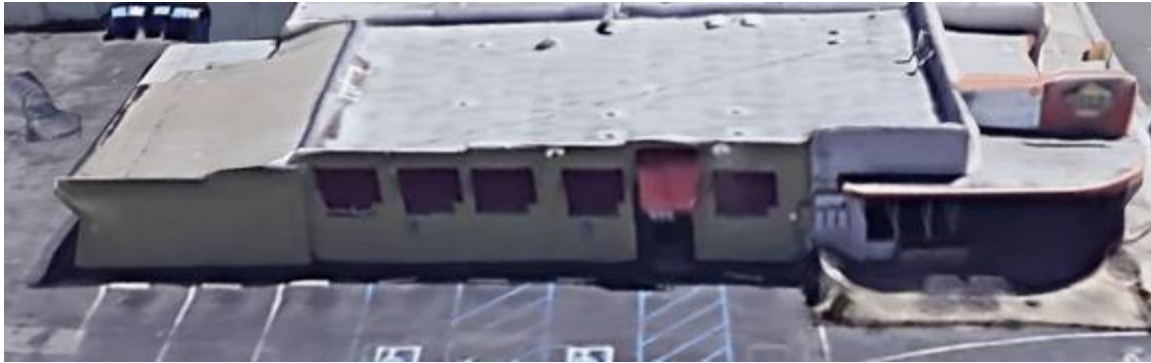
126 N. Catalina Avenue, north elevation (Google Earth, c2019)

The south side of the building is not visible as it is adjacent to the building at 124 N. Catalina Avenue. The north side of the building faces the parcel's parking area. The very front of the north elevation is the wrap-around of the front windows and includes the return of the curved canopy with its Modernistic flair. However, beyond that, making up most of this side elevation, there is no architectural detailing and no continuation of any Modernistic style influences. Rather, it is a simple wall with regularly placed small windows arranged along its elevation. The front portion of this elevation is distinguished from the rear portions that have dropped parapets and appears as an appendage to the front structure and has a different finished surface.

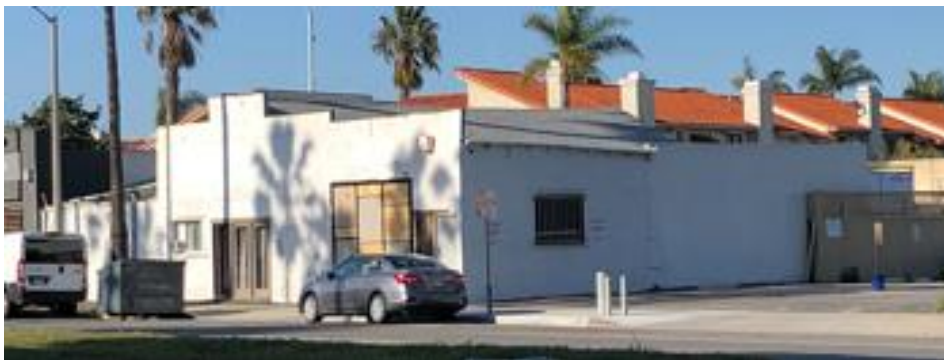
This building, constructed in 1905, was used as a blacksmith shop, ironworks and woodworking shop over the decades with business including Star Blacksmith (1924), H.J. Campeau Ornamental Iron and E.L. Martin, Blacksmith (1931), and E.L. Martin, Blacksmith (1947). Inside the building mechanical systems that supported industrial operations remain. The building had a relationship to the train tracks and the operations and maintenance facilities of the railroad from the early 20th Century when the main track of the narrow gauge Redondo Railway and the area to the south and east of the building was used as a freight yard for a railroad. This parcel and the northern portion of the block continued to be used for operations of the Redondo Railway until the 1940s with aerial photographs showing that the train tracks traversed the area behind this building in the 1930s and 1940s.

132 N. Catalina Avenue, west and south elevations

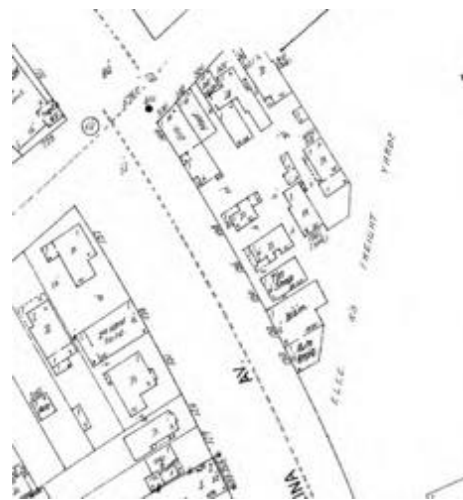
Sanborn Maps show how the footprint of the building has evolved over time. The 1906 Sanborn Map shows the building as “L” shape in plan. The 1916 Sanborn Map shows an addition to the south with an angled rear side. The 1946 Sanborn Map shows an additional extension to the south with the rear elevation continuing to be angled. By 1959 the farthest south extension had been eliminated. The angled shape was determined by the railroad tracks, conforming to the tracks, and operations to the south and east of the building with the use continuing into the 1940s.

1916 Sanborn Map excerpt

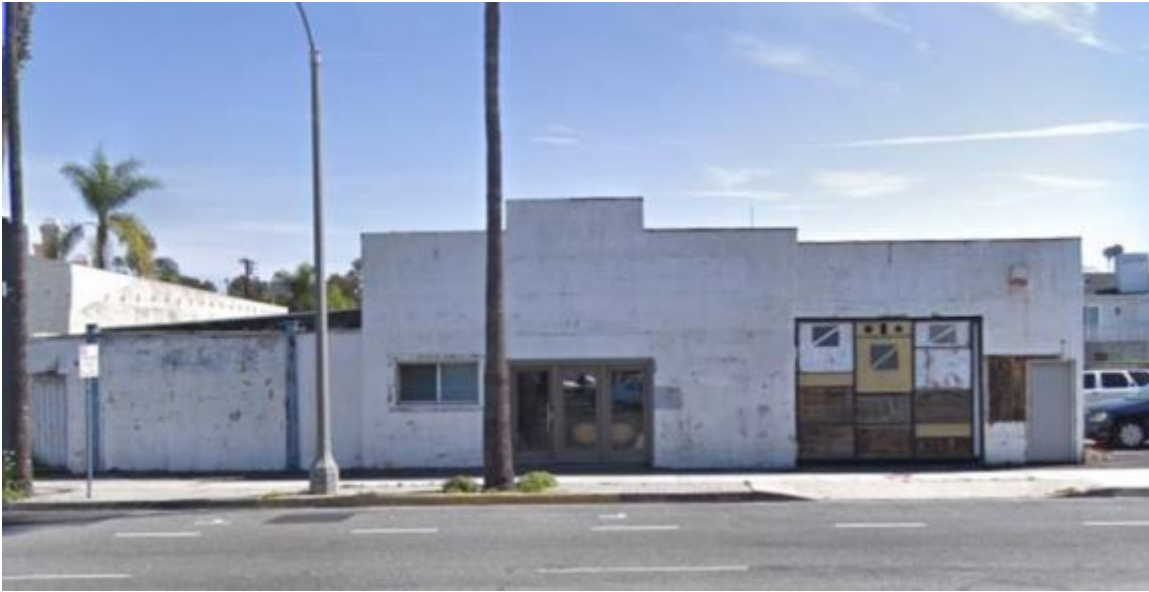
The front façade at the central portion and south addition is wood covered with metal panels stamped with a brick-like pattern; other sections of the exterior walls are exposed concrete masonry units and some areas of plywood. The metal panels are nailed and screwed onto the façade and also wrap the southwest corner and continue for approximately ten feet along the south side of the building. Metal panels would have been installed after the construction of the south addition.

Over the years doors and windows have been replaced; currently there is a large central opening and a horizontal window opening to the north of the entry way. A large gate marks the end of the central portion of the structure and serves as entry into the south addition. There is also a door at the southern end of the front façade that accesses an electrical closet directly behind the front of the building.

132 N. Catalina Avenue, west (front) elevation

Initial investigation found unfinished vertical wood siding that is in poor condition behind the metal panels. The wood framing of the wall behind the woodwork appears to be of relatively recent construction. At the front façade of the north portion, the woodwork at the columns and wall is in extremely poor condition. The enclosed north area has a low sloping roof that spans across the space but leaves a gap along the side property line. This structure may require removal or re-construction.

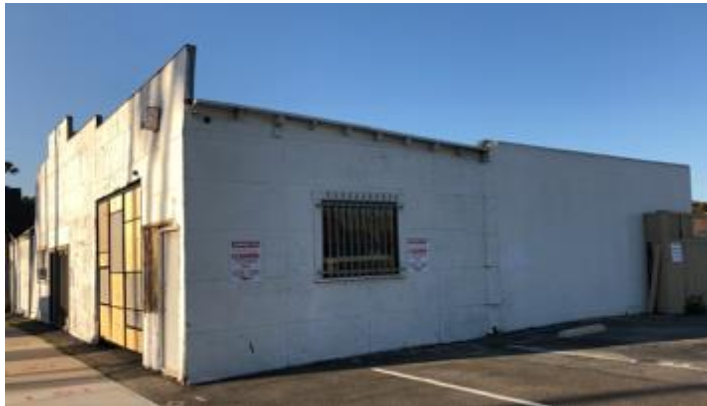
132 N. Catalina Avenue, west and south elevations

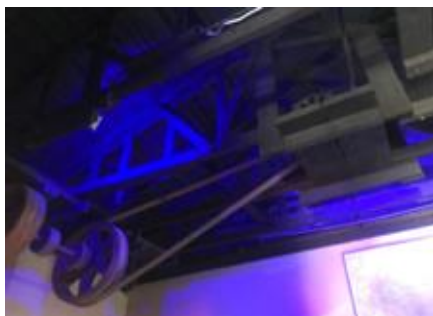
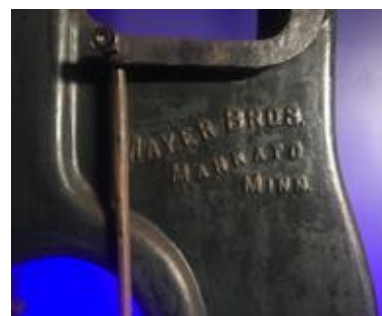
Much of the structure from the interior appears updated with plywood sheathing although some lumber looks older with true dimensions and square corners. Interior elements that relate to the building's original use as a blacksmith and metalwork chop remain. Large pulleys in the ceiling at the back of the main building connect a series of machines with a single motor. The assembly of machine elements are an interesting feature of the interior space.

132 N. Catalina Avenue, historic mechanical system inside

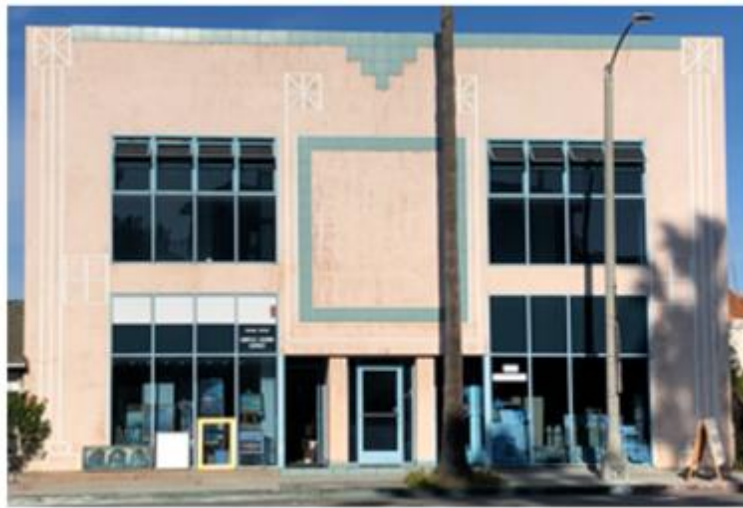
The building at 112 N. Catalina Avenue retains its original volume and massing as well as the division of the front façade into three modules and symmetrical design. There are no architectural details on the sides of the building except for five pilasters. During a 1993 remodel original features were removed or covered. The proposed rehabilitation of the building includes restoring original elements based on photographic documentation of the building's pre-1993 front façade.

The building at 112 N. Catalina Avenue will be adapted to a new use providing housing units. The historic character of the building will be restored with the rehabilitation of the front façade which is based on photographic documentation. The distinctive massing and volume of the building will be retained. The only changes to the building are demolition of a small portion of the rear of the building and the introduction of windows on the upper stories of the north side elevation and garage openings on the ground floor level portion of the building – an area of the building that has not been visible for 100 years. As such, there will be no adverse impact on the north side elevation. The reconstruction of historic features of the front elevation are evidence based.

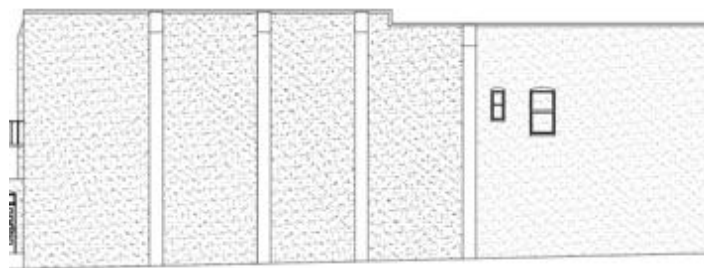
north elevation will become fully visible with the demolition of the non-historic 116 N. Catalina Avenue building which will be replaced by a driveway that will provide access into the complex. About 20 percent of the building, at the rear, will be demolished; one pilaster, the farthest back, will be removed. On the second and third floors of the building, new double-hung windows will be inserted to support the new interior residential program. At the first floor level most of the building will have garage openings that will lead to parking spaces. The first level parking space closest to the front of the building will have a roll up garage door as this area of the building will be the most visible from the public right of way.

The south elevation is similar to the north elevation with five pilasters and few windows, and it has been visible at least since the adjacent parcel at 100 N. Catalina Avenue was cleared of buildings in recent decades. There are no architectural details on either the north or south side elevations as it was thought that the adjacent parcels could be developed with buildings with no side yard setbacks. The proposed Catalina Village project will add a three-story building adjacent to and abutting the 112 N. Catalina Avenue building on its south side. As a result, the south elevation will no longer be visible.

132 N. Catalina Avenue, drawing of existing side (north) elevation

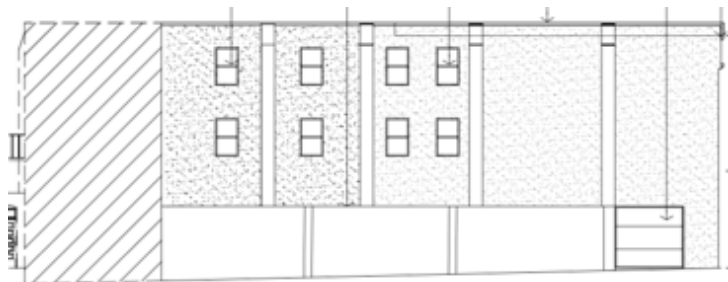
132 N. Catalina Avenue, drawing of proposed side (north) elevation

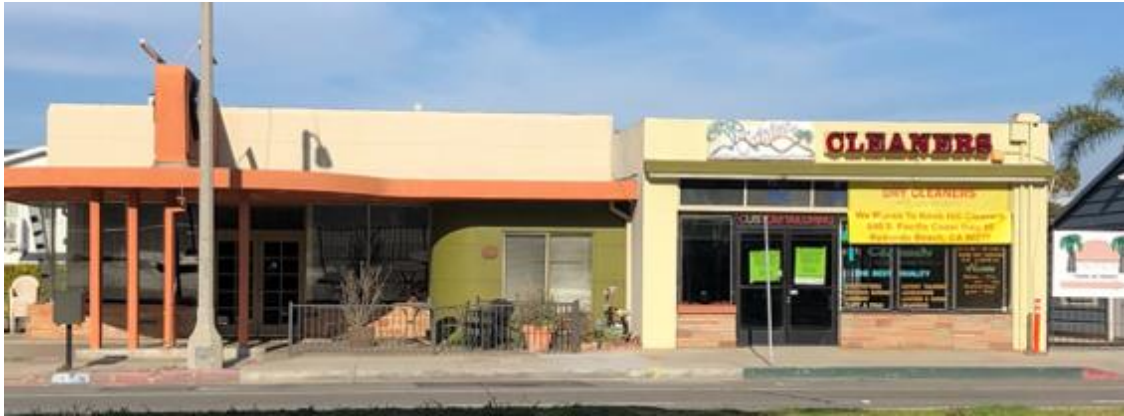
126 N. Catalina Avenue and 124 N. Catalina Avenue

The building at 124 N. Catalina Avenue was constructed in 1946 on a 25-foot wide parcel to house a clothes cleaning service. Four of the similarly narrow parcels to the north were consolidated to create a 200-foot wide parcel and in 1949 an addition to the existing cleaners building was constructed on that parcel. Known as 126 N. Catalina Avenue, the building offered drive-through service window with most of the building supporting clothes cleaning operations.

The 126 N. Catalina Avenue building was sited on the south half of the parcel, abutting the 124 N. Catalina Avenue building (with which it shared operations). This allowed for the north half of the parcel to be used to support vehicle parking as well as for vehicles to use the drive-through area of the cleaners. It is unknown when the drive-through service ended. The building was adapted into a Coffee Shop in 1994 and has generally functioned as a café for almost 25 years.

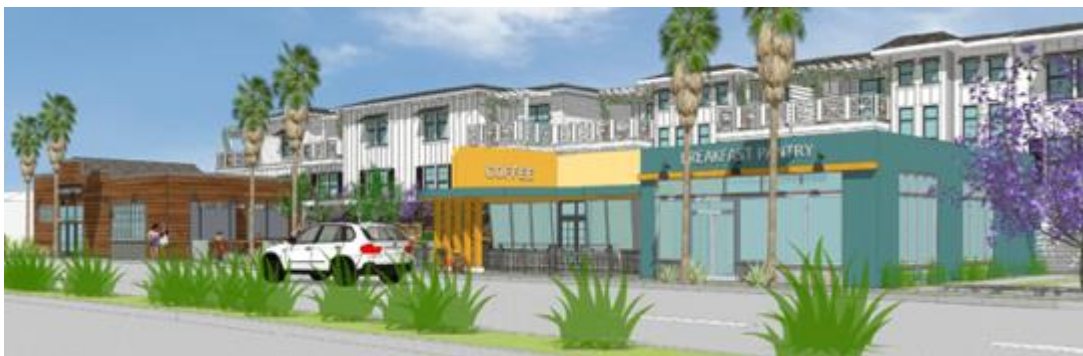
Sketch of 126 N. Catalina Avenue and 124 N. Catalina Avenue as part of Catalina Village

The two buildings will function as a single unit in the proposed project. The buildings will be adapted to function together as a café. Each storefront will retain their original designs.

The industrial rear portion of each building will be demolished. These areas supported cleaning operations and the side and rear elevations of each building have unadorned walls. The rear of these buildings were a shell to house the industrial operations of a cleaning plant. There are no historic features or elements of historic significance on this area of the building in terms of construction, design or the operations it housed. The historic significance of each of these buildings is based on their storefronts, street-facing architectural designs which will be retained, and the storefronts will be rehabilitated. The buildings' historic significance is not based on the industrial use of the buildings or the architectural design of the rear portions of these buildings.

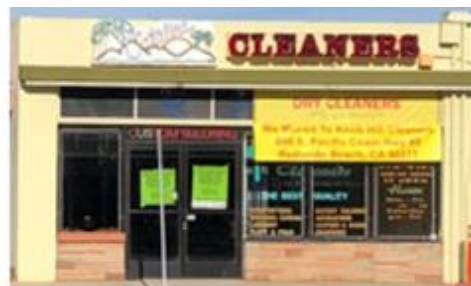
Drawing of 124 N. Catalina Ave., existing front elevation Photo of 124 N. Catalina Ave., front elevation.

The front elevation of 124 N. Catalina Avenue will remain the same. The original windows and doors remain as well as the original stacked stone bulkhead. A new sign

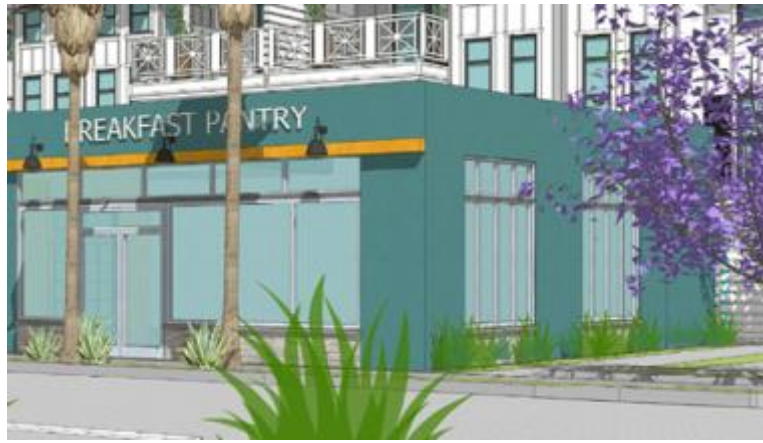
Sketch of 124 N. Catalina Ave., front (west) and proposed side (south) elevation

Two new windows will be inserted into the front portion, the original retail section, of the 100 - 132 N. Catalina Avenue building. They will be the same height as the front storefront windows but will be differentiated with more mullions. There will be a stacked stone bulkhead under each of the windows. The stacked stone will be discontinuous along this elevation to differentiate it from the original continuous stacked stone bulkhead of the front façade. The addition of similarly sized windows and the treatment of the glazing and stacked stone bring design elements of the front façade to this visible side of the building, but their design is sufficiently differentiated.

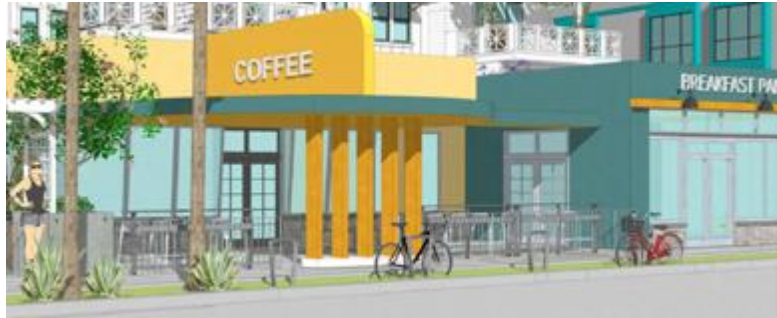
126 N. Catalina Ave., and 124 N. Catalina Ave. showing proposed north side elevation of 124 N. Catalina Ave.

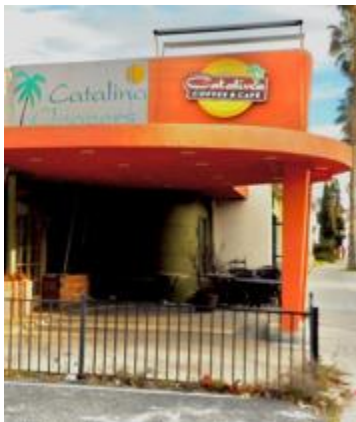
Beige wall is north elevation of 124 N. Catalina Ave. and green is projecting addition of 126 N. Catalina Ave.

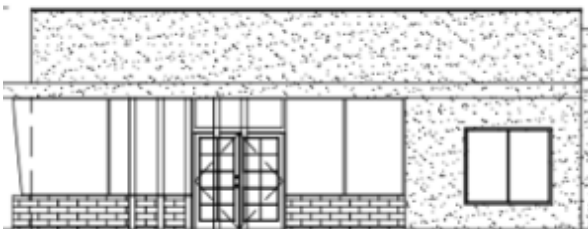
126 N. Catalina Ave., drawing of front elevation

The proposed rehabilitation of the Mid-Century Modern building at 126 N. Catalina Avenue includes retention of all original features on the historic street-facing storefront elevation – windows, doors, and canopy with its integral blade sign and pillars. The rehabilitation proposal for the front elevation of 126 N. Catalina Avenue also proposes demolition of the projecting office wing (painted green) on its south end. This wing was added at a later point in time. Although there are no building permit records, physical evidence shows that this is not original: the position and type of windows located on this projecting office wing are dissimilar to the other windows on the front elevation and are not representative of window types employed on the front elevation. Also, the stacked stone bulkhead which is a feature of the main portion of the front elevation is missing from the projecting office wing. Removal of this wing will not result in an adverse impact to any historic features.

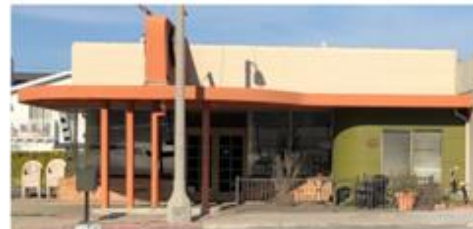
126 N. Catalina Ave., photo of front elevation

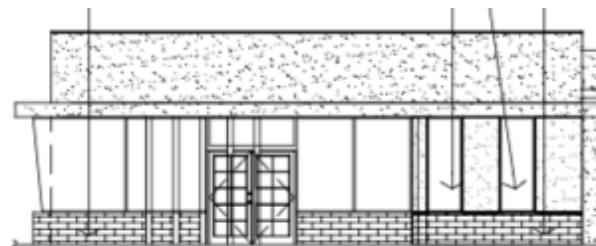
126 N. Catalina Ave., drawing of proposed front elevation

With the removal of this added wing, the front elevation will be a single plane. The new wall section will be consisting of four windows of the same height as the original windows of the storefront façade. The new windows will differ from the original windows in that they will be narrower. A stacked stone bulkhead, similar to the original, will be constructed; the stacked stone bulkhead is an existing feature on both buildings and filling in the “gap” provides continuity of design along this elevation. The Modernistic curved canopy with its projecting blade sign and pillars will be retained.

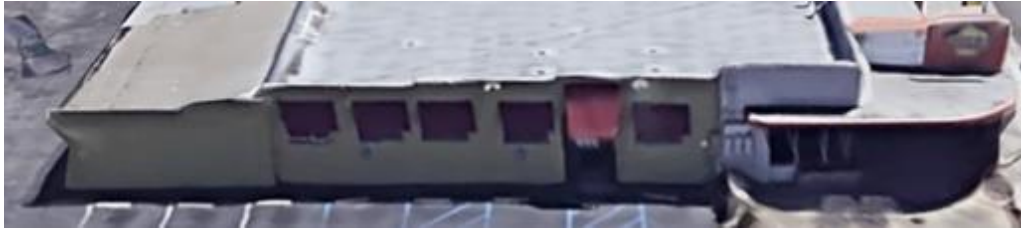
Photo of side (north) elevation of 126 N. Catalina Ave.

representative of window types employed on the front elevation. Also, the stacked stone bulkhead which is a feature of the main portion of the front elevation is missing from the projecting office wing. Removal of this wing will not result in an adverse impact to any historic features.

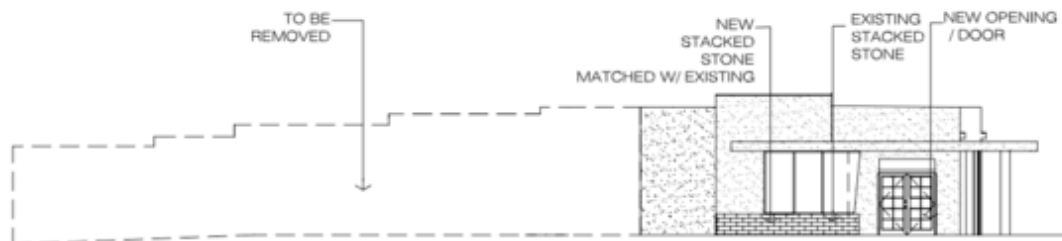
Proposed side (north) elevation of 126 N. Catalina Avenue

The proposed design retains all the existing original elements of the Modernistic design of the front portion of the historic 126 N. Catalina Avenue building. The new windows that are to be added are compatible with the original design. The replacement of the stacked stone bulkhead will use similar sized stone and pattern. The Modernistic curved canopy with its projecting sign and pillars is retained. Although a portion of the building will be demolished, the rear two-thirds of the building, this section has no Modernistic architectural features nor is its use as an industrial cleaning plant of historic significance.

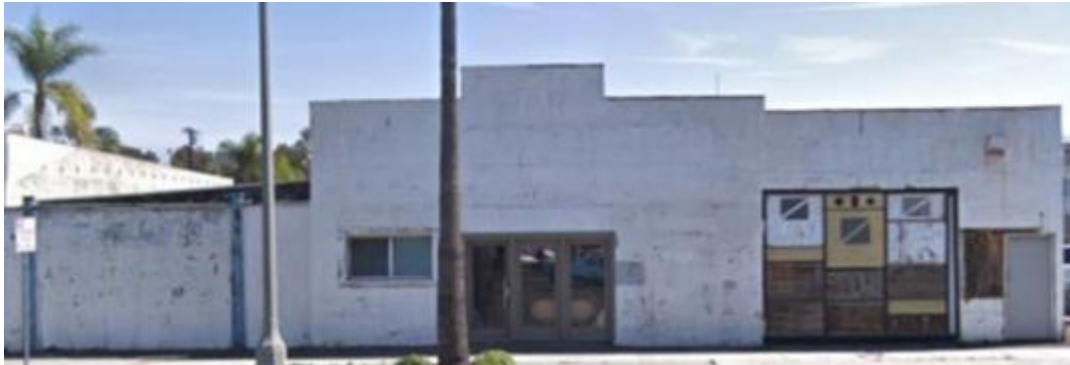
132 N. Catalina Avenue, photograph of front elevation

The building at 132 N. Catalina Avenue retains the original form of its stepped front parapet that hides the gabled roof building. A portion of the rear of the building will be demolished but the gable roof form will remain and will be visible looking at the rear of the building.

The building is proposed to be adapted from industrial uses/office to a tasting room. The lean-to shed on the north side of the building will be demolished to make way for a driveway into the complex. This shed lean-to is of unknown provenance and not a substantive element of the building. While the windows and doors are not original their location and size appears to have been in place for decades. The pattern and size will be retained; a set of transom windows will be added above the entry doors. The thin metal siding is not original; it will be replaced by horizontal wood siding.

The building will be adapted from industrial uses/office to a tasting room. The lean-to shed on the north side of the building will be demolished to make way for a driveway into the complex. This shed lean-to is of unknown provenance and not a substantive element of the building. While the windows and doors are not original their location and size appear to have been in place for decades. The pattern and size will be retained; a set of transom windows will be added above the entry doors. The thin metal siding is not original; it will be replaced by horizontal wood siding.

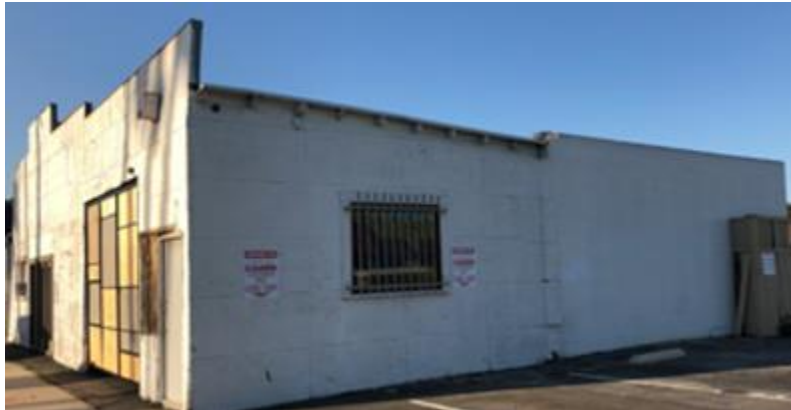
132 N. Catalina Avenue, front and side (south) elevations

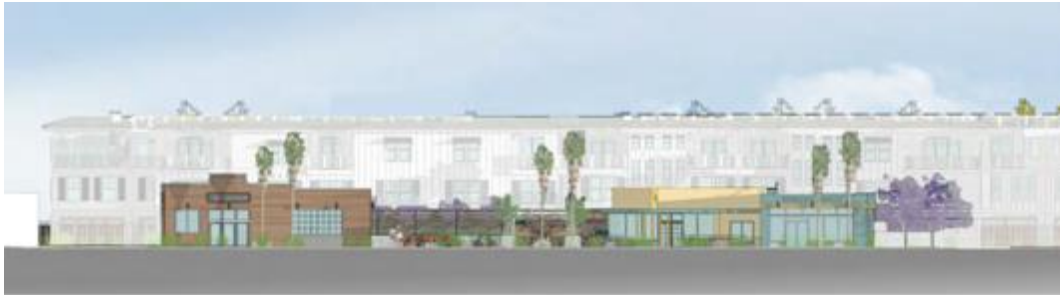
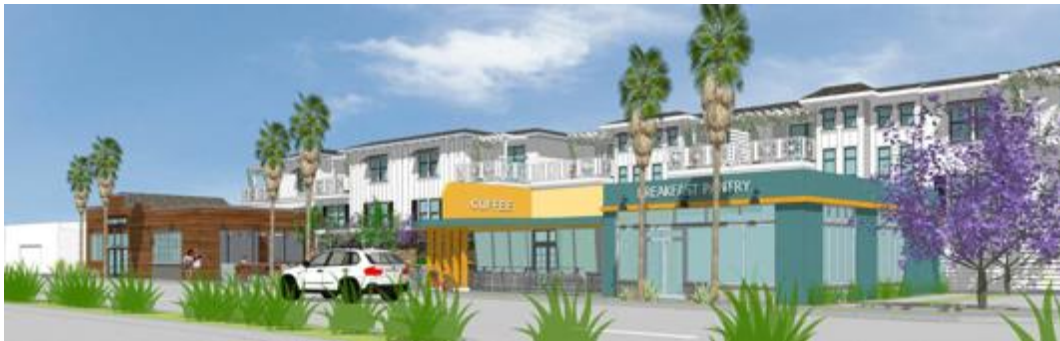
New residential apartment buildings to be constructed at the back of parcels

The Catalina Village project proposes to add new three-story residential apartment buildings to the rear of the parcels that contain contributing buildings of the eligible early 20th Century commercial district: 112 N. Catalina Avenue, 124 N. Catalina Avenue, 126 N. Catalina Avenue and 132 N. Catalina Avenue. The proposed multi-family buildings are set back at the rear property line of the parcels. This is an urbanized area of the city. The parcels directly to the east, abutting the subject parcels of the eligible historic district, are already developed with multi-story multi-family residential buildings; none of these buildings are historic resources. The proposed buildings are similar in height and massing to some of those (non-historic) existing buildings. The proposed residential buildings are uniform in height and neutral in color. As such they provide a neutral backdrop for the streetfront historic district.

The proposed multi-family buildings will not have an adverse impact on the setting of the eligible historic district or an adverse impact on any individual building of the eligible historic district.
