**100-132 N. Catalina Avenue
Redondo Beach, California
Historic Resource Evaluation**

November 20, 2020

100 – 132 N. Catalina Avenue
Historic Preservation Plan
Redondo Beach, California

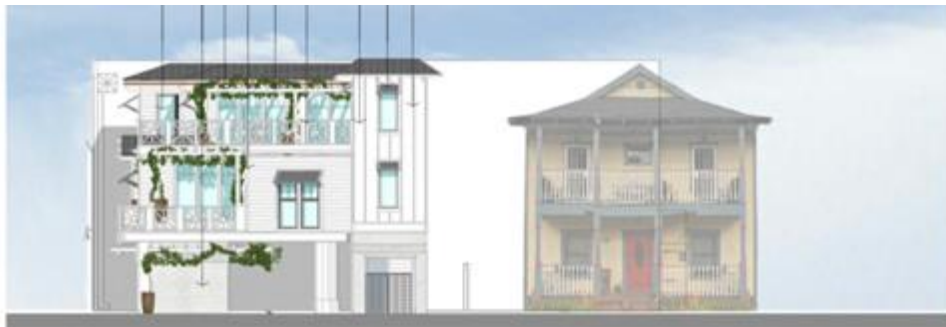
Emerald Street showing Catalina Village proposed apartment building and the City of Redondo Beach Landmark building, the Oklahoma Apartments at 305 Emerald Street

The proposed Catalina Village project also includes construction of a 3-story apartment building on the undeveloped corner parcel at 100 N. Catalina Avenue. On the parcel due east of the 100 N. Catalina Avenue parcel contains a designated City of Redondo Beach Landmark, the Oklahoma Apartments at 305 Emerald Street. The setting of the along Emerald Street already includes multi-story multi-family buildings from the late 20th Century. The adjacency of these buildings has not impacted the historic designation of the Oklahoma Apartments. The proposed building to the west of the Oklahoma

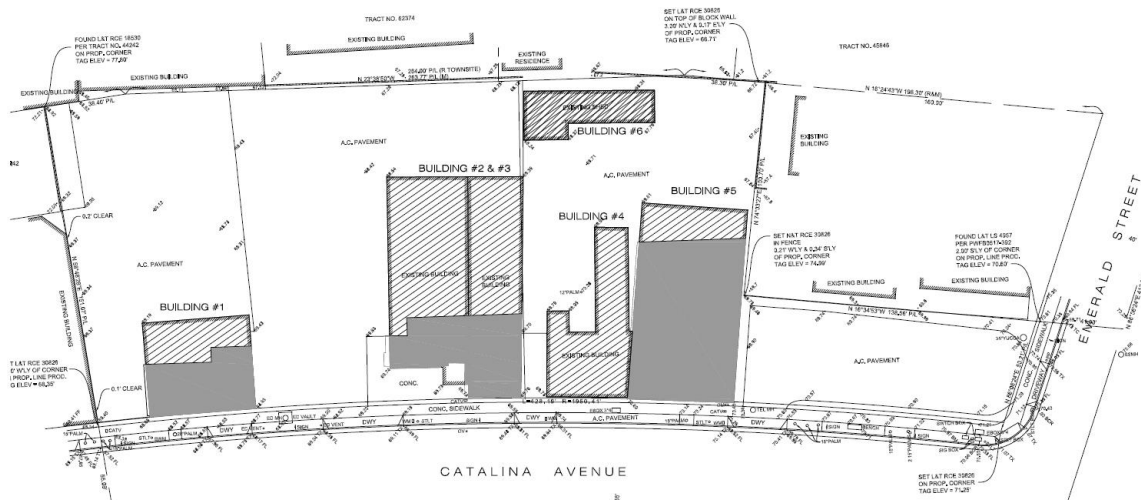
Project property with retained historic contributors highlighted in solid gray. Currently the area between buildings is paved open space used for parking and storage

The overall site is in fair condition with significant deferred maintenance for all structures. Asphalt paving in fair condition covers much of the open space.

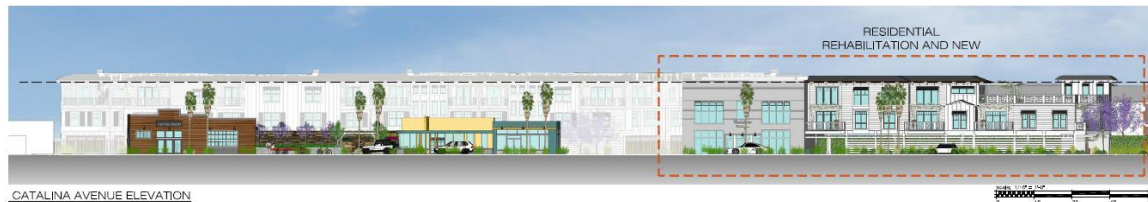
Overall street front view along N. Catalina Avenue of adaptively reused and rehabilitated contributors to the historic district with new housing as backdrop and at south corner.

furnishings for enhanced public outdoor areas along the street front relating to uses in the adjacent rehabilitated buildings. No new structures are placed between the identified street front resources. The new housing is arranged behind the low rise structures and creates a backdrop that highlights the varied street front historic resources. New housing is also sited at the end of the block, south of the two story building that provides a transition to the existing two story housing including a historic landmark around the corner on Emerald Street.

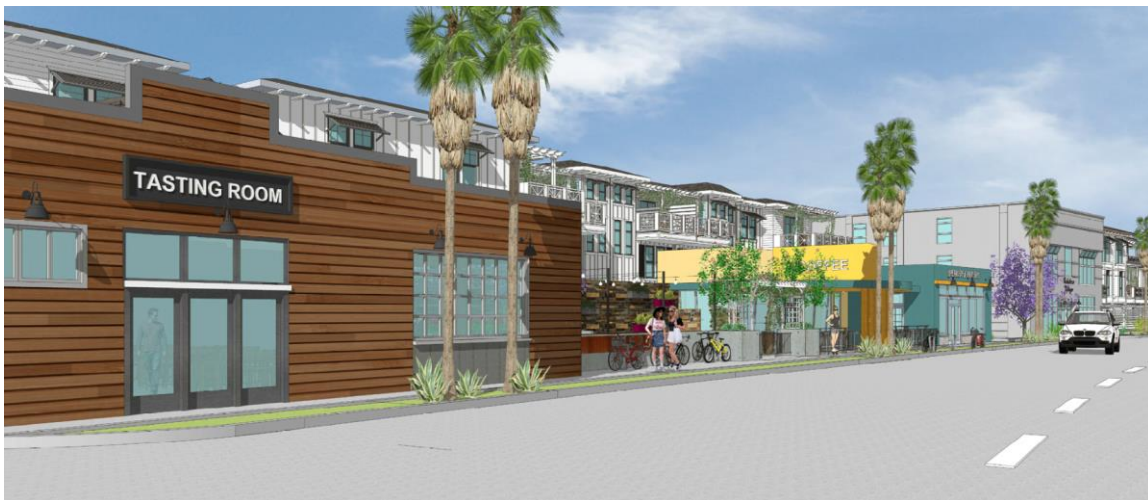
View looking south along North Catalina shows how the historic buildings are featured along the street front, framed and highlighted by the new housing development

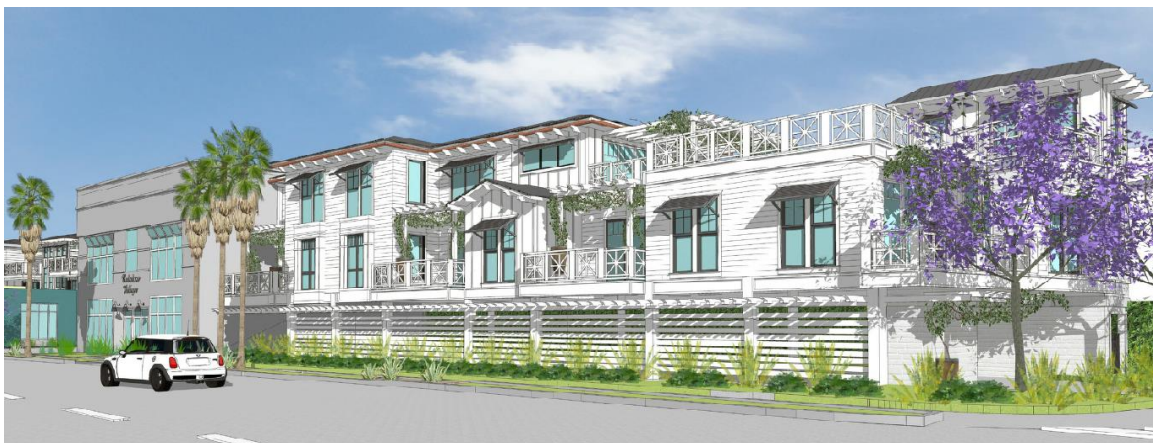
View looking north with new housing at the vacant corner lot adjacent to the existing two story building. The Housing helps to frame the historic district as well as to transition around the corner to adjacent historic multi-story housing.

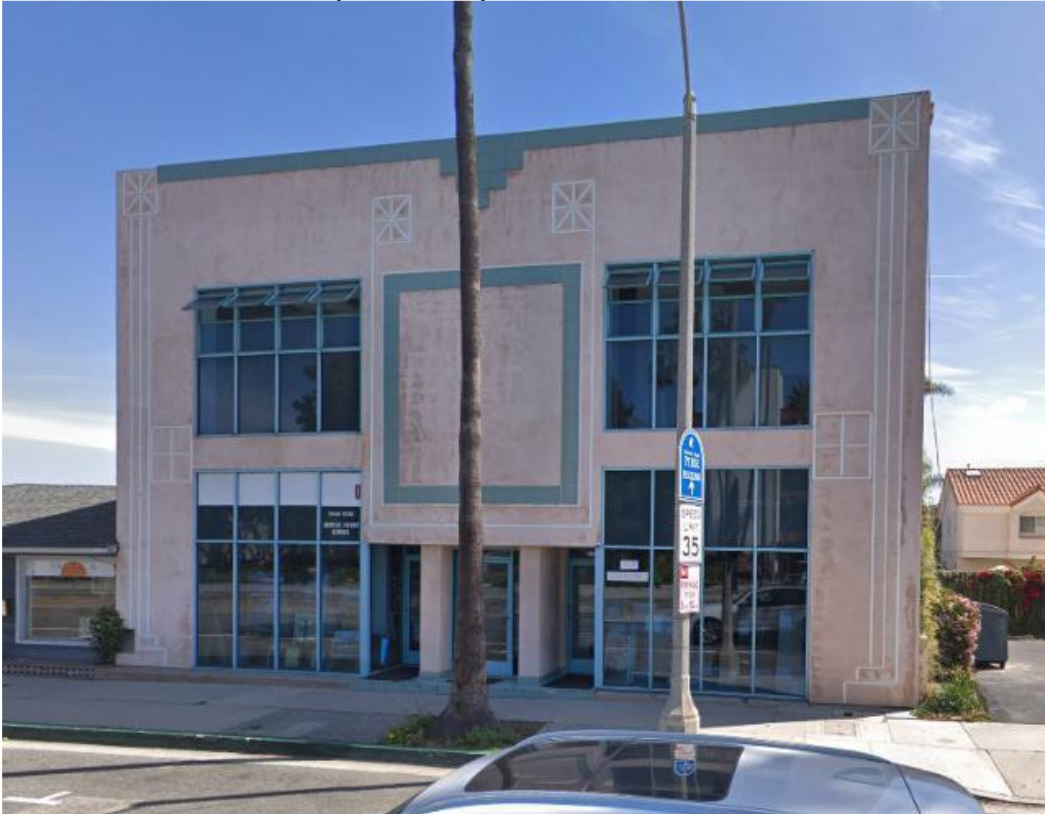
112 N. Catalina Avenue

The building exterior is in relatively good condition although the front façade is a dated design with minimal references to the original building design. Along with fading, the textured plaster has accumulated dirt creating an uneven appearance. Aluminum mullions for windows and doors have faded but otherwise the window assemblies appear in satisfactory condition.

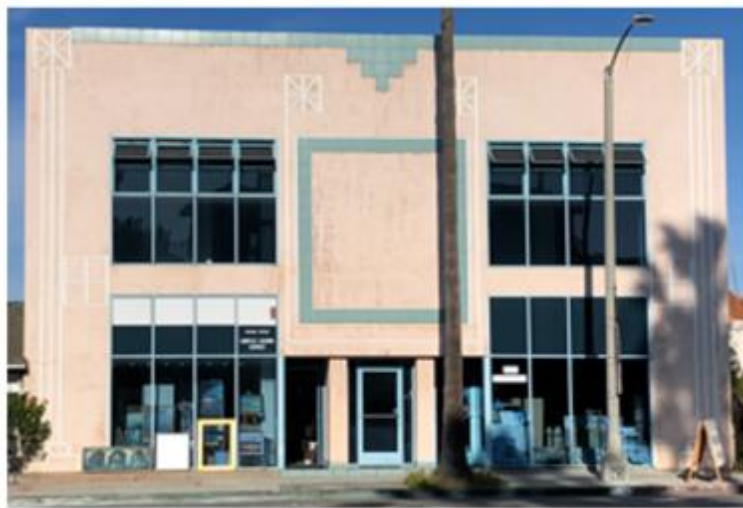
The 112 N. Catalina Avenue building retains its original volume and massing as well as the division of the front façade into three modules and symmetrical design. There are no architectural details on the sides of the building except for five pilasters. During a 1993 remodel original features were removed or covered. The proposed rehabilitation of the building includes restoring original elements based on photographic documentation of the building's pre-1993 front façade.

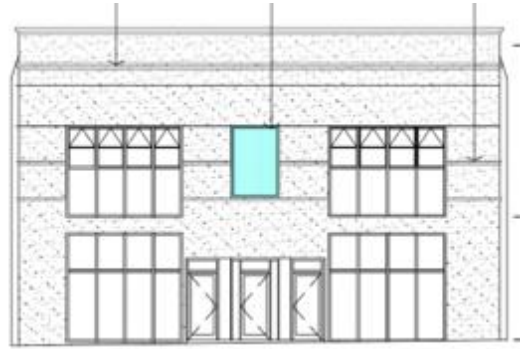
Drawing of proposed front elevation

The building at 112 N. Catalina Avenue will be adapted to provide housing units. The first floor level of the north side elevation has been obscured from view since construction of the adjacent building (116 N. Catalina Avenue) in 1921. The north elevation is a blank wall except for the five pilasters, a cornice and two windows. The north elevation will become fully visible with the demolition of the non-historic 116 N. Catalina Avenue building which will be replaced by a driveway that will provide access into the complex. About 20 percent of the building, at the rear, will be demolished; one pilaster, the farthest back, will be removed. On the second and third floors of the building, new double-hung windows will be inserted to support the new interior residential program. At the first floor level most of the building will have garage openings that will lead to parking spaces. The first level parking space closest to the front of the building will have a roll up garage door as this area of the building will be the most visible from the public right of way.

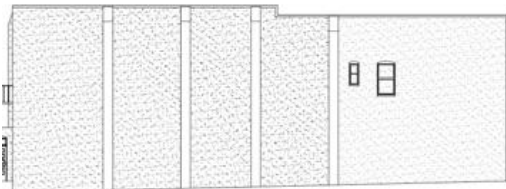
The south elevation is similar to the north elevation with five pilasters and few windows, and it has been visible at least since the adjacent parcel at 100 N. Catalina Avenue was cleared of buildings in recent decades. There are no architectural details on either the north or south side elevations as it was thought that the adjacent parcels could be developed with buildings with no side yard setbacks. The proposed Catalina Village project will add a three-story building adjacent to and abutting the 112 N. Catalina Avenue building on its south side. As a result, the south elevation will no longer be visible.

112 N. Catalina Avenue, drawing of existing side (north) elevation

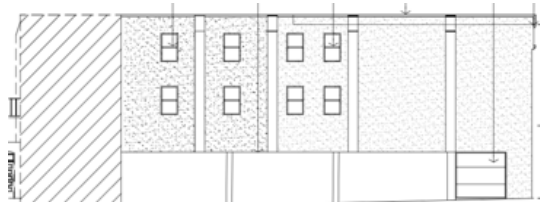
112 N. Catalina Avenue, drawing of proposed side (north) elevation

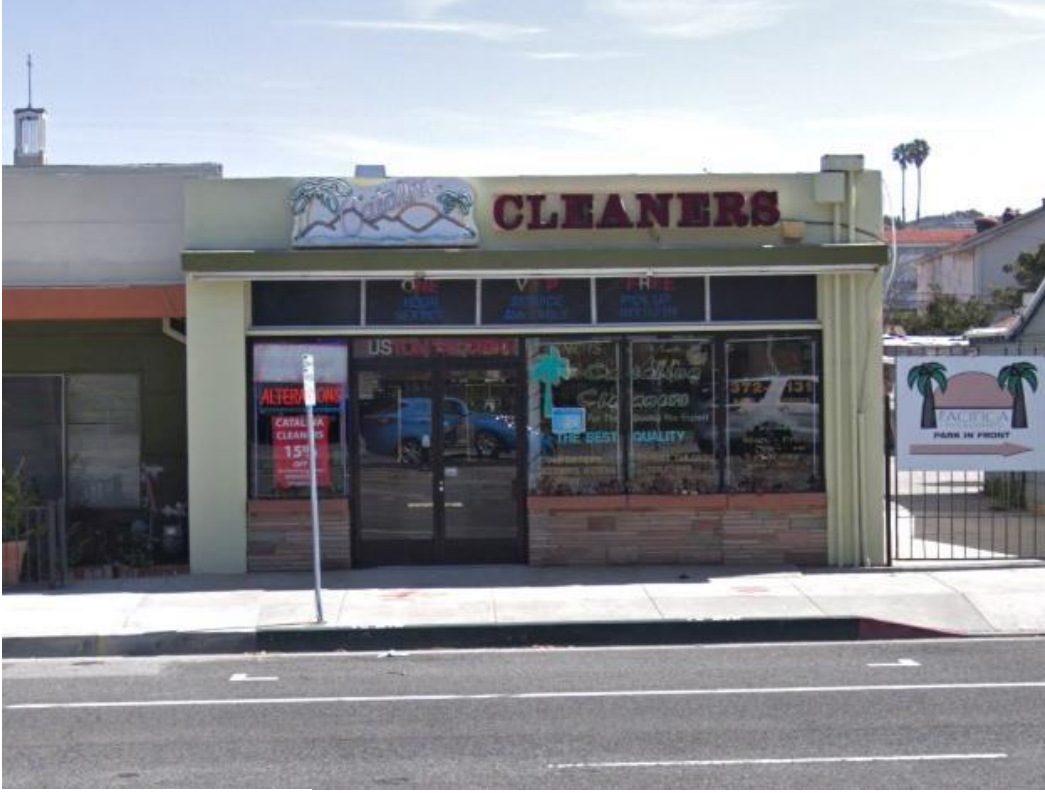
124 N. Catalina Avenue

The façade is generally in satisfactory condition. There have been unattractive modifications to the front façade mostly from exposed electrical service and outdoor lighting applied to the building that impacts the historic quality of the building. The horizontal wood mullion separating the transom windows should be refurbished.

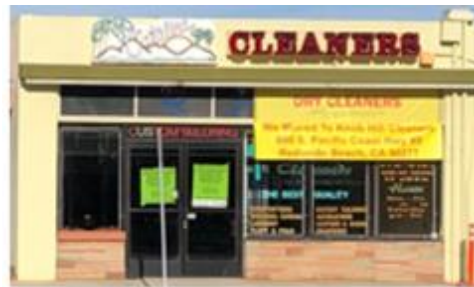
Drawing of 124 N. Catalina Ave., existing front elevation Photo of 124 N. Catalina Ave., front elevation.

The front elevation of 124 N. Catalina Avenue will remain the same. The original windows and doors remain as well as the original stacked stone bulkhead. A new sign will be placed at the upper level of the building – the traditional location on the building for signage.

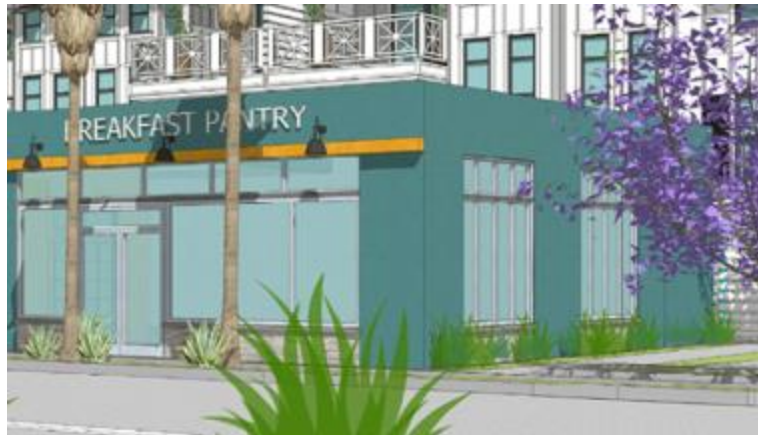
Sketch of 124 N. Catalina Ave., front (west) and proposed side (south) elevation

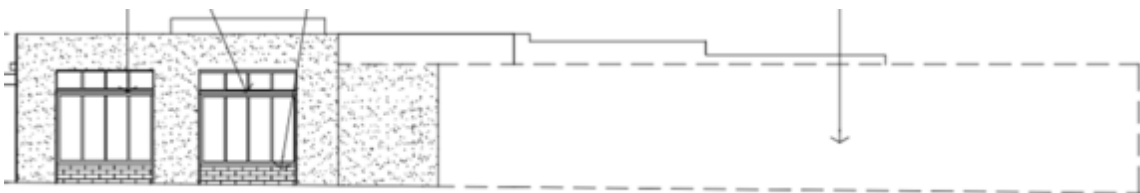
124 N. Catalina Ave., Drawing of proposed side (south) elevation

Two new windows will be inserted into the front portion, the original retail section, of the 124 N. Catalina Avenue building. They will be the same height as the front storefront windows but will be differentiated with more mullions. There will be a stacked stone bulkhead under each of the windows. The stacked stone will be discontinuous along this elevation to differentiate it from the original continuous stacked stone bulkhead of the front façade. The addition of similarly sized windows and the treatment of the glazing and stacked stone bring design elements of the front façade to this visible side of the building, but their design is sufficiently differentiated.

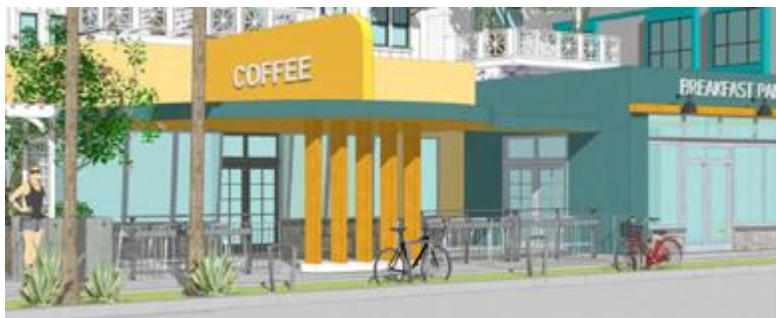
126 N. Catalina Ave., and 124 N. Catalina Ave. showing proposed north side elevation of 124 N. Catalina Ave.

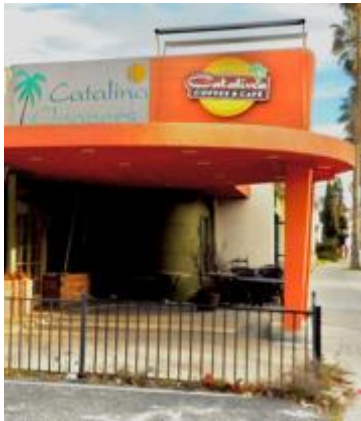
Beige wall is north elevation of 124 N. Catalina Ave. and green is projecting addition of 126 N. Catalina Ave.

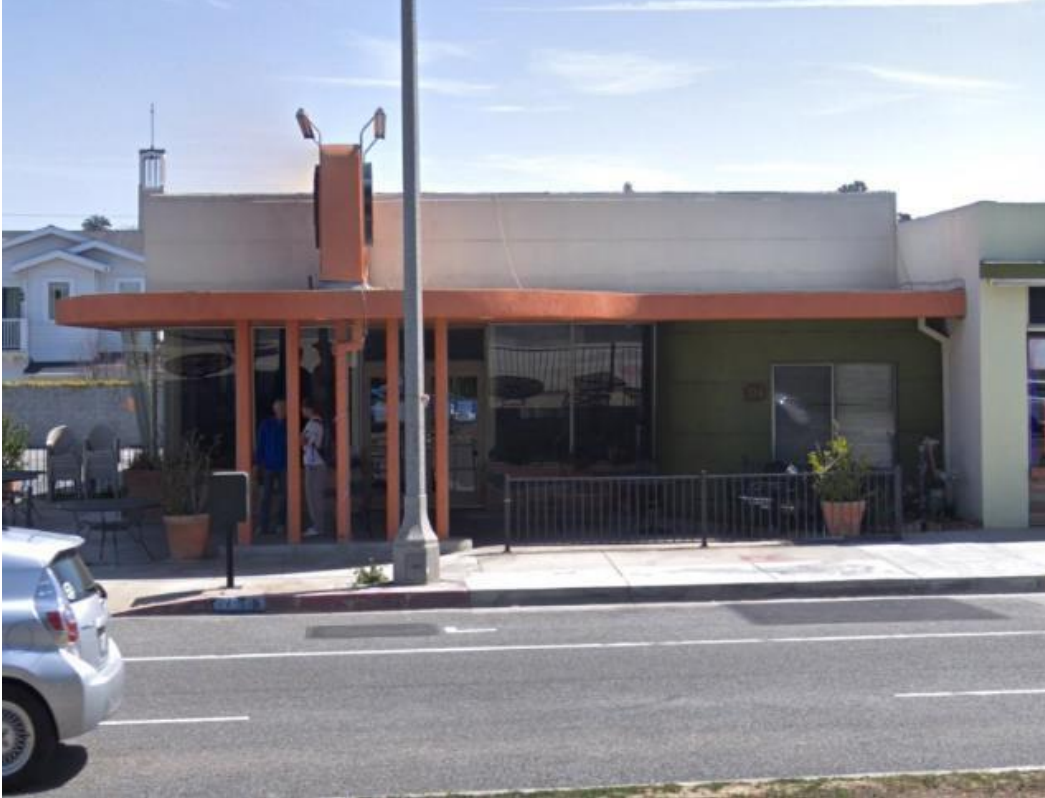
126 N. Catalina Avenue

The coffee shop front façade is generally in good condition with stylistic architectural elements intact. The glazed storefront including the corner without mullions will need further assessment to ensure longevity. The pair of front entry

doors may not be original but are in satisfactory condition. The curved and rough plastered extension at the south end with large sliding window do not appear original but both appears in satisfactory condition.

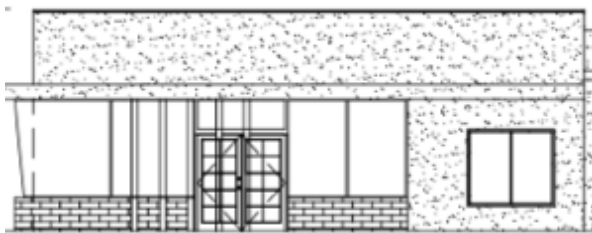
126 N. Catalina Ave., drawing of front elevation

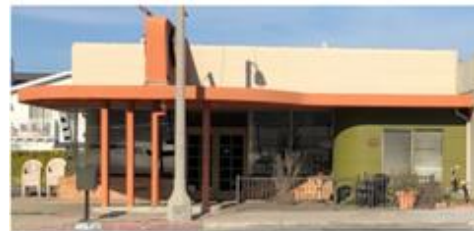
126 N. Catalina Ave., photo of front elevation

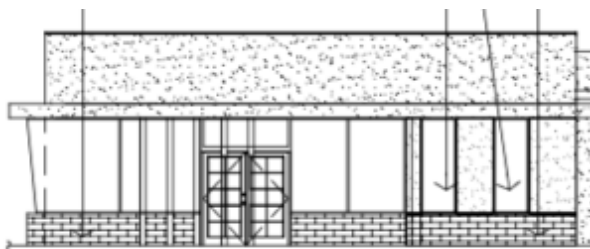
126 N. Catalina Ave., drawing of proposed front elevation

With the removal of this added wing, the front elevation will be a single plane. The new wall section will be consisting of four windows of the same height as the original windows of the storefront façade. The new windows will differ from the original windows in that they will be narrower. A stacked stone bulkhead, similar to the original, will be constructed; the stacked stone bulkhead is an existing feature on both buildings and filling in the “gap” provides continuity of design along this elevation. The Modernistic curved canopy with its projecting blade sign and pillars will be retained.

Rehabilitation of the Mid-Century Modern building at 126 N. Catalina Avenue includes retention of all original features on the historic street-facing storefront elevation – windows, doors, and canopy with its integral blade sign and pillars. The rehabilitation proposal for the front elevation of 126 N. Catalina Avenue also proposes demolition of the projecting office wing (painted green) on its south end. This wing was added at a later point in time. Although there are no building permit records, physical evidence shows that this is not original: the position and type of windows located on this projecting office wing are dissimilar to the other windows on the front elevation and are not

representative of window types employed on the front elevation. Also, the stacked stone bulkhead which is a feature of the main portion of the front elevation is missing from the projecting office wing. Removal of this wing will not result in an adverse impact to any historic features.

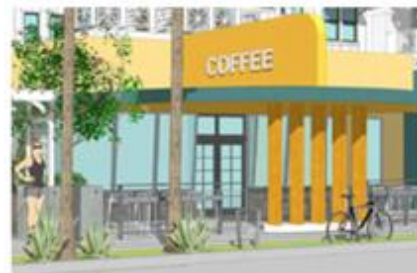
Sketch of front elevation

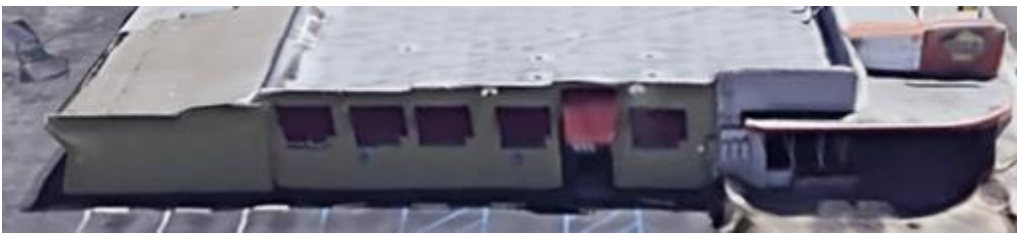
Photo of side (north) elevation of 126 N. Catalina Ave.

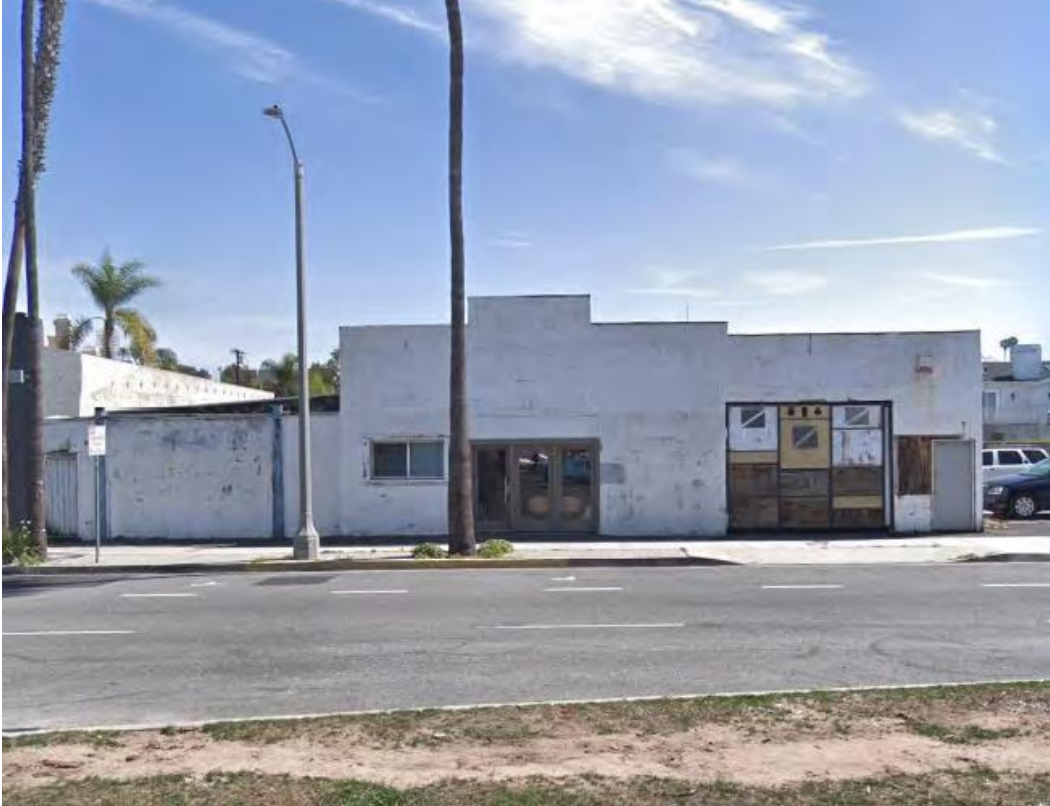
132 N. Catalina Avenue

Initial investigation found unfinished vertical wood siding that is in poor condition behind the metal panels. The wood framing of the wall behind the woodwork appears to be of relatively recent construction. At the front façade of the north portion, the woodwork at the columns and wall is in extremely poor condition. The enclosed north area has a low sloping roof that spans across the space but leaves a gap along the side property line. This structure may require removal or re-construction.

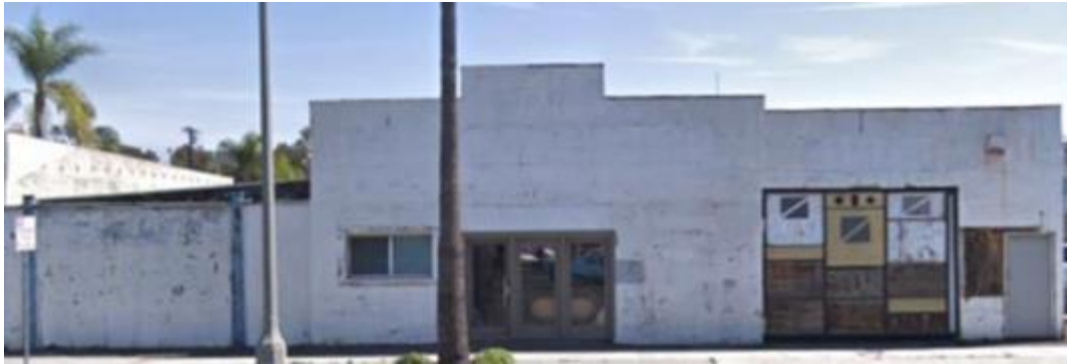
132 N. Catalina Avenue, photograph of front elevation

The 132 N. Catalina Avenue building retains the original form of its stepped front parapet that hides the gabled roof building. A portion of the rear of the building will be demolished but the gable roof form will remain and will be visible looking at the rear of the building.

The building will be adapted from industrial uses/office to a tasting room. The lean-to shed on the north side of the building will be demolished to make way for a driveway into the complex. This shed lean-to is of unknown provenance and not a substantive element of the building. While the windows and doors are not original their location and size appear to have been in place for decades. The pattern and size will be retained; a set of transom windows will be added above the entry doors. The thin metal siding is not original; it will be replaced by horizontal wood siding.

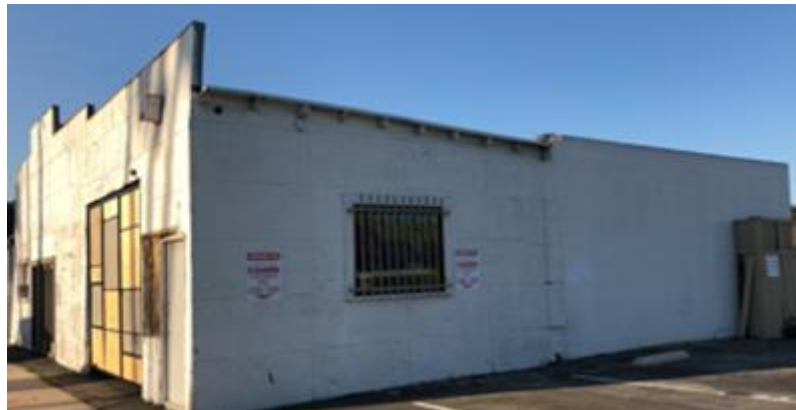
132 N. Catalina Avenue, front and side (south) elevations

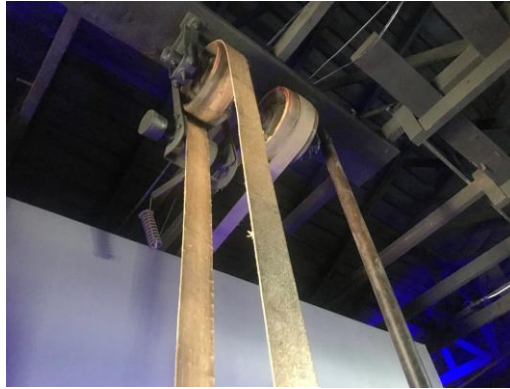
Pulleys connect to equipment

There is some residual machinery inside the building which are interesting artifacts. Although the machinery is not part of the public exterior view of the historic district, this equipment provides reference to an earlier era and the prior industrial uses of the site. Pieces of the equipment with possible connection via pulleys to an overhead shaft or similar is planned within the reconfigured interior as part of an interpretive exhibit.

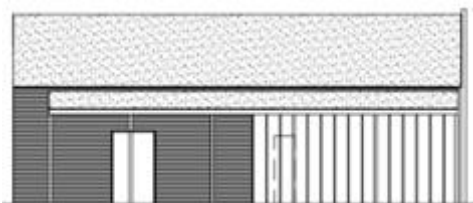
132 N. Catalina Ave., drawing of existing north elevation
