**100-132 N. Catalina Avenue
Redondo Beach, California
Historic Resource Evaluation**

November 20, 2020

**Kaplan Chen Kaplan
2526 Eighteenth Street
Santa Monica, CA 90405**

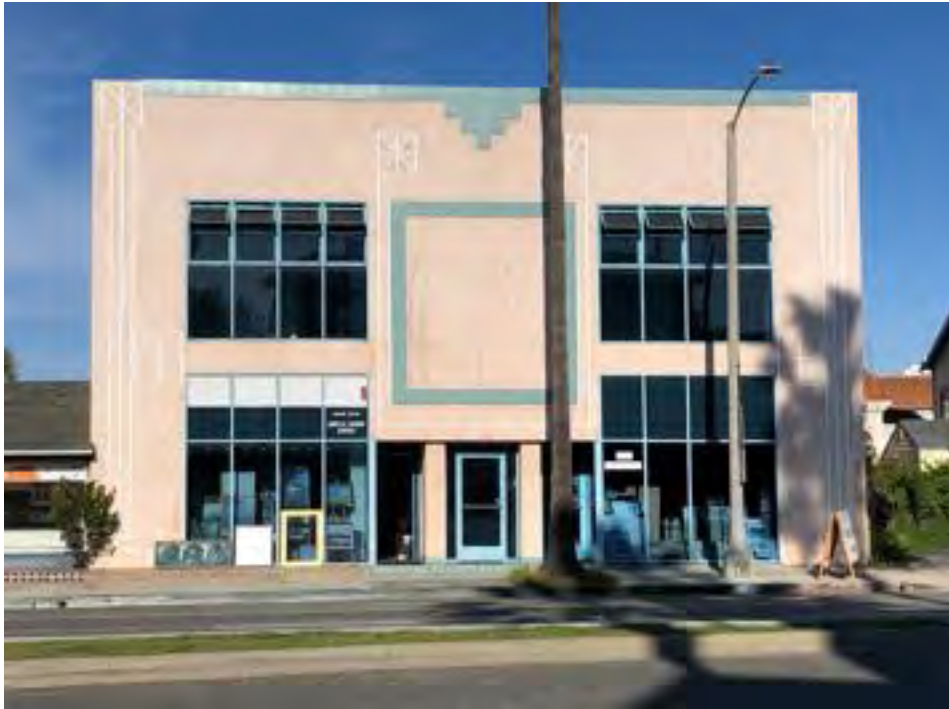
112 N. Catalina Avenue, front (west) elevation

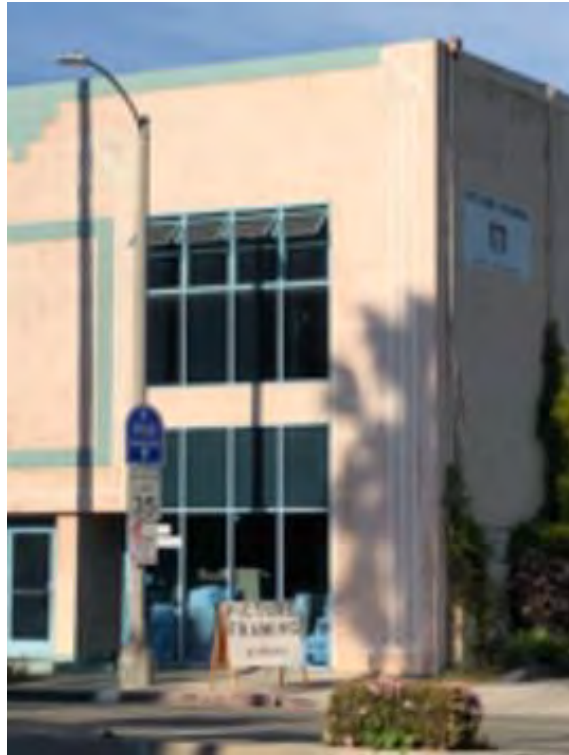
In 1993 the building underwent a seismic retrofit upgrade which included insertion of new steel frames across the building including a frame behind the front façade. The front façade of the building was remodeled at that time.

South end of west elevation, 2019

The original building exterior was re-plastered, and the original windows were removed and replaced. The photograph of the building from 1993 shows a defined horizontal cornice panel at the top of the building. The photograph also shows that there was a window centered along the upper elevation which has been enclosed; the other window openings are in the original locations of windows and generally of the same size. There was a horizontal band above a storefront with a recessed entry. There is an exposed original cornerstone setback at the northwest corner of the building.

Alterations to the front façade during the 1993 remodel included addition of new applied decorative elements. The building's front façade features tile details including decoration at the parapet with a centered inverted triangle of tile located at the center of the building. Other added decorative features on the front façade include scoring at each end of the front elevation. These are topped by a square with diagonals through each square. That square pattern is repeated above each side of the centered rectangle. On the upper level there are two large aluminum frame, multi-pane windows which have operable upper sashes. None of these windows are original. The blank wall between the upper story windows and above the centered ground level entry is enframed by a rectangular tile outline. At the ground floor there are another two windows. There are three entrances at the street level each consisting of a single glazed aluminum frame door with aluminum frame transom. Including. None of the windows or doors are original.

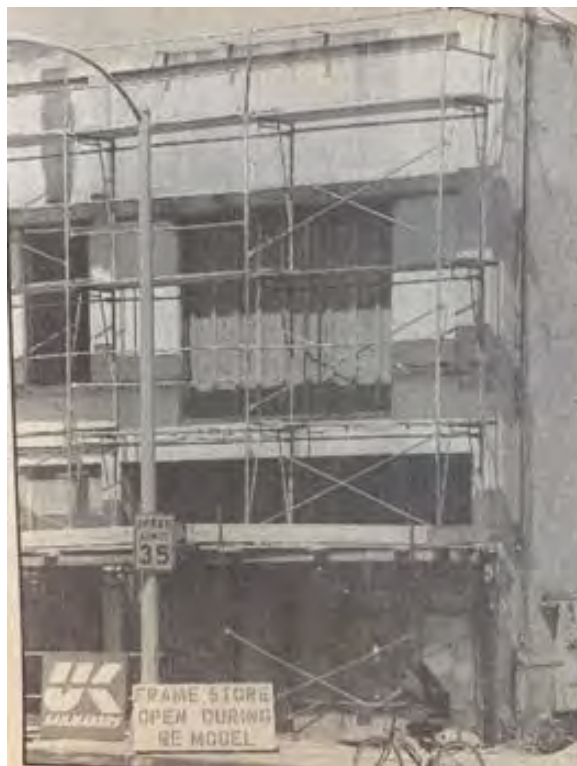
South end of west elevation, c1992

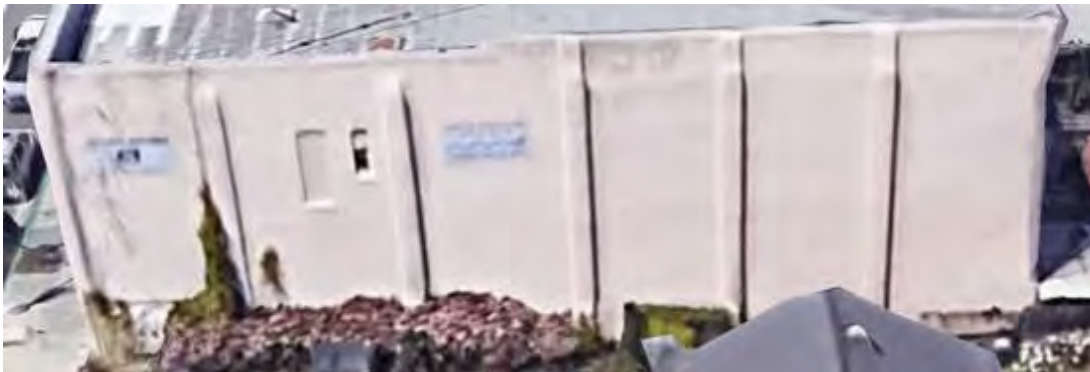
North (side) elevation of 112 N. Catalina Avenue (Google Earth, c2019)

The long side elevations are broken up by a series of vertical pilasters that stop short of reaching the parapet. The side walls are windowless except for one large and one small window. There are arched brick headers in the second bay from the front on both sides and infilled openings in the first and third bays on the south side. There are no architectural details other than the pilasters on the side elevations. The lack of fenestration and architectural details on the side elevations was likely due to aspirations and anticipation of adjacent development which would obscure views of these elevations.

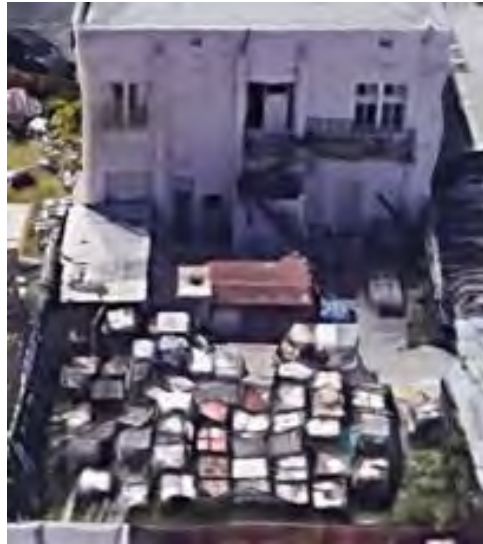
The rear elevation has three arched opening on the upper floor and an exterior metal stair. There are storage sheds and surface parking at the rear of the parcel.

112 N. Catalina Avenue, east (rear) elevation, Google Earth, c2019

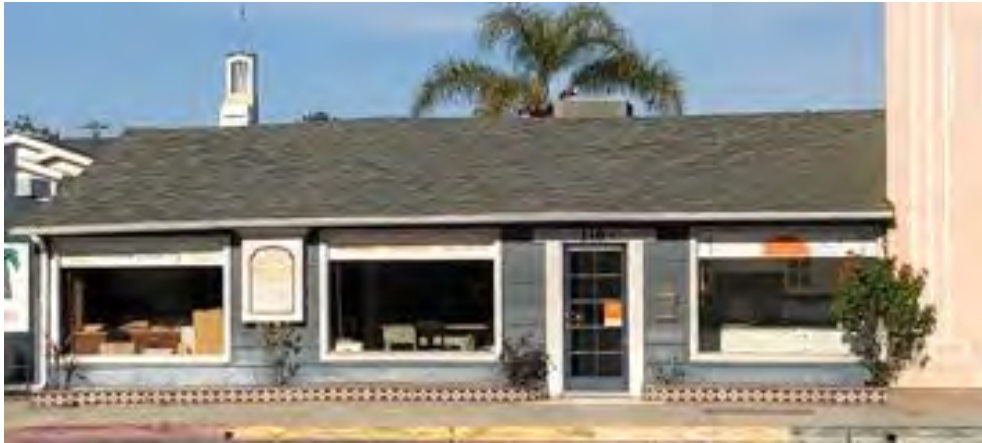
The building is a commercial building constructed in 1921. In 1925 a duplex dwelling was added onto the building. Later a portion of the duplex, on the north side, was demolished to create a driveway to provide vehicular access to the rear of the parcel. The remaining portion of the dwelling was converted to commercial uses. The building has served as a carpentry shop and cabinet shop for several decades.

116 N. Catalina Avenue, front (west) elevation

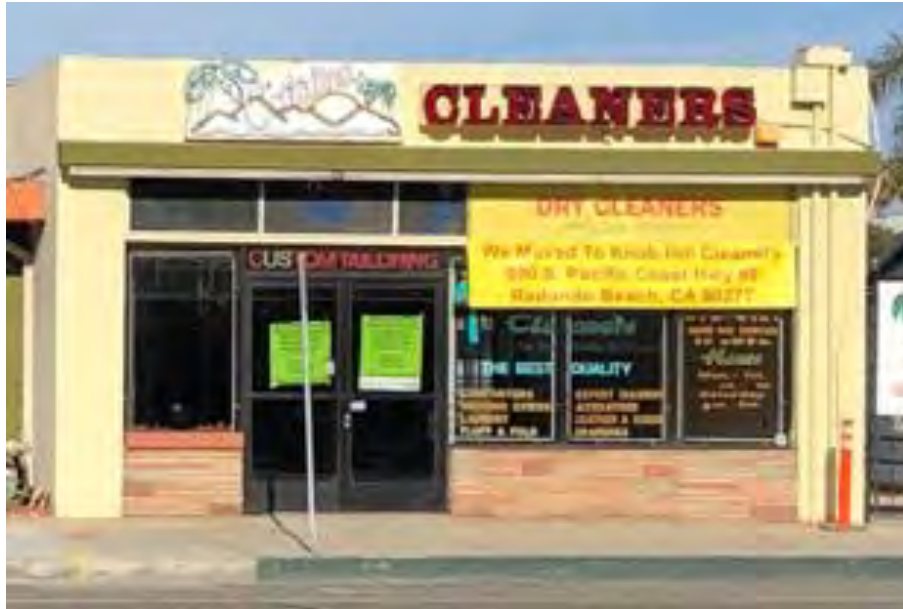
This vernacular commercial/industrial building was constructed in 1946 as a retail dry cleaning service for Wardrobe Cleaners with on-site cleaning facilities. Dry cleaning businesses have operated in the building since its construction.

124 N. Catalina Avenue, west (front) elevation

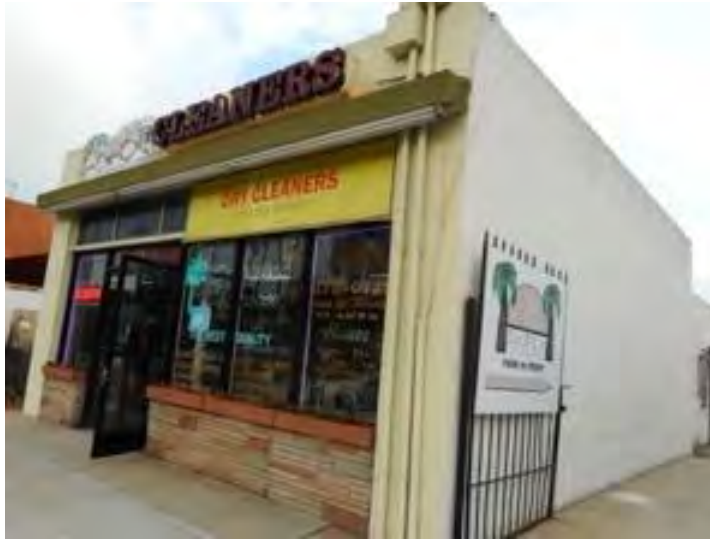
The front retail section of the one-story building is rectangular in plan with simple massing. The north side of the building is adjacent to the neighboring building. The south elevation of the building faces a driveway that leads to surface parking at the rear of the parcel. A long rear section of the building contains the industrial dry cleaning plant. Between 1946 and 1959 the rear was extended.

124 N. Catalina Avenue, west and south elevation

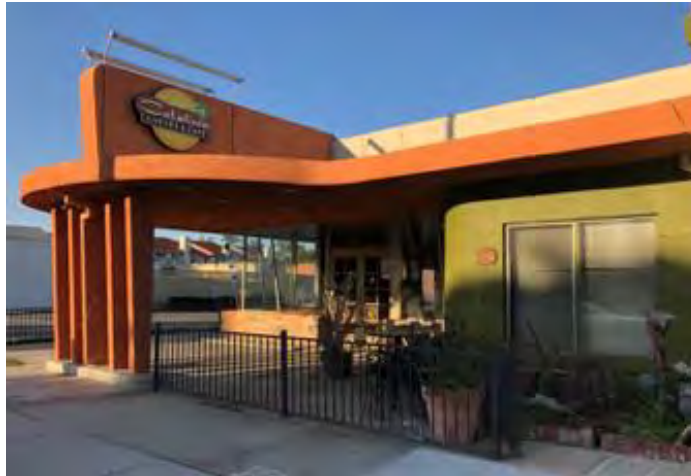
The building is setback from the front property line and features a patio area. The building has a canopy that covers the patio. The canopy is a slightly projecting band along the front wing of the elevation but where the building is recessed at its north end, the canopy juts out to create a semi-circular roof and is supported by a series of tapered posts. The angles of the front windows and the tapered columns align with the curve of the canopy giving the building a dynamic aesthetic. Adding to that dynamism is the projecting sign, integral to the canopy, that sits atop the canopy.

126 N. Catalina Avenue, west elevation and canopy

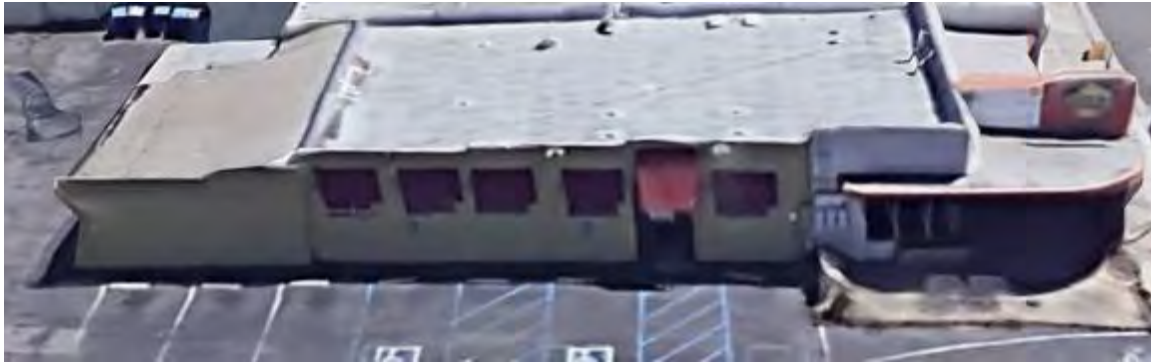
126 N. Catalina Avenue, north elevation (Google Earth, c2019)

The south side of the building is not visible as it is adjacent to the building at 124 N. Catalina Avenue. The north side of the building faces the parcel's parking area. The very front of the north elevation is the wrap-around of the front windows and includes the return of the curved canopy with its Modernistic flair. However, beyond that, making up most of this side elevation, there is no architectural detailing and no continuation of any Modernistic style influences. Rather, it is a simple wall with regularly placed small windows arranged along its elevation. The front portion of this elevation is distinguished from the rear portions that have dropped parapets and appears as an appendage to the front structure and has a different finished surface.

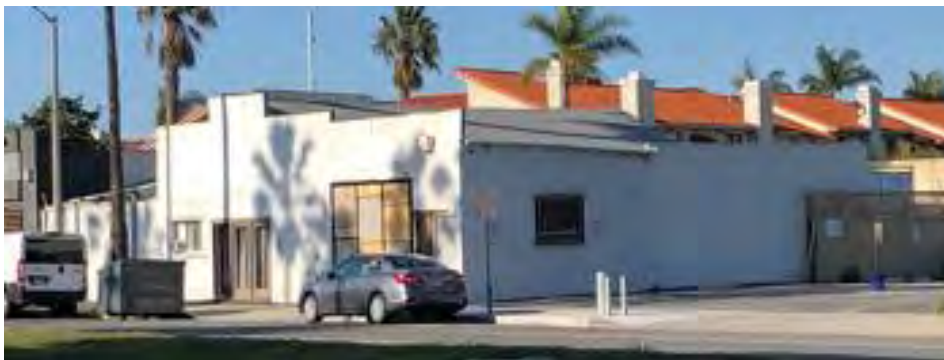
This building, constructed in 1905, was used as a blacksmith shop, ironworks and woodworking shop over the decades with business including Star Blacksmith (1924), H.J. Campeau Ornamental Iron and E.L. Martin, Blacksmith (1931), and E.L. Martin, Blacksmith (1947). Inside the building mechanical systems that supported industrial operations remain. The building had a relationship to the train tracks and the operations and maintenance facilities of the railroad from the early 20th Century when the main track of the narrow gauge Redondo Railway and the area to the south and east of the building was used as a freight yard for a railroad. This parcel and the northern portion of the block continued to be used for operations of the Redondo Railway until the 1940s with aerial photographs showing that the train tracks traversed the area behind this building in the 1930s and 1940s.

132 N. Catalina Avenue, west and south elevations

Sanborn Maps show how the footprint of the building has evolved over time. The 1906 Sanborn Map shows the building as “L” shape in plan. The 1916 Sanborn Map shows an addition to the south with an angled rear side. The 1946 Sanborn Map shows an additional extension to the south with the rear elevation continuing to be angled. By 1959 the farthest south extension had been eliminated. The angled shape was determined by the railroad tracks, conforming to the tracks, and operations to the south and east of the building with the use continuing into the 1940s.

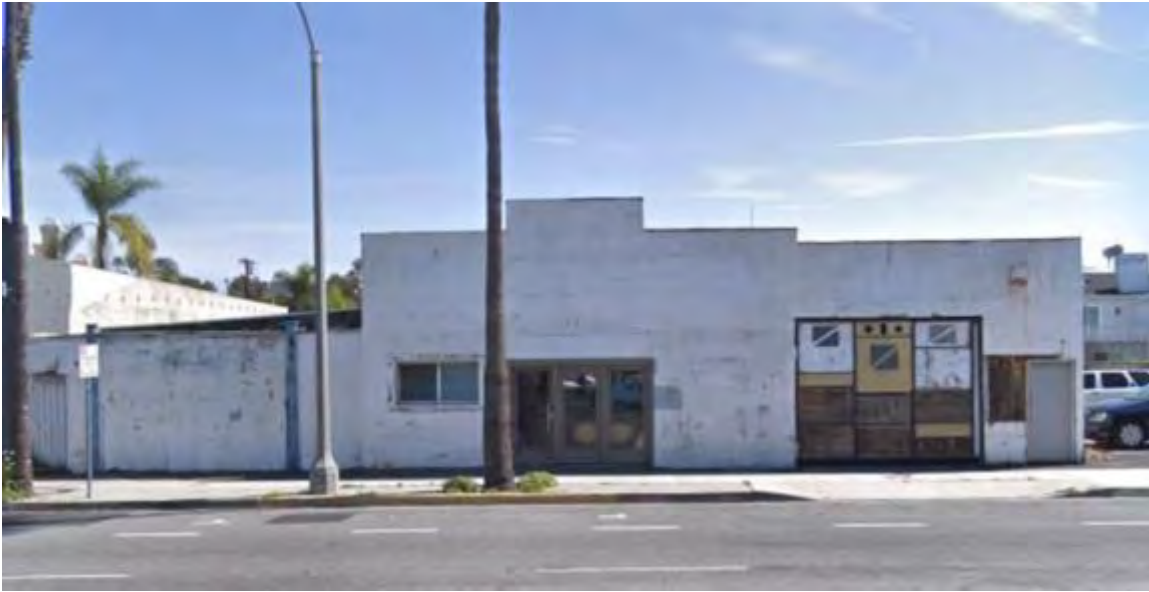
Over the years doors and windows have been replaced; currently there is a large central opening and a horizontal window opening to the north of the entry way. A large gate marks the end of the central portion of the structure and serves as entry into the south addition. There is also a door at the southern end of the front façade that accesses an electrical closet directly behind the front of the building.

132 N. Catalina Avenue, west (front) elevation

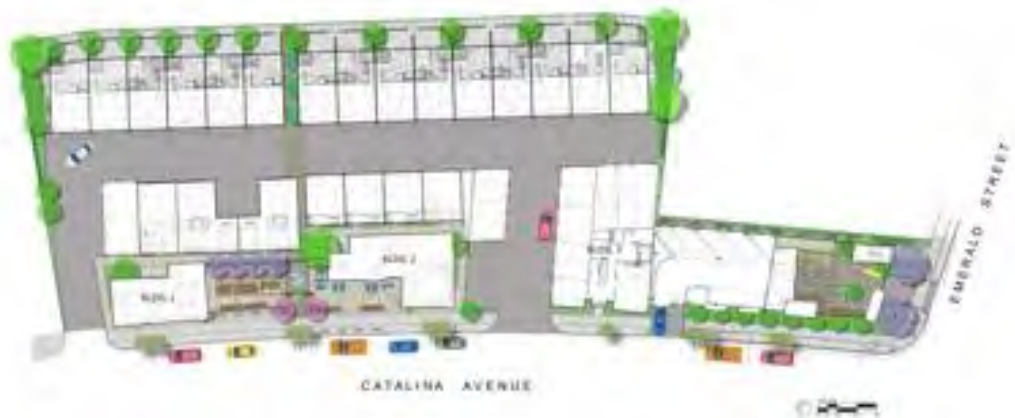
Proposed Project Site Plan

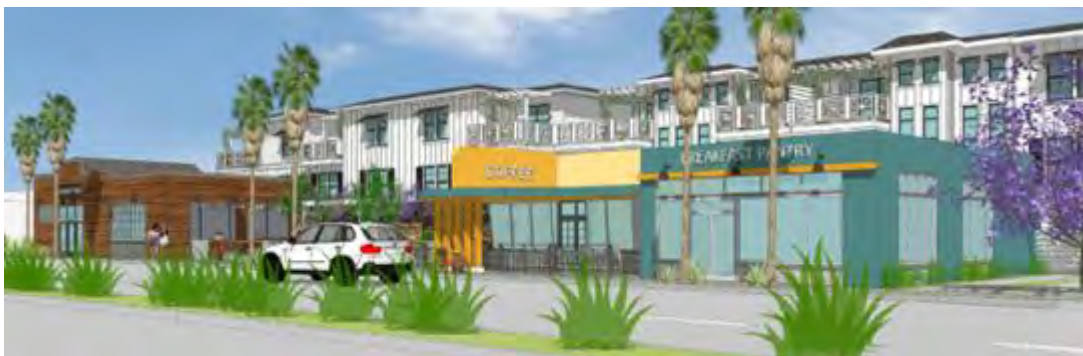
Sketch of 126 N. Catalina Avenue and 124 N. Catalina Avenue as part of Catalina Village

The 126 N. Catalina Avenue building was sited on the south half of the parcel, abutting the 124 N. Catalina Avenue building (with which it shared operations). This allowed for the north half of the parcel to be used to support vehicle parking as well as for vehicles to use the drive-through area of the cleaners. It is unknown when the drive-through service ended. The building was adapted into a Coffee Shop in 1994 and has generally functioned as a café for almost 25 years.

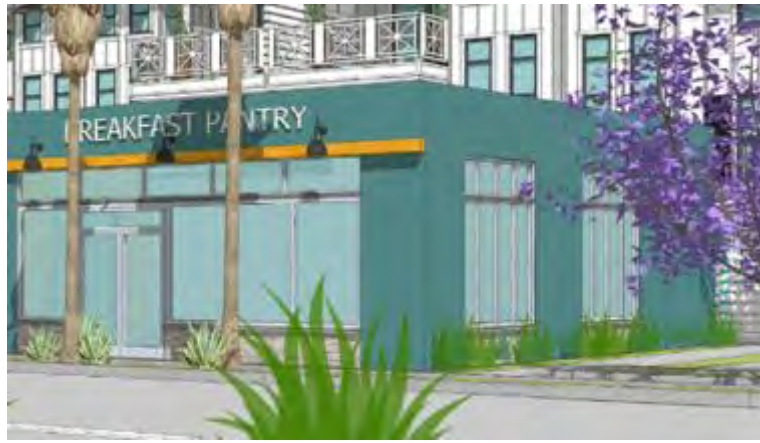
Sketch of 124 N. Catalina Ave., front (west) and proposed side (south) elevation

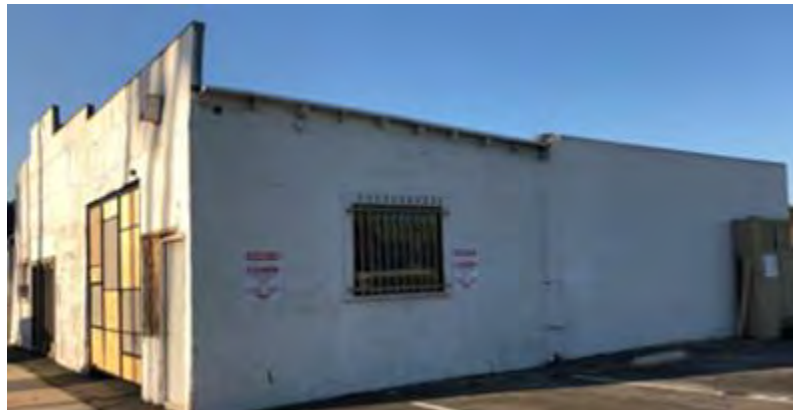
The building is proposed to be adapted from industrial uses/office to a tasting room. The lean-to shed on the north side of the building will be demolished to make way for a driveway into the complex. This shed lean-to is of unknown provenance and not a substantive element of the building. While the windows and doors are not original their location and size appears to have been in place for decades. The pattern and size will be retained; a set of transom windows will be added above the entry doors. The thin metal siding is not original; it will be replaced by horizontal wood siding.

132 N. Catalina Avenue, front and side (south) elevations

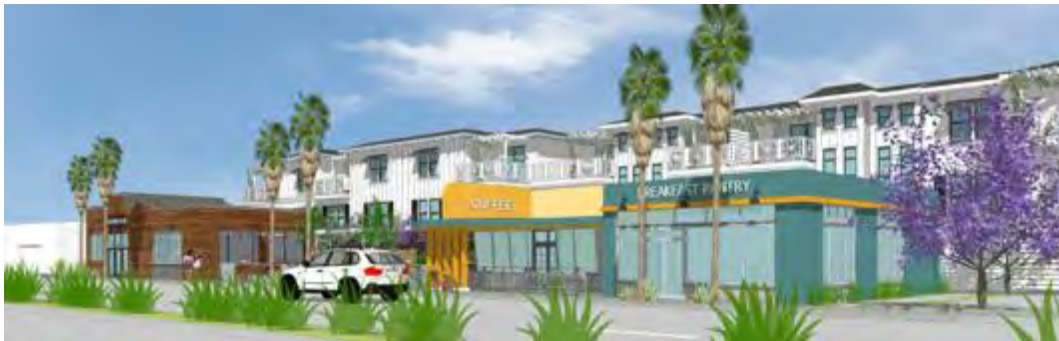
New residential apartment buildings to be constructed at the back of parcels
