100 – 132 N. Catalina Avenue
Historic Preservation Plan
Redondo Beach, California

NORTH CATALINA AVENUE HISTORIC DISTRICT
Rehabilitation and Adaptive Reuse – Historic Preservation Plan
100 – 132 N. Catalina Avenue, Redondo Beach, California

Historic Rehabilitation and Reuse Plan

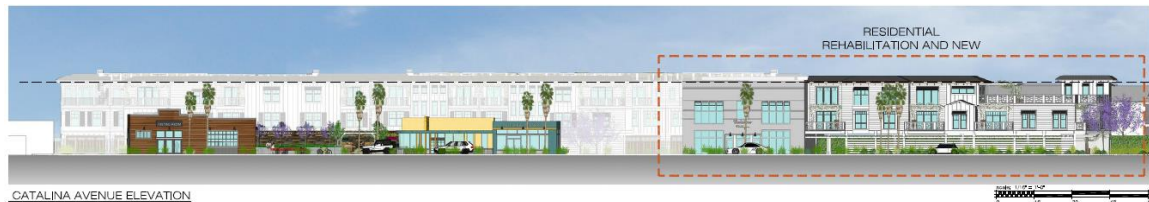
Overall street front view along N. Catalina Avenue of adaptively reused and rehabilitated contributors to the historic district with new housing as backdrop and at south corner.

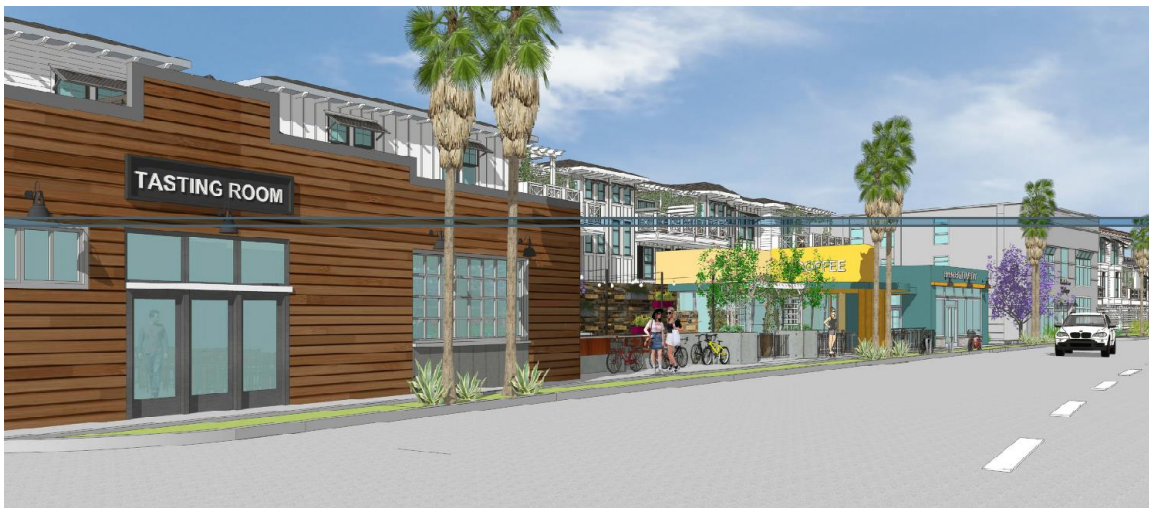
View looking south along North Catalina shows how the historic buildings are featured along the street front, framed and highlighted by the new housing development

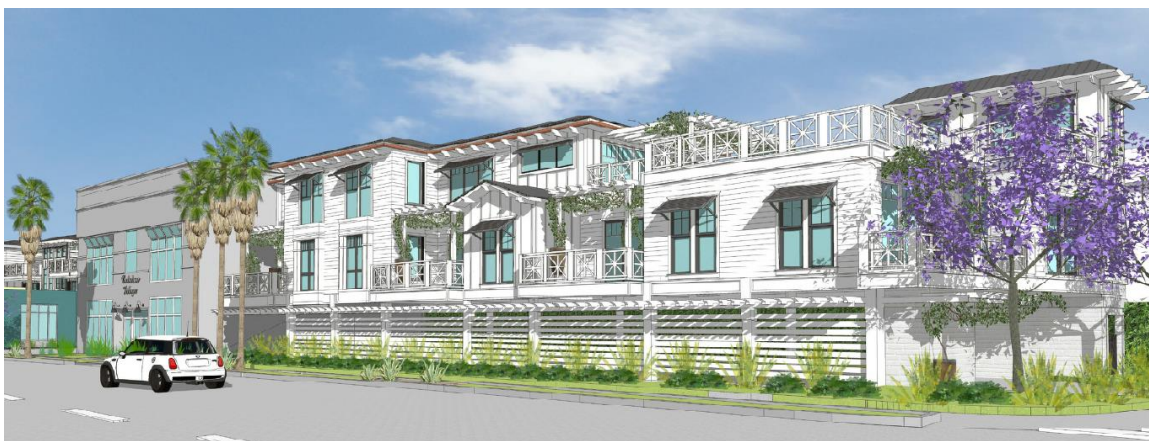
View looking north with new housing at the vacant corner lot adjacent to the existing two story building. The Housing helps to frame the historic district as well as to transition around the corner to adjacent historic multi-story housing.

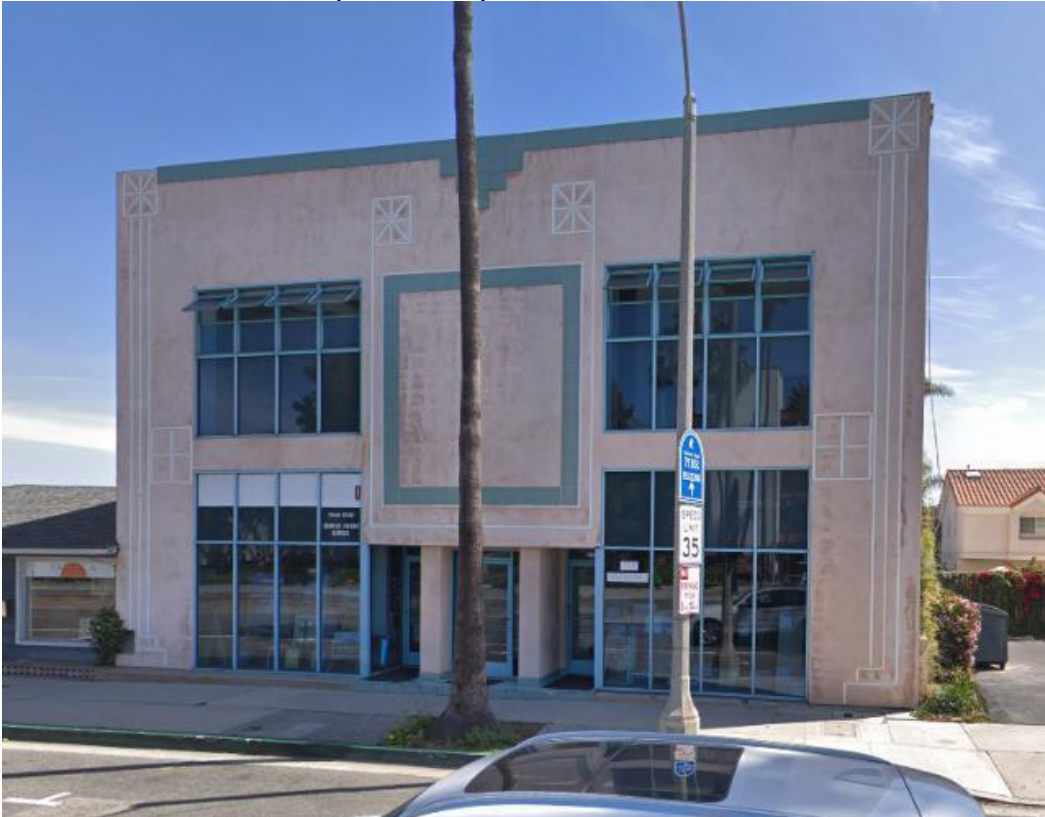
The building at 112 N. Catalina Avenue is a two story masonry structure with plaster façade. The current façade was installed in 1992 along with seismic upgrades. Seismic upgrade included new steel frames throughout the building including a frame behind the front façade. The front windows are aluminum storefront at both ground and upper level. There is operable upper sash on the second floor windows. The long side elevations are articulated by a series of vertical pilasters. The side walls are windowless except for one large and one small window with arched brick headers in the second bay from the front on both sides. The rear elevation has three arched openings on the upper floor and an exterior metal stair. The entire front façade appears to have been plastered over at one time.

The building exterior is in relatively good condition although the front façade is a dated design with minimal references to the original building design. Along with fading, the textured plaster has accumulated dirt creating an uneven appearance. Aluminum mullions for windows and doors have faded but otherwise the window

assemblies appear in satisfactory condition.

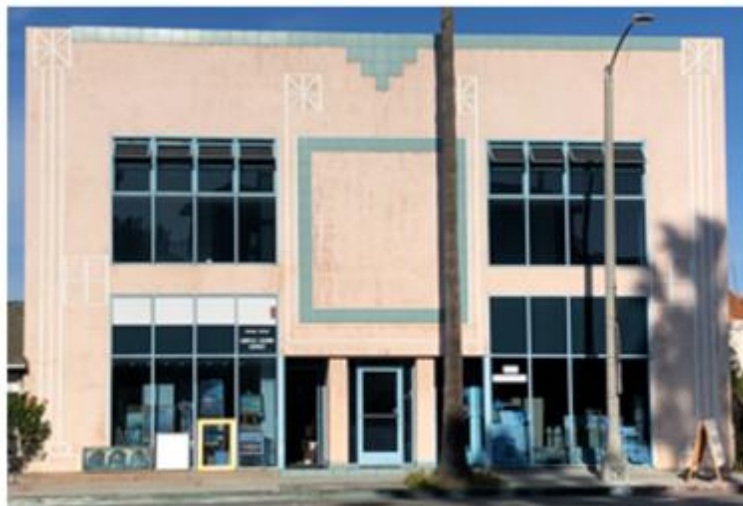
The 112 N. Catalina Avenue building retains its original volume and massing as well as the division of the front façade into three modules and symmetrical design. There are no architectural details on the sides of the building except for five pilasters. During a 1993 remodel original features were removed or covered. The proposed rehabilitation of the building includes restoring original elements based on photographic documentation of the building's pre-1993 front façade.

The original building design included a cornice which will be reconstructed. Also, horizontal banding at the upper level of windows will be reintroduced. The original upper middle window had been removed; that area will re-reconfigured with a centered window similar to the original design.

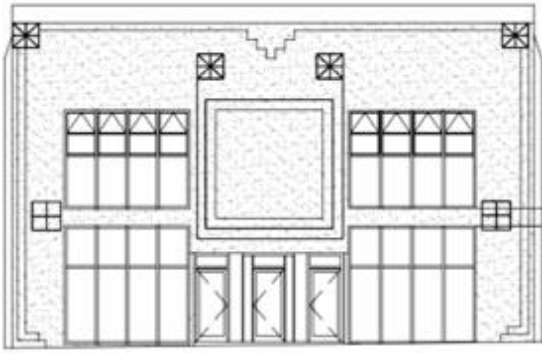
112 N. Catalina Ave., drawing of existing front elevation

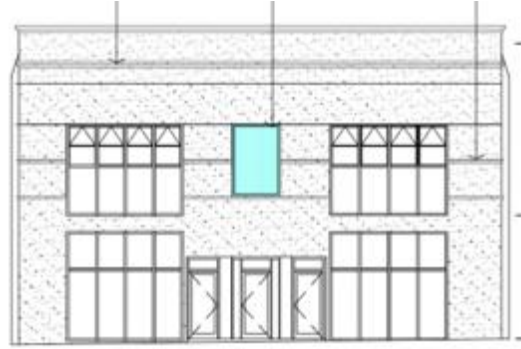
Drawing of proposed front elevation

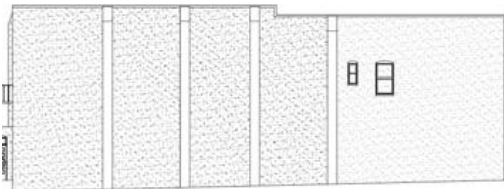
132 N. Catalina Avenue, drawing of existing side (north) elevation

The building at 112 N. Catalina Avenue will be adapted to provide housing units. The first floor level of the north side elevation has been obscured from view since construction of the adjacent building (116 N. Catalina Avenue) in 1921. The north elevation is a blank wall except for the five pilasters, a cornice and two windows. The north elevation will become fully visible with the demolition of the non-historic 116 N. Catalina Avenue building which will be replaced by a driveway that will provide access into the complex. About 20 percent of the building, at the rear, will be demolished; one pilaster, the farthest back, will be removed. On the second and third floors of the building, new double-hung windows will be inserted to support the new interior residential program. At the first floor level most of the building will have garage openings that will lead to parking spaces. The first level parking space closest to the front of the building will have a roll up garage door as this area of the building will be the most visible from the public right of way.

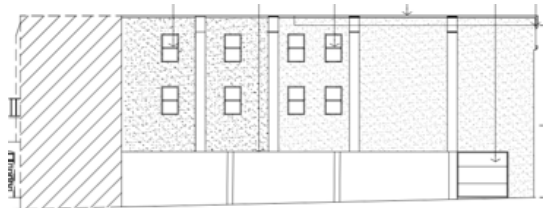
132 N. Catalina Avenue, drawing of proposed side (north) elevation

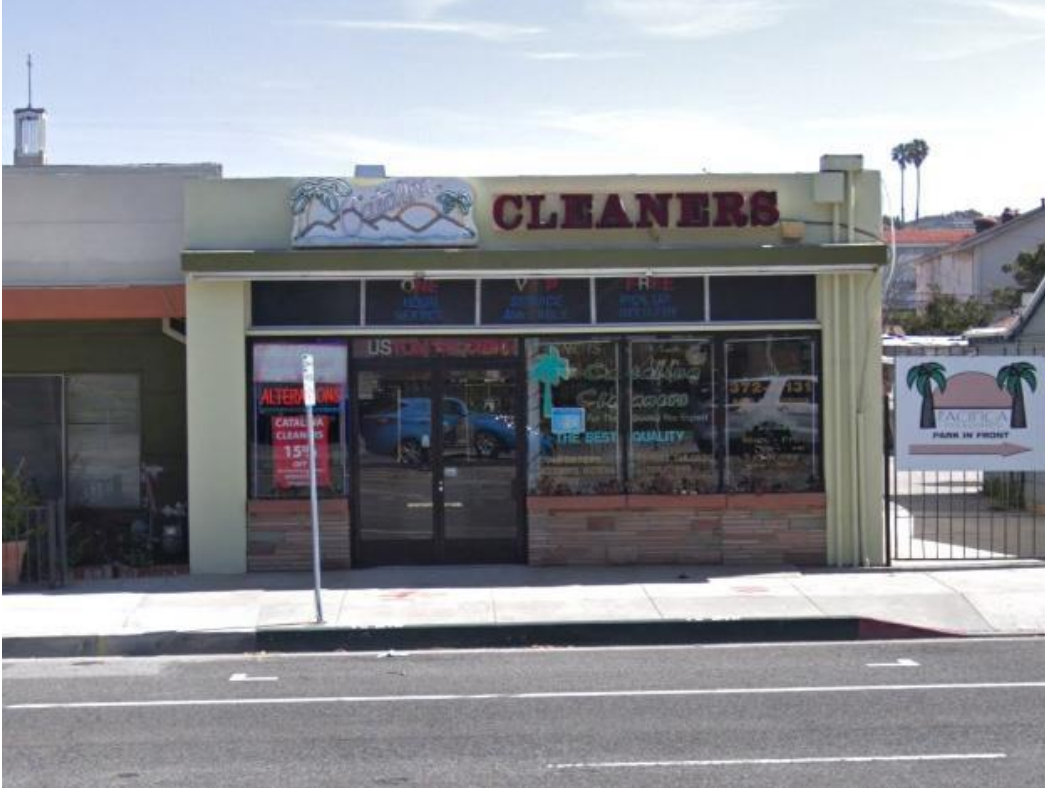
124 N. Catalina Avenue

The front façade retains the original configuration of the storefront opening including the horizontal mullion that separates the upper transom windows although the window sash and storefront has been changed to dark finished aluminum. There is a decorative pattern of masonry at the bulkhead that may be original. Existing signage is not original. The building extends back into the parcel with space for laundry equipment. That area is generally unadorned on the exterior and the massing offsets along the south elevation separating the significant front part of the building from the less meaningful rear structure.

The façade is generally in satisfactory condition. There have been unattractive modifications to the front façade mostly from exposed electrical service and outdoor lighting applied to the building that impacts the historic quality of the building. The horizontal wood mullion separating the transom windows should be refurbished.

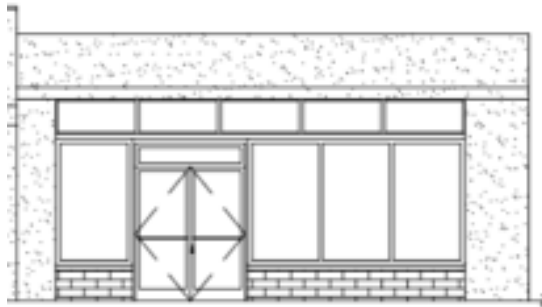
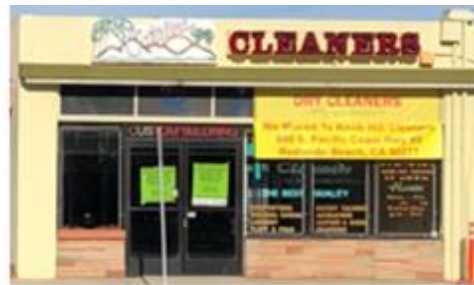
Drawing of 124 N. Catalina Ave., existing front elevation Photo of 124 N. Catalina Ave., front elevation.

The front elevation of 124 N. Catalina Avenue will remain the same. The original windows and doors remain as well as the original stacked stone bulkhead. A new sign will be placed at the upper level of the building – the traditional location on the building for signage.

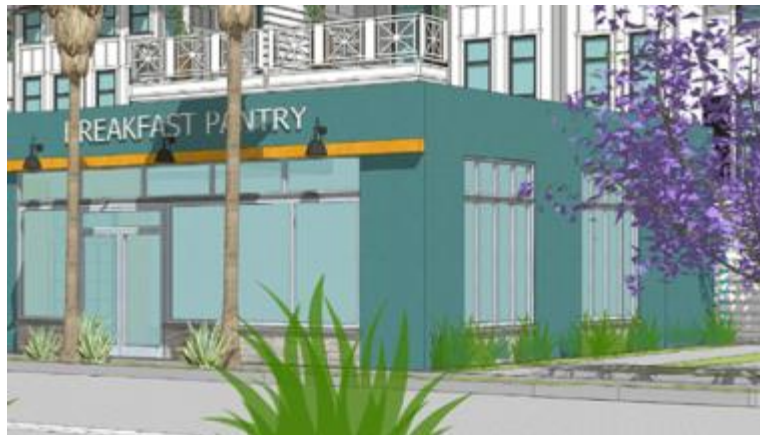
Sketch of 124 N. Catalina Ave., front (west) and proposed side (south) elevation

Two new windows will be inserted into the front portion, the original retail section, of the 124 N. Catalina Avenue building. They will be the same height as the front storefront windows but will be differentiated with more mullions. There will be a stacked stone bulkhead under each of the windows. The stacked stone will be discontinuous along this elevation to differentiate it from the original continuous stacked stone bulkhead of the front façade. The addition of similarly sized windows and the treatment of the glazing and stacked stone bring design elements of the front façade to this visible side of the building, but their design is sufficiently differentiated.

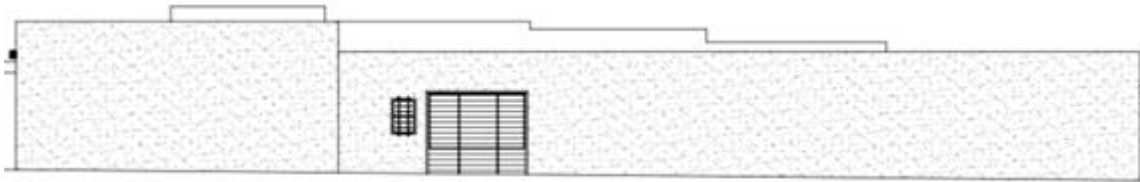
124 N. Catalina Ave., Drawing of existing side (south) elevation

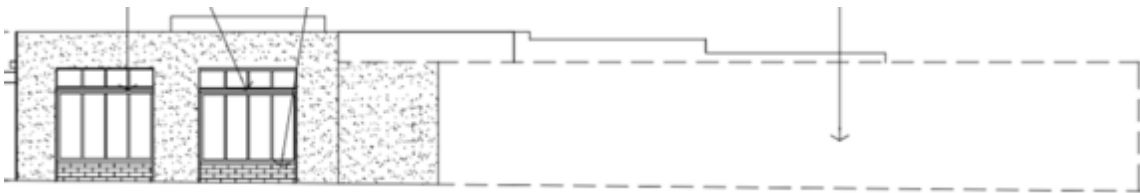
124 N. Catalina Ave., Drawing of proposed side (south) elevation

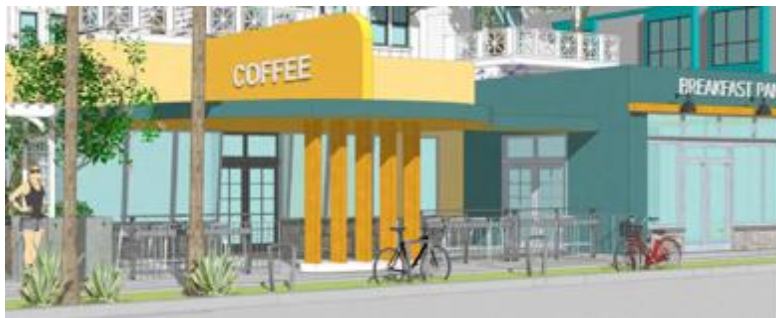
126 N. Catalina Ave., and 124 N. Catalina Ave. showing proposed north side elevation of 124 N. Catalina Ave.

A new door will be added to the north elevation of the 124 N. Catalina Avenue building. As the 126 N. Catalina Avenue building is set-back from the sidewalk (with the canopy over the setback area) a portion of the north elevations of 124 N. Catalina Avenue is currently visible. More of that elevation was visible before the projecting office wing of 126 N. Catalina Avenue was constructed. That office wing (painted green) will be demolished, exposing more of the north elevation of 124 N. Catalina Avenue. To support the adaptive reuse of the two buildings, a set of glazed double doors will be inserted into that elevation. The wall is blank so there are no architectural details that would be impacted with the addition of the door.

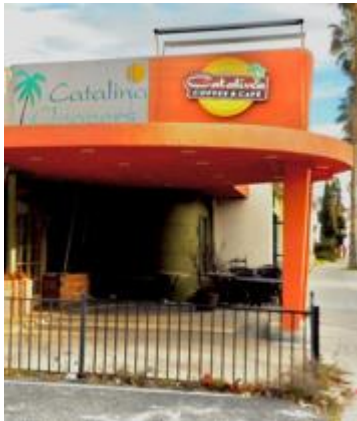
Beige wall is north elevation of 124 N. Catalina Ave. and green is projecting addition of 126 N. Catalina Ave.

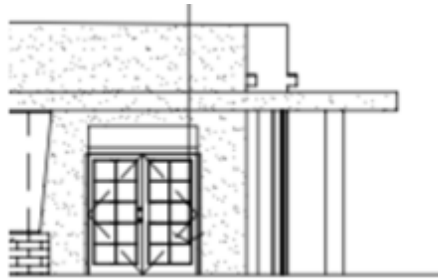
When green projecting wing of 126 N. Catalina Ave. is demolished, more of the north elevation of 124 N. Catalina Ave. will be revealed. A set of double doors will be added to that elevation

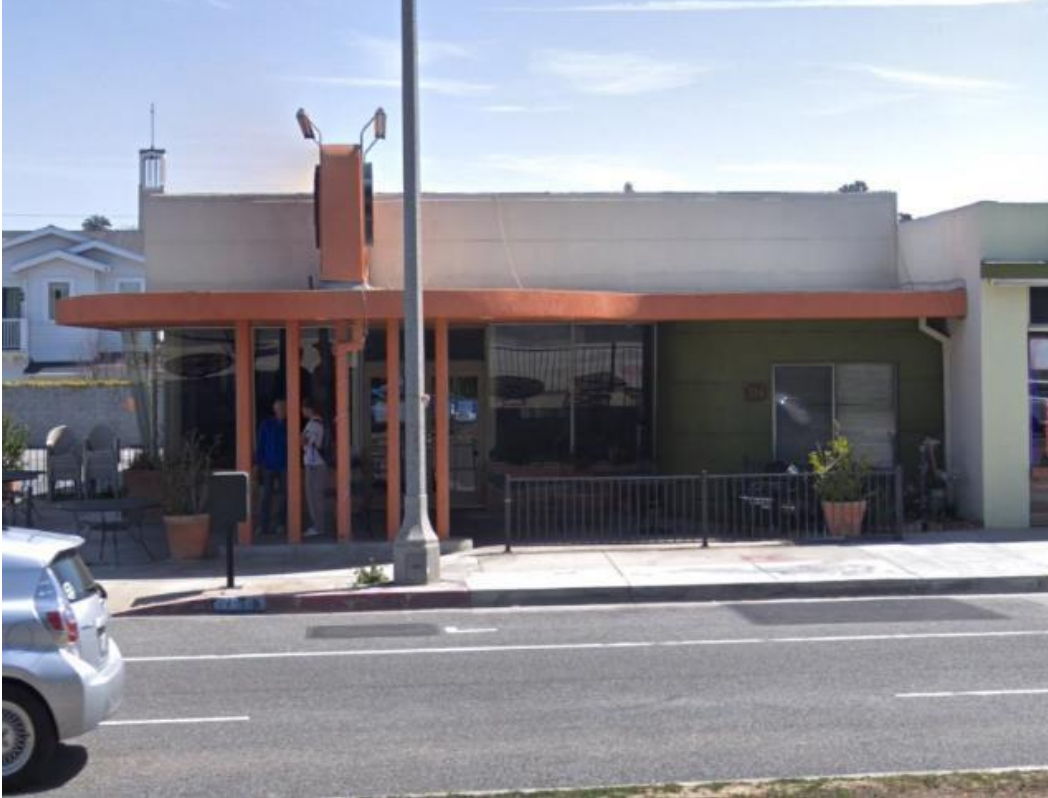
126 N. Catalina Avenue

The one-story building is designed with a modernist flair with expressive front entry covering and angled supports. The storefront setback within the space is continuous glazing with corner butt-joint glass. A large aluminum sliding window at the south end does not appear original. The exterior surface of the front portion of the building is a heavily textured plaster. The base of the storefront has a bulkhead with a decorative masonry pattern very similar to the adjacent building. An odd downspout has been strapped to a front column. Electrical conduits are visible by the upper signage. The south side abuts the neighboring building while the north side is visible facing open space. The front portion of the building is distinguished from the rear portions that have a dropped parapet and appear as an appendage to the front structure with a different finished surface.

The coffee shop front façade is generally in good condition with stylistic architectural elements intact. The glazed storefront including the corner without mullions will need further assessment to ensure longevity. The pair of front entry

doors may not be original but are in satisfactory condition. The curved and rough plastered extension at the south end with large sliding window do not appear original but both appears in satisfactory condition.

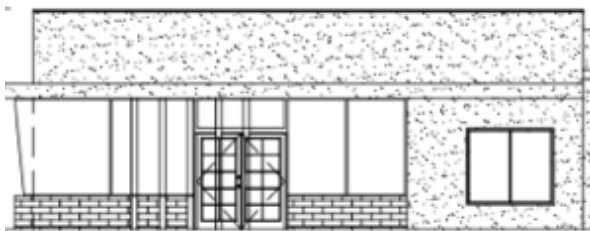
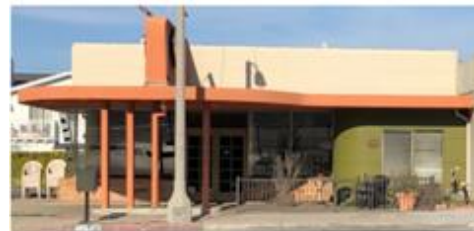
126 N. Catalina Ave., drawing of front elevation

126 N. Catalina Ave., photo of front elevation

Rehabilitation of the Mid-Century Modern building at 126 N. Catalina Avenue includes retention of all original features on the historic street-facing storefront elevation – windows, doors, and canopy with its integral blade sign and pillars. The rehabilitation proposal for the front elevation of 126 N. Catalina Avenue also proposes demolition of the projecting office wing (painted green) on its south end. This wing was added at a later point in time. Although there are no building permit records, physical evidence shows that this is not original: the position and type of windows located on this projecting office wing are dissimilar to the other windows on the front elevation and are not

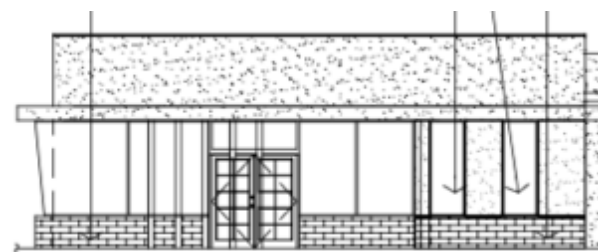
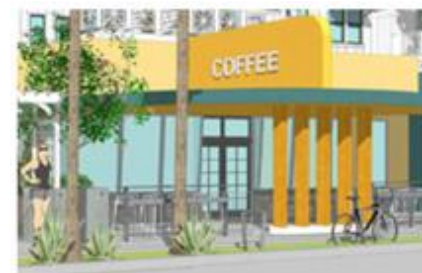
126 N. Catalina Ave., drawing of proposed front elevation

Sketch of front elevation

representative of window types employed on the front elevation. Also, the stacked stone bulkhead which is a feature of the main portion of the front elevation is missing from the projecting office wing. Removal of this wing will not result in an adverse impact to any historic features.

With the removal of this added wing, the front elevation will be a single plane. The new wall section will be consisting of four windows of the same height as the original windows of the storefront façade. The new windows will differ from the original windows in that they will be narrower. A stacked stone bulkhead, similar to the original, will be constructed; the stacked stone bulkhead is an existing feature on both buildings and filling in the “gap” provides continuity of design along this elevation. The Modernistic curved canopy with its projecting blade sign and pillars will be retained.

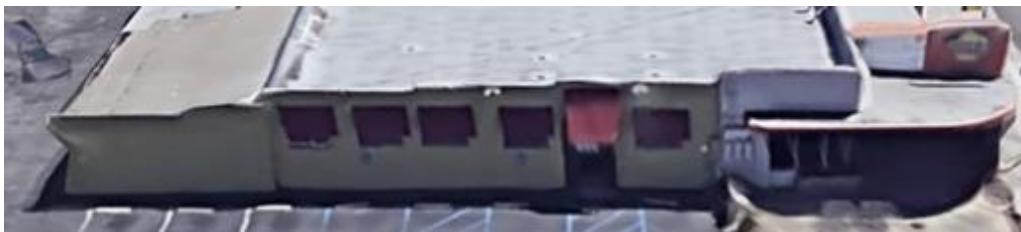
Photo of side (north) elevation of 126 N. Catalina Ave.

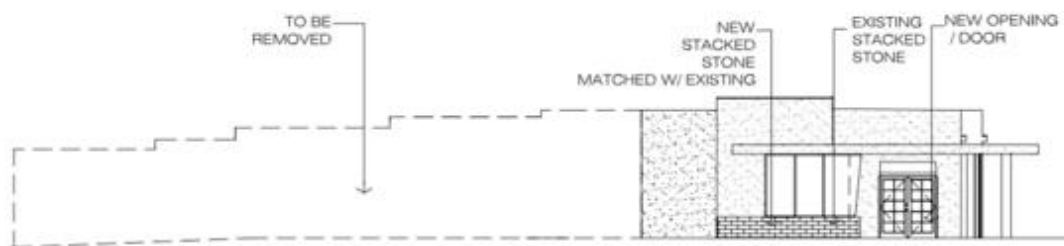
Proposed side (north) elevation of 126 N. Catalina Avenue

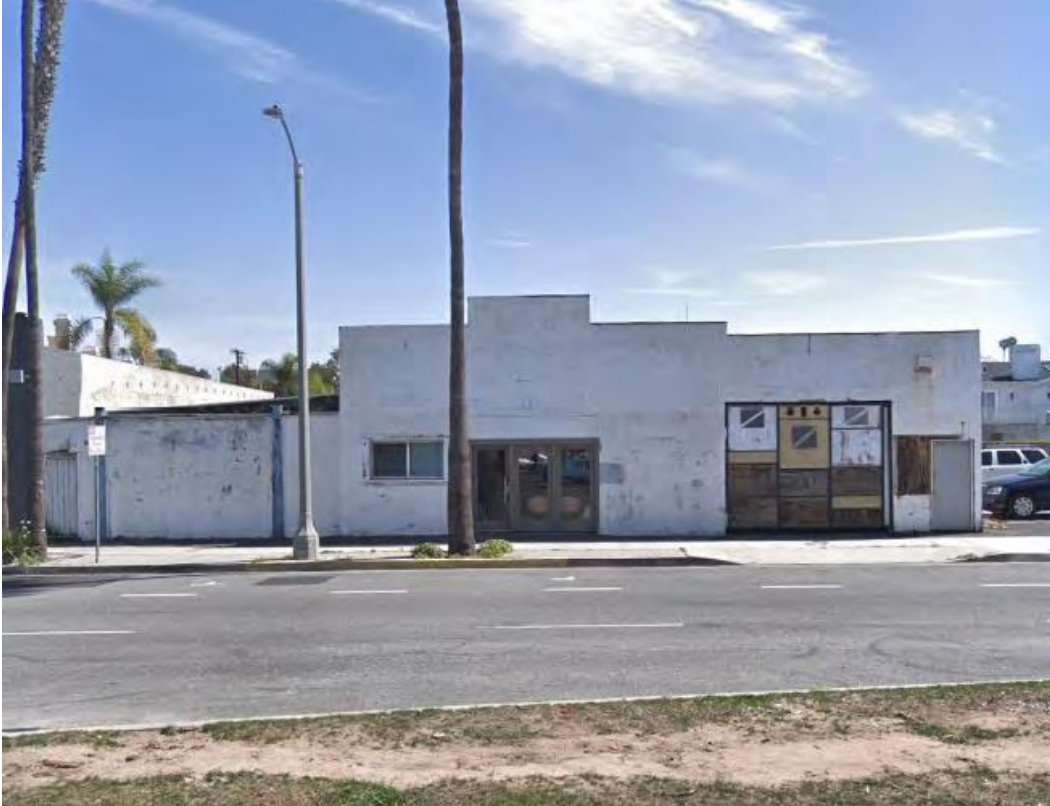
132 N. Catalina Avenue

The current structure retains the location and massing of the original building along with previous side additions on north and south. Little of the original structure remains while interior elements that relate to the buildings original use as a blacksmith and then later a metalwork shop are intact. The roof appears to be of more recent construction.

On the north is a covered area that has two column/pilaster elements with a wall constructed of wood and flat metal panels at the frontage that may have been originally a portal into the space that has since been infilled. According to the City of Redondo Beach Sanborn Insurance Map, a small building on site may have been moved into this location.

The front façade extending across the central portion with stepped parapet and south addition is vertical wood planks covered over with large metal panels stamped with a brick-like pattern. The metal panels are nailed and screwed onto the façade and also wrap the southwest corner and continue for approximately 10 feet along the south side of the building. Metal panels would have been installed after the construction of the south addition. There is a large central opening and a horizontal window opening to the north of the entry way. A large gate to the south at the street frontage marks the end of the central portion of the

Initial investigation found unfinished vertical wood siding that is in poor condition behind the metal panels. The wood framing of the wall behind the woodwork appears to be of relatively recent construction. At the front façade of the north portion, the woodwork at the columns and wall is in extremely poor condition. The enclosed north area has a low sloping roof that spans across the space but leaves a gap along the side property line. This structure may require removal or re-construction.

Much of the roof structure from the interior appears updated with plywood sheathing although some lumber looks older with true dimensions and square corners. The current main façade appears to have been constructed around WWII. The assessor indicates changes in 1930 which may relate to the additions to the building. One possibility is that there may have been a masonry façade that collapsed in the Long Beach Earthquake. Alternatively, the building may have had a vertical wood façade that was eventually covered with the metal siding although it is unusual that a wood façade would be unfinished. The current condition is that the wood façade behind the metal panels appears heavily deteriorated. The metal panels have also been applied in a haphazard process with a mix of nails and screws and metal panels were bent around the corner to extend along the south facade.

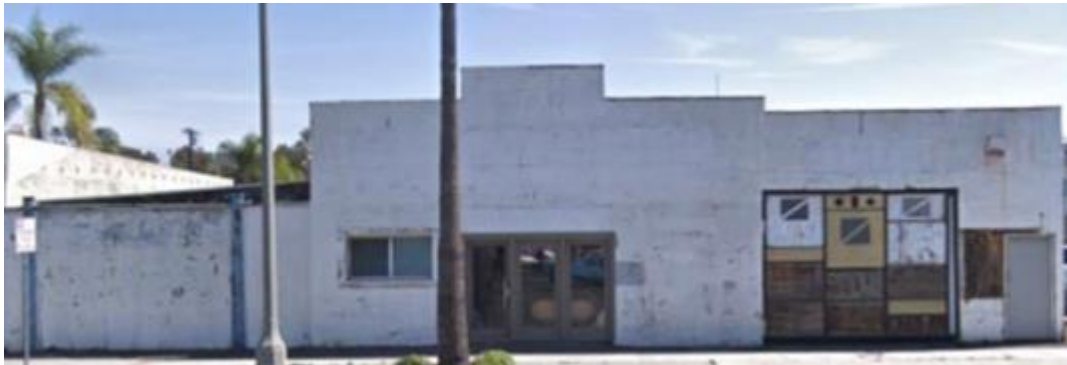
132 N. Catalina Avenue, photograph of front elevation

The 132 N. Catalina Avenue building retains the original form of its stepped front parapet that hides the gabled roof building. A portion of the rear of the building will be demolished but the gable roof form will remain and will be visible looking at the rear of the building.

The building will be adapted from industrial uses/office to a tasting room. The lean-to shed on the north side of the building will be demolished to make way for a driveway into the complex. This shed lean-to is of unknown provenance and not a substantive element of the building. While the windows and doors are not original their location and size appear to have been in place for decades. The pattern and size will be retained; a set of transom windows will be added above the entry doors. The thin metal siding is not original; it will be replaced by horizontal wood siding.

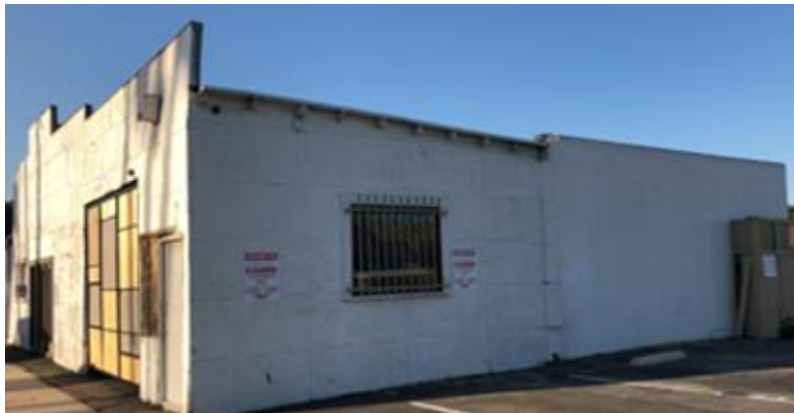
132 N. Catalina Avenue, front and side (south) elevations

The sides of 132 N. Catalina Avenue are devoid of any architectural style or detailing. To adapt the building into a tasting room two new windows will be inserted into the south side elevation. The north side elevation which will be facing the driveway will have a panel with a painted mural attached to the side of the building.

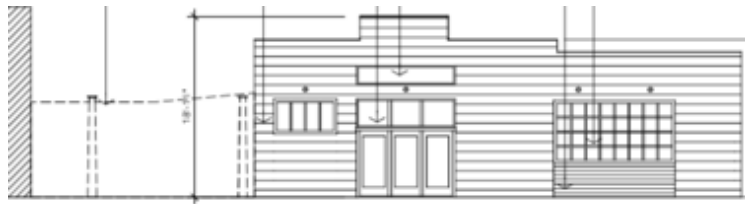
126 N. Catalina Avenue, drawing of proposed front elevation

The original exterior cladding of the building is unknown. Horizontal wood siding will be applied to the building and it will conform to the stepped front profile of the building. A unique feature of the building is period machinery in the building which will be retained.

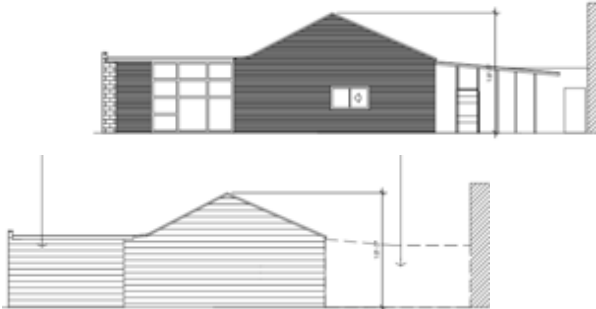
132 N. Catalina Ave., drawing of existing rear elevation

Drawing of proposed rear elevation

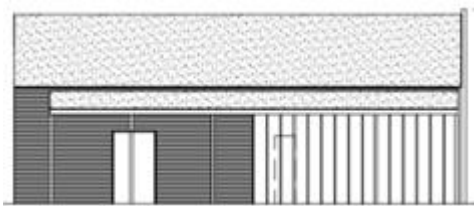
132 N. Catalina Ave., drawing of existing north elevation

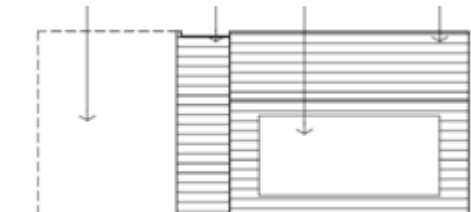
Drawing of proposed north elevation

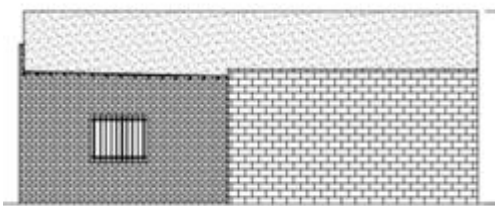
132 N. Catalina Ave., drawing of existing south elevation

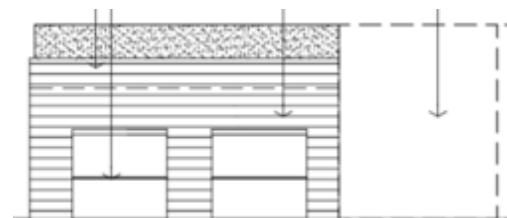
Drawing of proposed south elevation
