**CITY OF REDONDO BEACH
HARBOR COMMISSION AGENDA
Tuesday, October 27, 2020**

Final Sampling and Analysis Plan Report Sediment Characterization Study by Wood Environment & Infrastructure Solutions, Inc.

FINAL
Sampling and Analysis Plan Report
Sediment Characterization Study
In Support of Maintenance Dredging in
King Harbor with Potential Outer or
In-harbor Placement
City of Redondo Beach
Wood Project No. IR18166910
May 2020

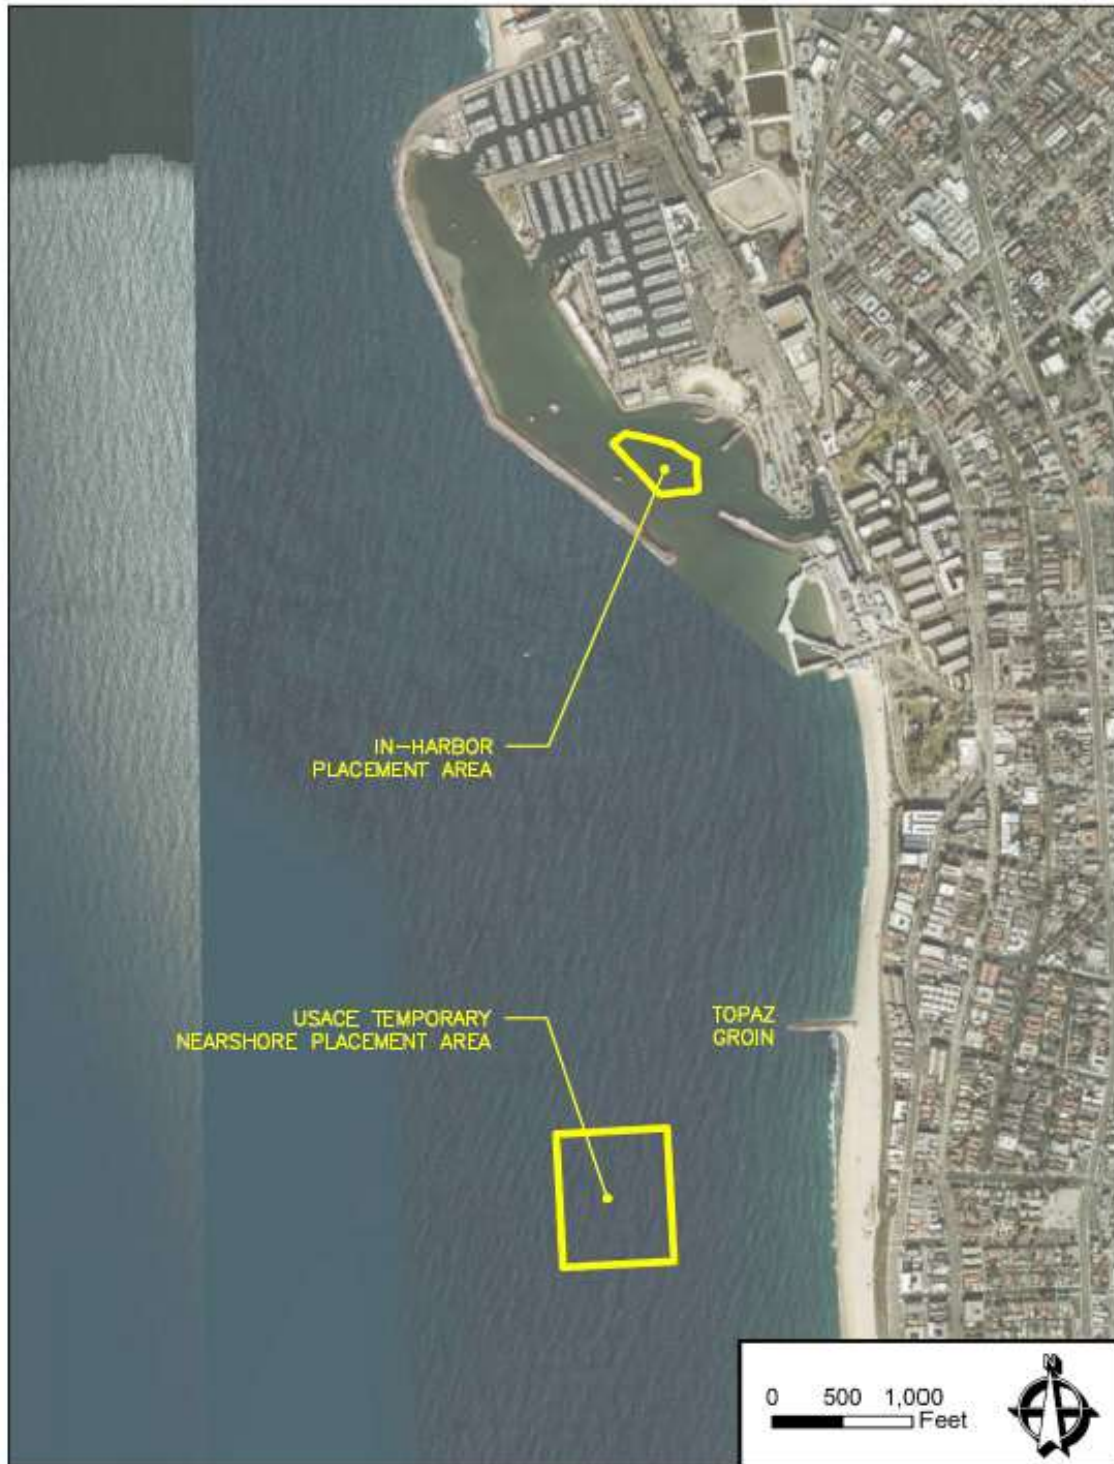
Figure 4. Plan View of Dredged Material Placement Areas

The In-harbor placement site will act as a sediment sink in which the dredged material will fill in a depressed harbor entrance bottom area that currently has a deeper water depth. While the surficial samples collected in the In-harbor placement area are finer than the samples collected in the dredging areas, deeper sediments at this location are expected to be coarser and more like those collected within the dredged area. Although the dredged material may not physically be compatible with the surface sediments at the in-harbor placement site, the placement of the dredged material will prevent further scour and help maintain a more even depth in this area. In addition, sediment chemistry for the In-harbor placement site does contain elevated levels of DDT’s and PCB congeners, which is similar to the dredged materials from the south portion of Dredging Area I. This indicates that the dredged materials at the south portion of Dredging Area I are more suitable for the In-harbor placement site. The location of this placement area is shown in Figure 4.
