CITY COUNCIL MEETING June 14, 2022

CONTINUED PUBLIC HEARING TO CONSIDER THE FISCAL YEAR 2022-23 PROPOSED BUDGET, FIVE-YEAR CAPITAL IMPROVEMENT PROGRAM, AND ASSOCIATED BUDGET RESPONSE REPORTS

Re: 2021/22 Pier Parking Structures Condition Assessment

CITY OF REDONDO BEACH NORTH PIER PARKING STRUCTURE 2021-CONDITION ASSESSMENT

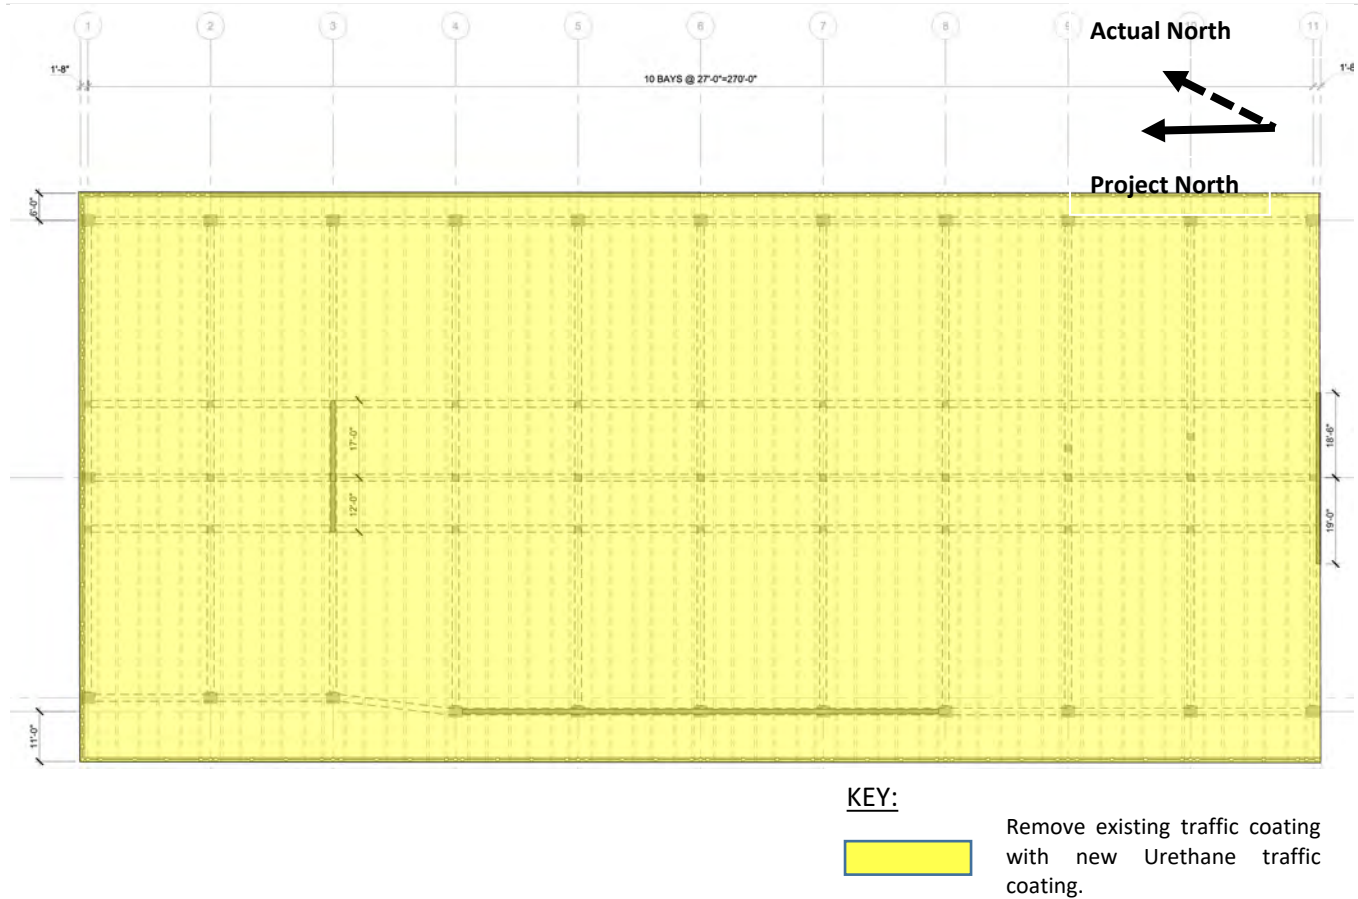
Figure 9– Proposed new traffic membrane, North Parking Pier Structure – Pier level

- Clean and paint misc. steel members.
- Repaint traffic markings.
- Paint slab soffit, walls, and columns

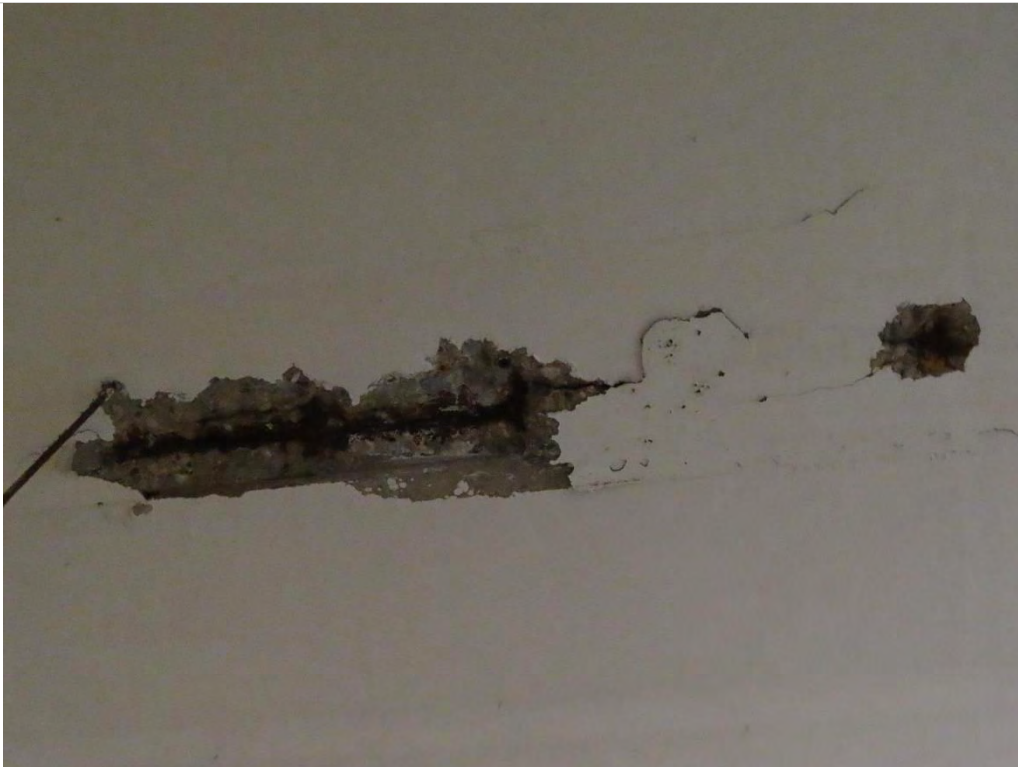
- Isolated concrete overlay deterioration with exposed reinforcement was observed on the Pier level (Photos 1.5 to 1.6).
- Typical Pier Level soffit slab deterioration and spalls with exposed and corroded reinforcement (Photos 1.7 and 1.8).

Photo 1.7- Soffit slab deterioration and spall with exposed reinforcement, Pier Level (SH3-312)

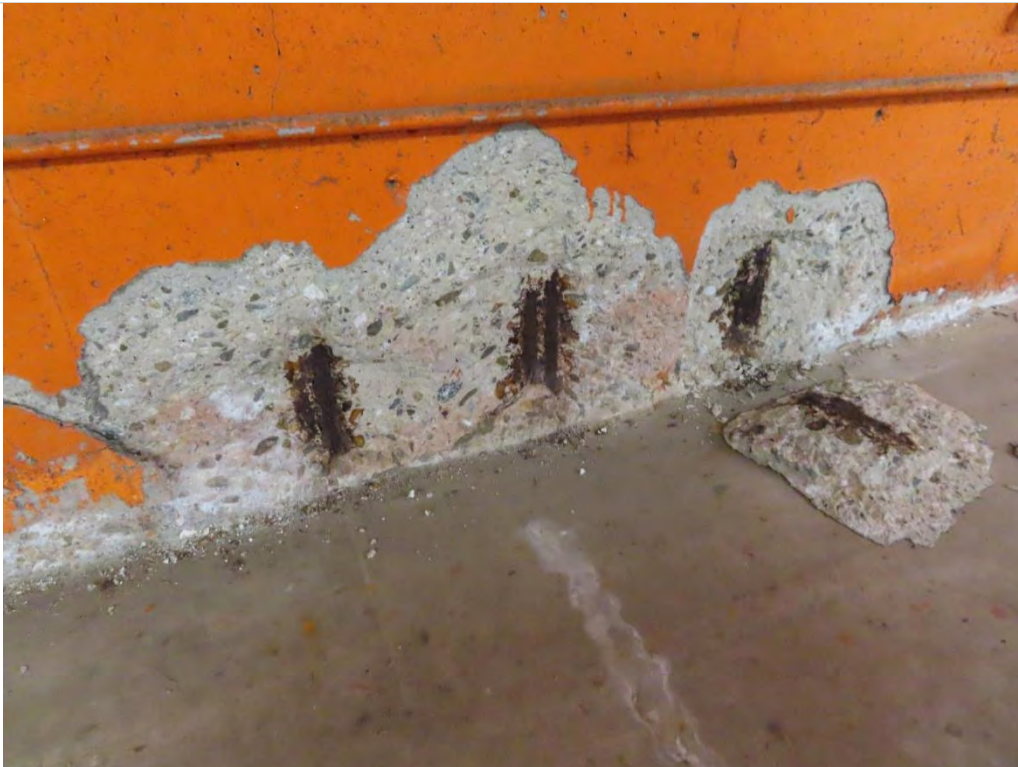
- Typical concrete wall delamination and spalling with exposed rebar on the Basement Level (Photos 1.17 and 1.18).
- Typical beam deterioration with exposed and corroded reinforcement was observed on the Basement Level (Photos 1.19 and 1.20).
- Typical wall cracks were also observed on the Basement Level (Photo 1.21).

Photo 1.17- Exposed rebar on wall, Basement Level (SH3-308)

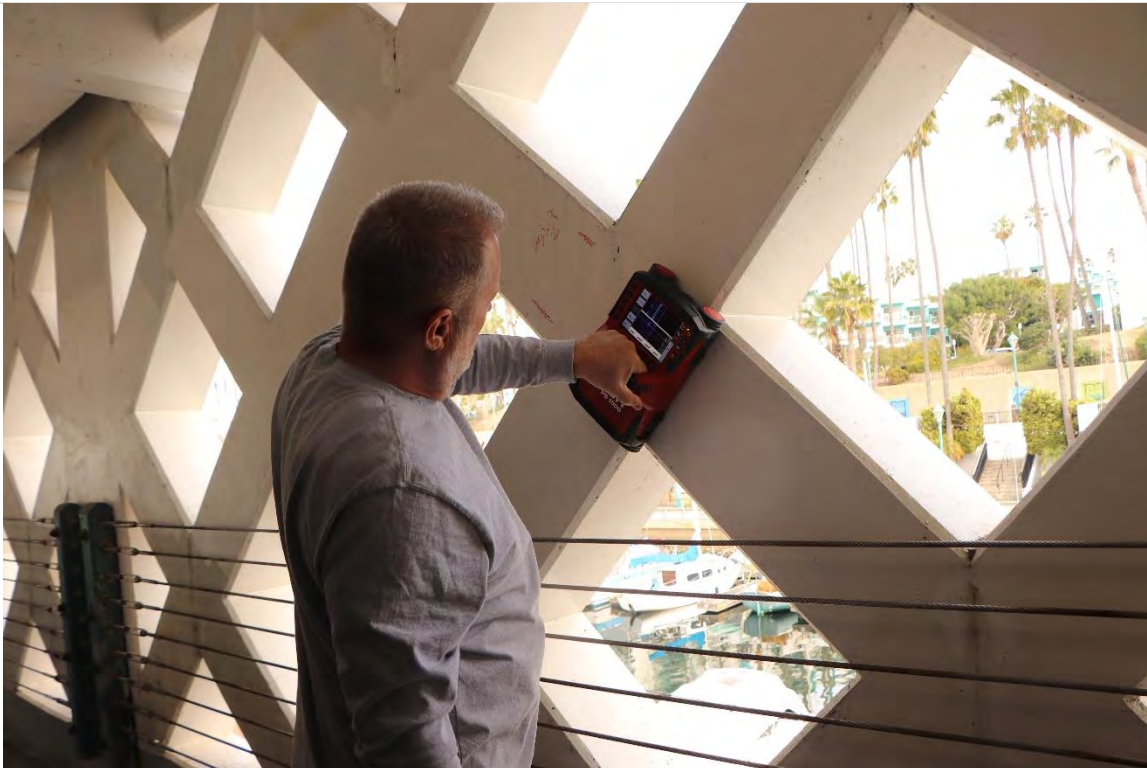
Photo 2.2- Detecting waffle wall steel reinforcement using GPR, East Wall, 1992 Retrofit – Pier Level (BA2-12)

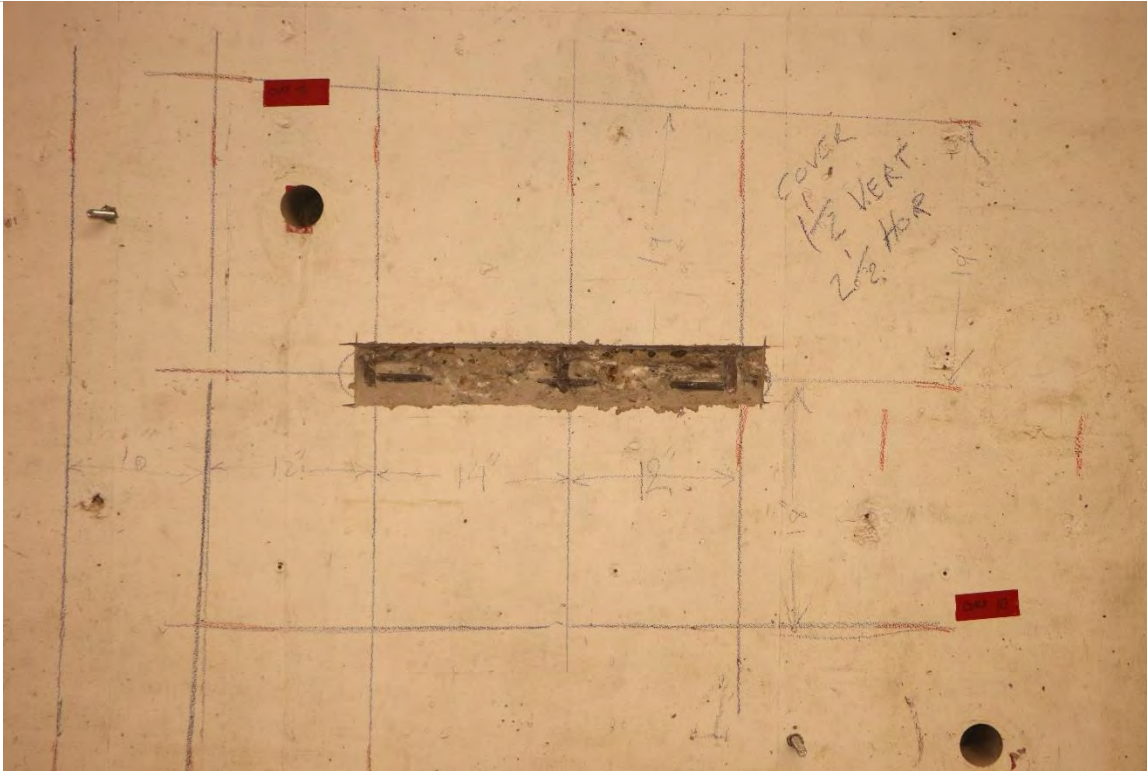
We also performed destructive testing to expose the steel reinforcement in the concrete walls for measuring bar sizes and spacings. Overall, we exposed steel reinforcement at 8 locations on the walls of which 5 were on the original concrete walls in the Basement. We also exposed 3 locations on the second floor retrofit waffle walls to check the presence of confinement steel in the wall diagonal members. Locations of destructive openings are shown in Figures 2.1 and 2.2. Steel reinforcement sizes and spacings measured during testing are shown in Table 2 and Figures 2.3 and 2.4. During our investigation of the wall opening, we did not observe any significant sign of rusting and deterioration on the exposed bars. Wall steel reinforcement were generally in good condition. We

Photo 2.10—Destructive wall location (DT3), South wall, 1962 Construction - Basement (BA2-404)

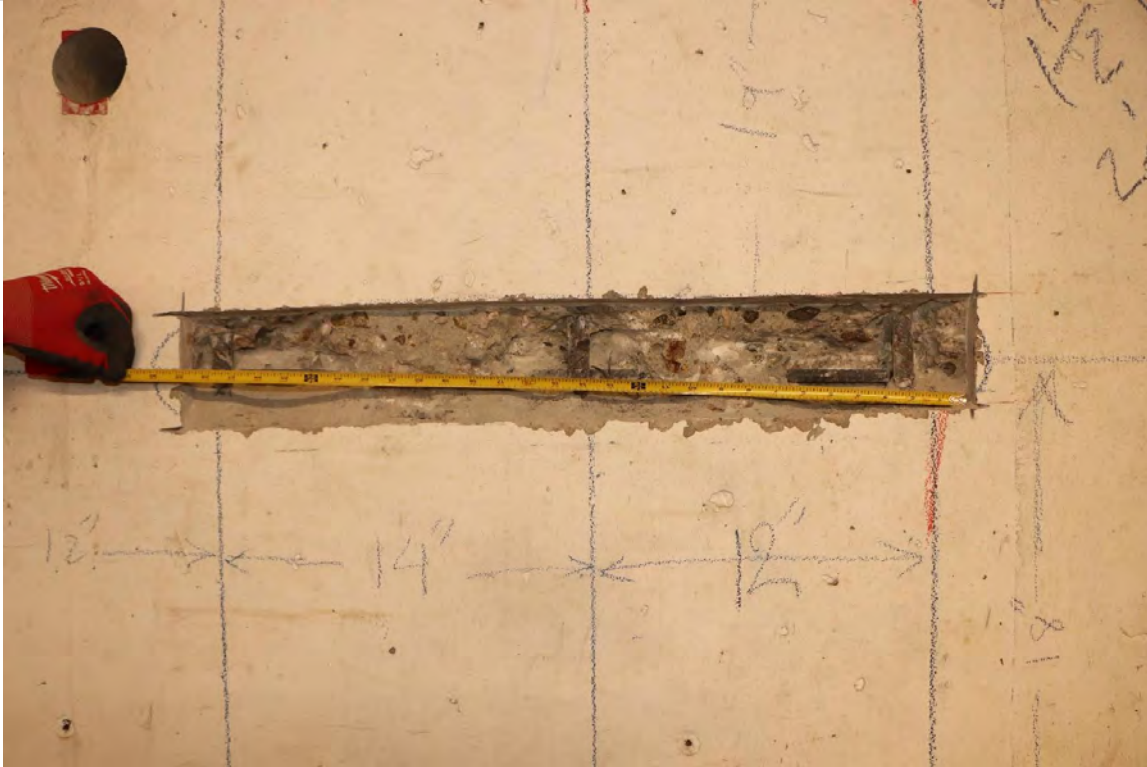
Photo 2.14— Vertical rebar placement at destructive location (DT3), South wall, 1962 Construction - Basement (BA2-409)

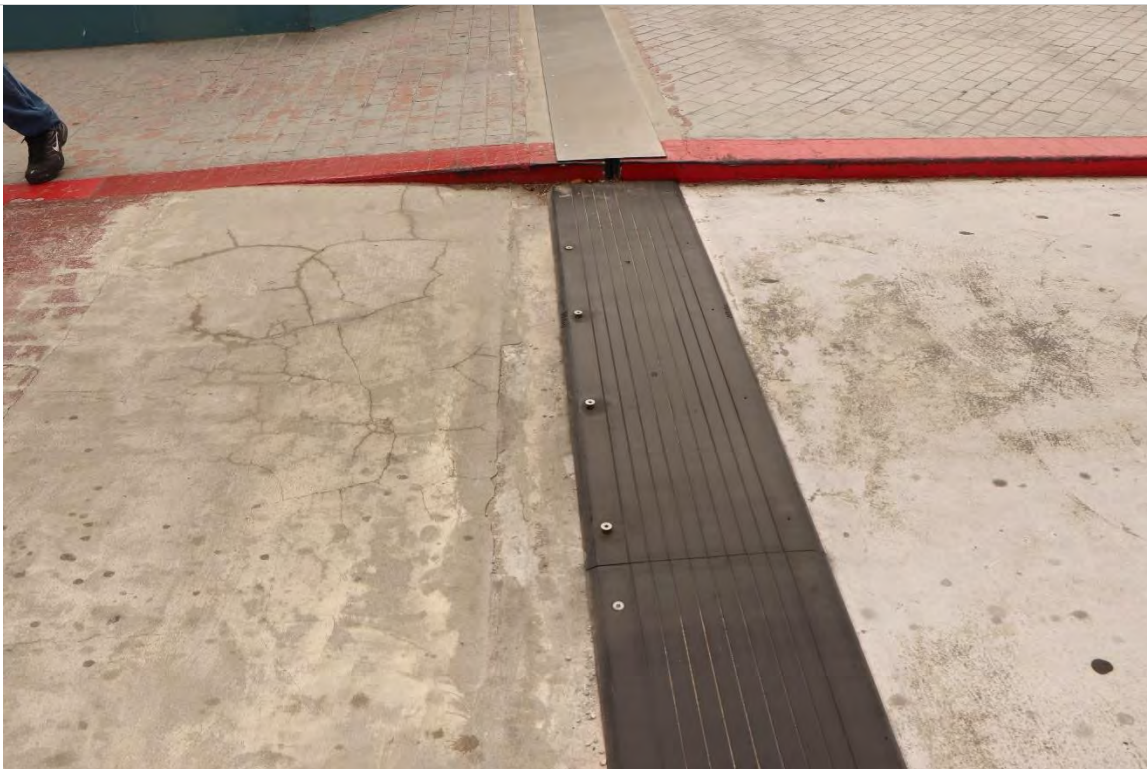
- Expansion joint cover plate bolts were seen projecting out, missing or loose (Photos 1.12 and 1.13).
- Typical deteriorated / spalled concrete planter walls (Photos 1.14).

Photo 1.12- Expansion joint cover plate bolts projecting out, Village level (BA1-139)

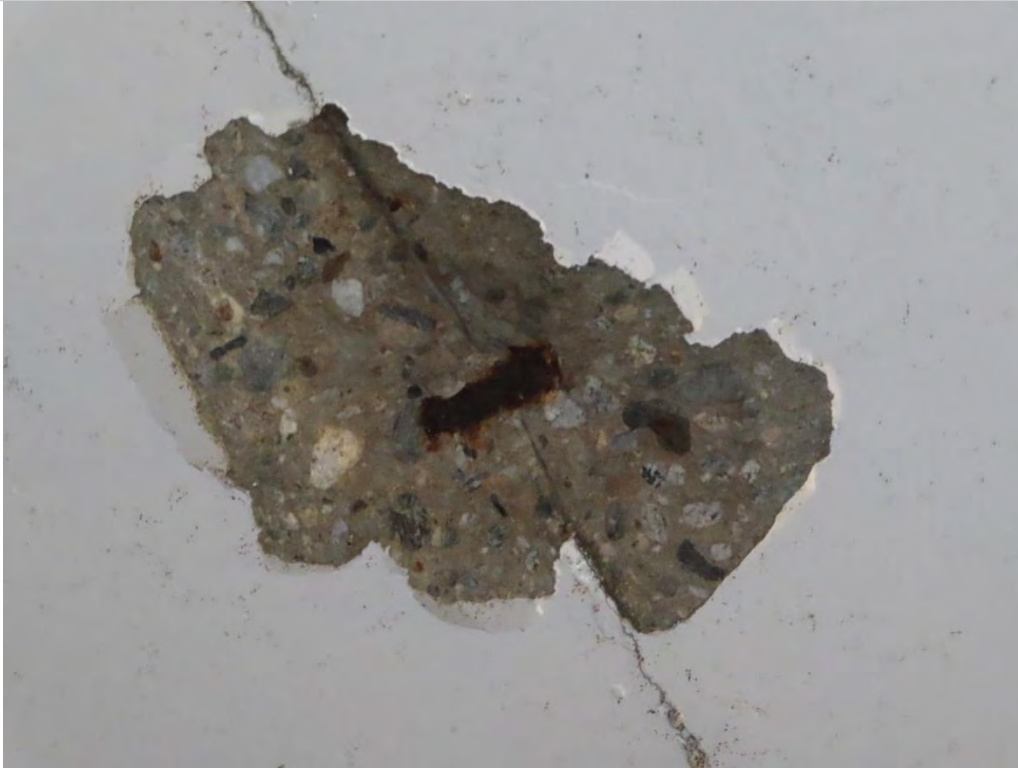
- Typical Pier level soffit slab deterioration and spalls with exposed and corroded reinforcement (Photos 1.26 to 1.28).
- Isolated beam deterioration with exposed and corroded reinforcement was observed primarily below the expansion joint (running north-south at south end of the garage) with other isolated locations (Photos 1.29 and 1.30).

Photo 1.27- Soffit slab deterioration and spalls with exposed reinforcement, Pier level (SH2-58)

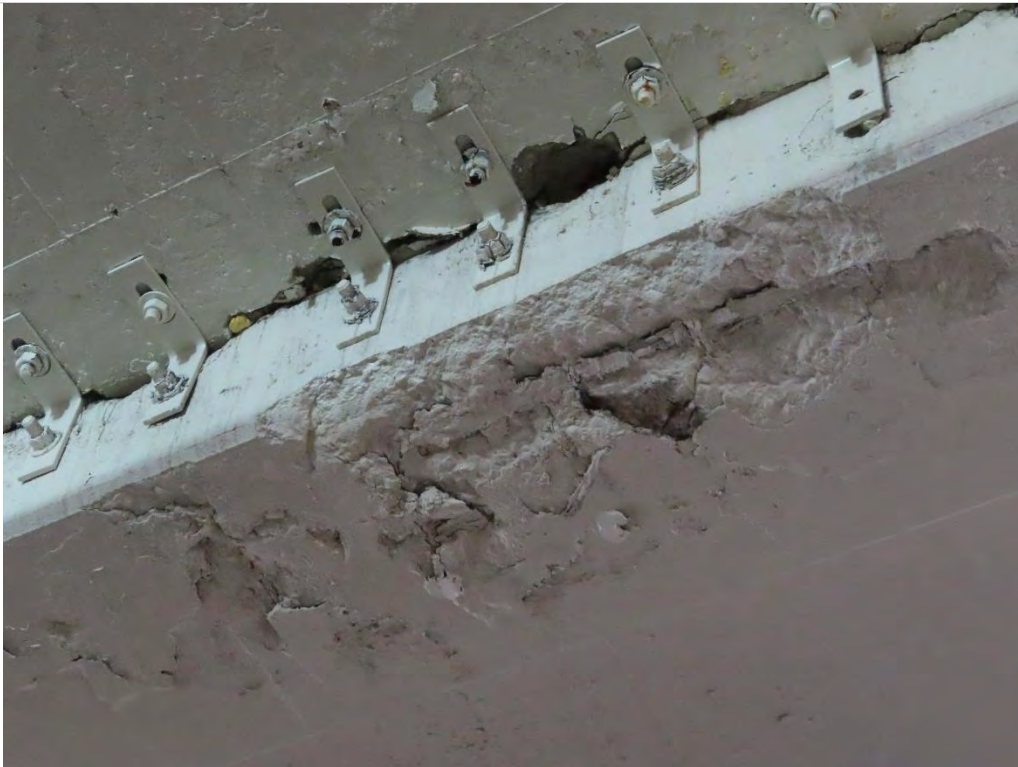
Photo 1.30- Concrete beam spalling below the expansion joint, Pier level (MM1-46)

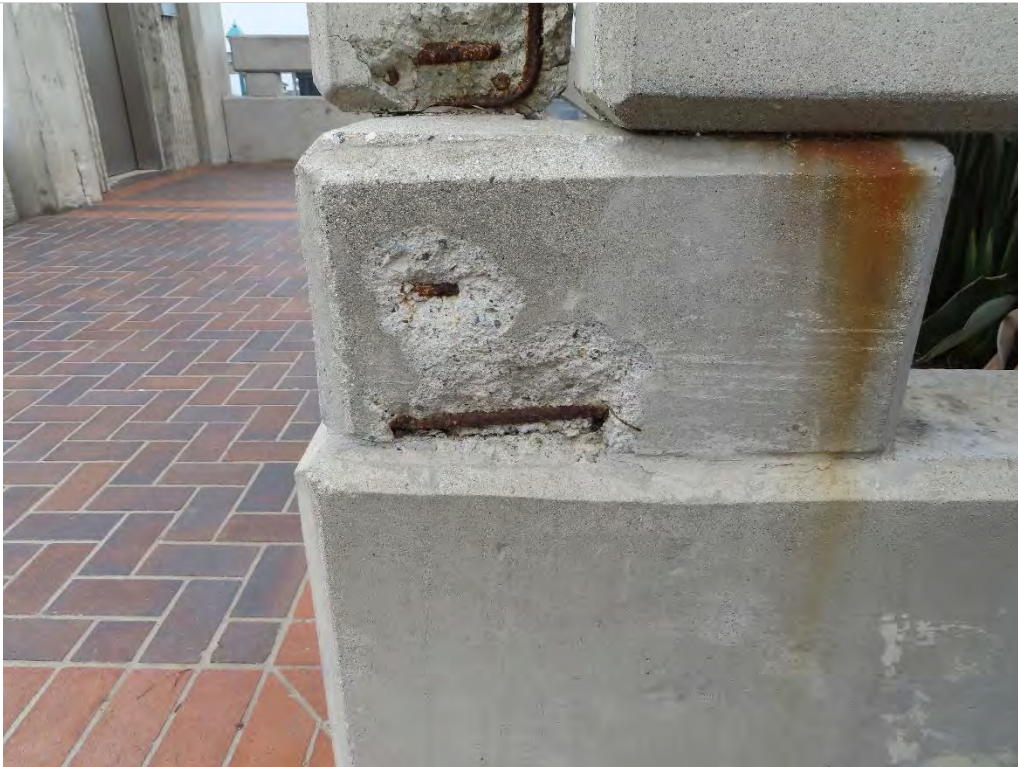
- Typical precast concrete spandrel deterioration with exposed and corroded reinforcement (Photo 2.1 and 2.2).
- Missing roof tiles above the stair tower were observed (Photo 2.3).
- Drains were plugged with leaves and minor amounts of trash (Photo 2.4).

Photo 2.2- Spalled precast concrete spandrel with exposed rebar, Plaza level (SH2-266)

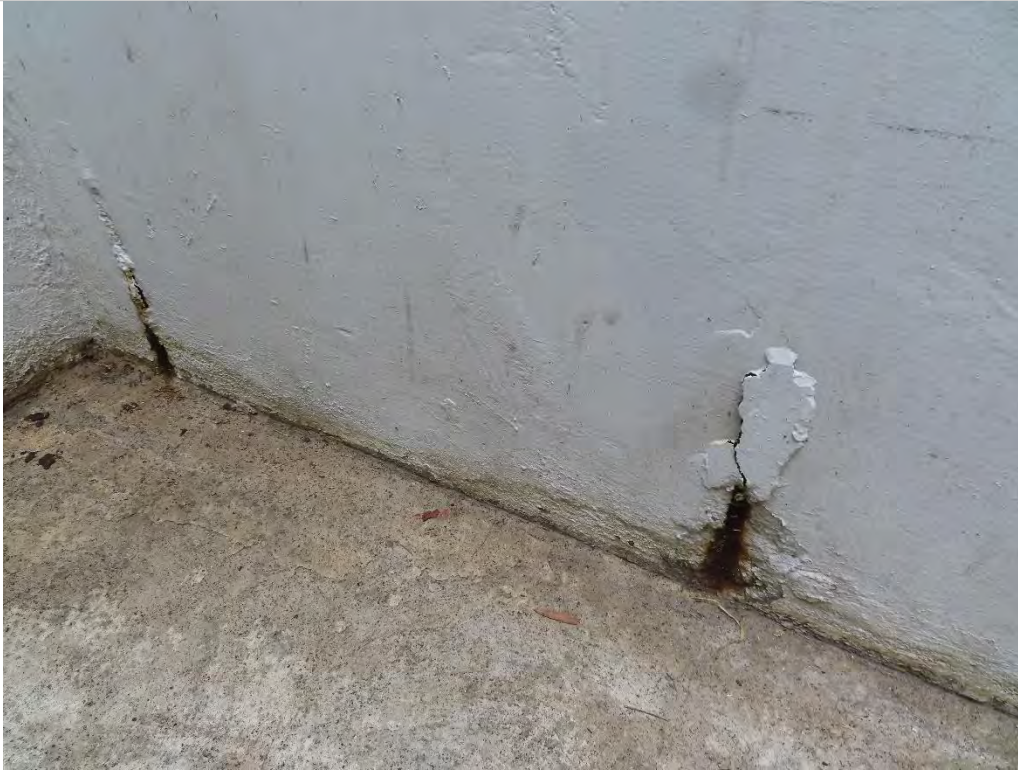
- Isolated delaminated concrete ceiling (Photo 2.10).
- Isolated delamination on the concrete walls exposing corroded reinforcement (Photo 2.11 and 2.12).
- Concrete stair deterioration was observed (Photo 2.13 and 2.14).
- Isolated damaged P/T rebar of a concrete beam (Photo 2.15).

Photo 2.11- Exposed rebar on wall, Basin level (SH2-166)

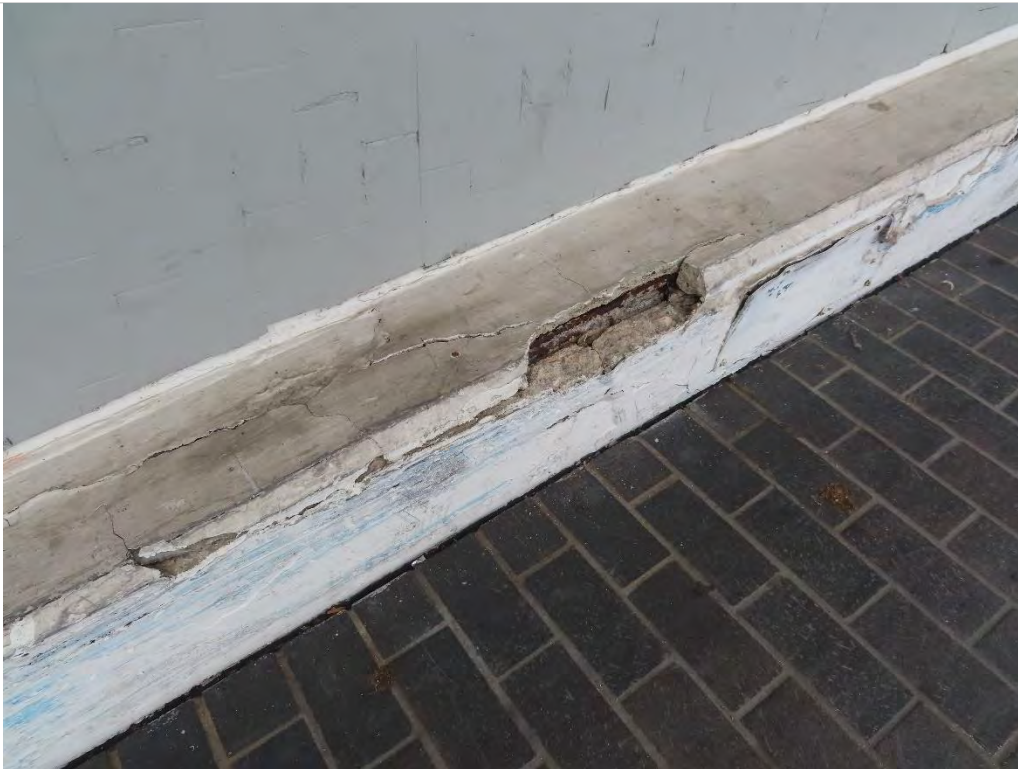
- Slab edge spalling and exposed rebar was observed mainly at the southwest end of South Pier parking garage. (Photo 3.1).
- Isolated concrete curb delamination was observed at the south end of South Pier parking garage (Photo 3.2).
- Isolated concrete wall delamination with exposed corroded rebar was observed on the south end of the South Pier parking garage (Photo 3.3).

Photo 3.2- Exposed and corroded rebar, Exterior - South elevation (SH2-257)
