Re: 2021/22 Pier Parking Structures Condition Assessment

CITY OF REDONDO BEACH NORTH PIER PARKING STRUCTURE 2021-CONDITION ASSESSMENT

CITY OF REDONDO BEACH
Redondo Beach, CA

WALKER
CONSULTANTS

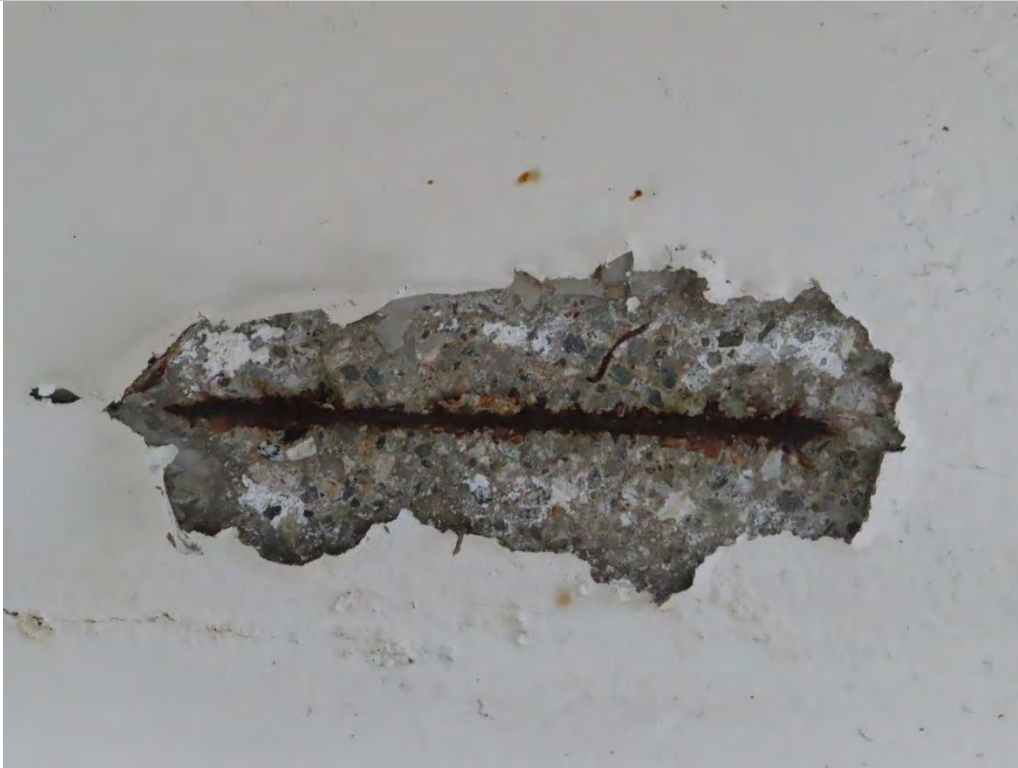
- Typical Village Level soffit slab deterioration and spalls with exposed and corroded reinforcement (Photos 1.1 and 1.4).

Photo 1.1- Soffit slab deterioration and spall with exposed reinforcement, Village Level (SH3-79)

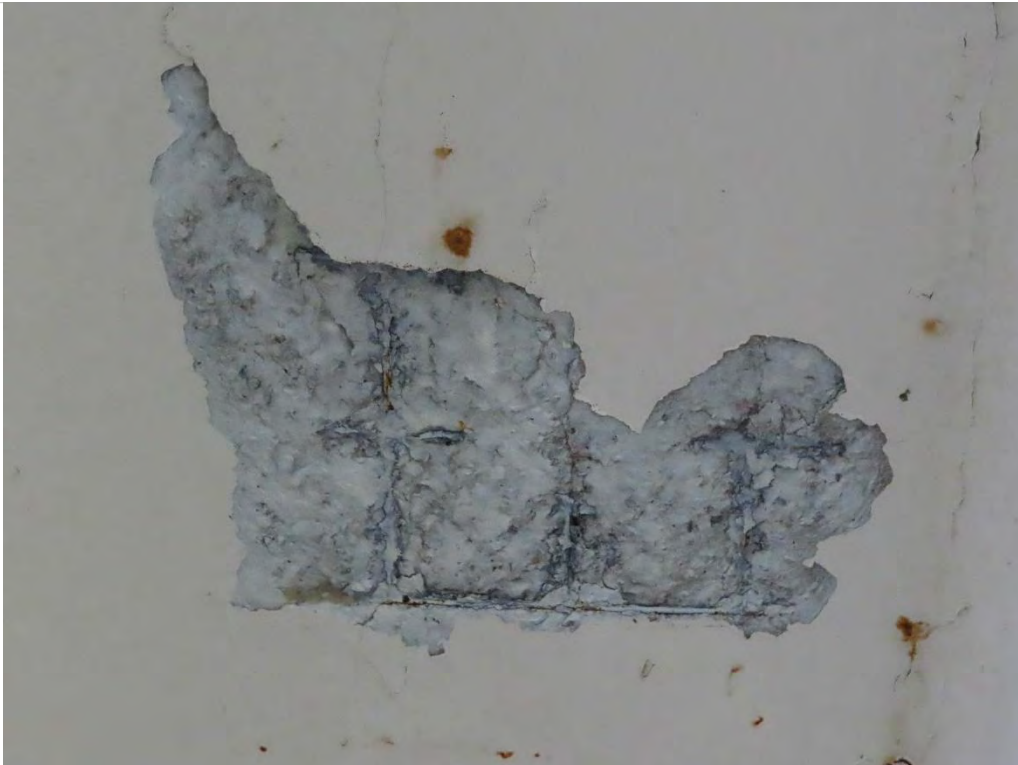
Photo 1.2- Soffit slab deterioration and spall with exposed reinforcement, Village Level (SH3-87)

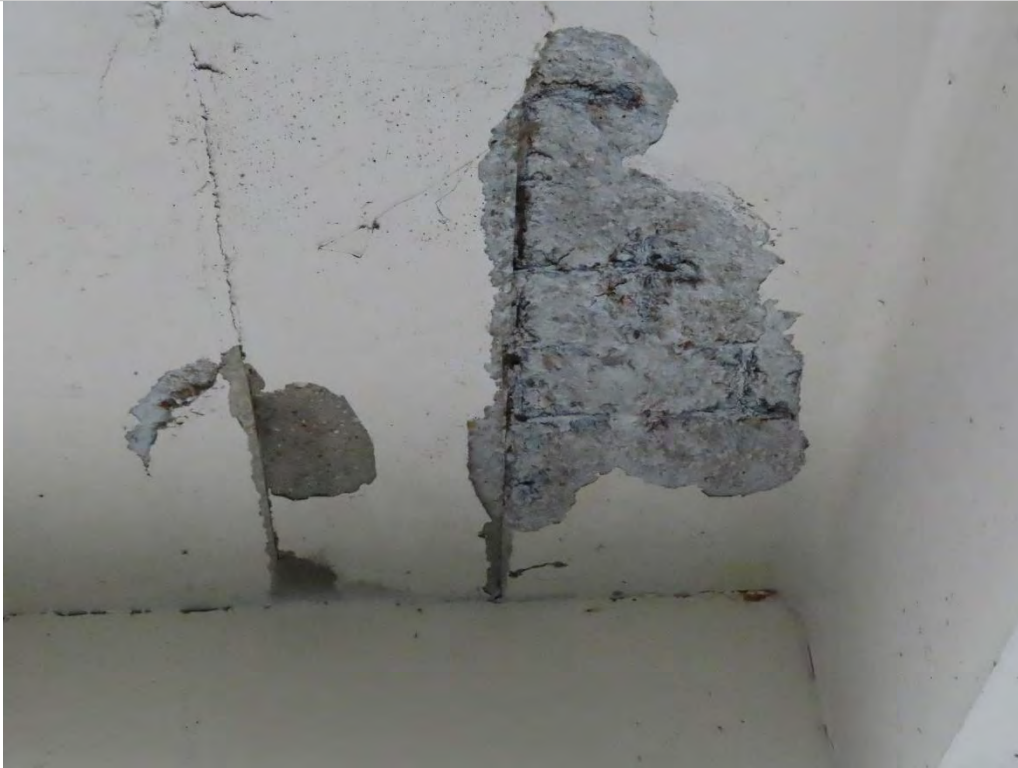
Photo 1.4- Soffit slab deterioration and spall with exposed reinforcement, Village Level (SH3-98)

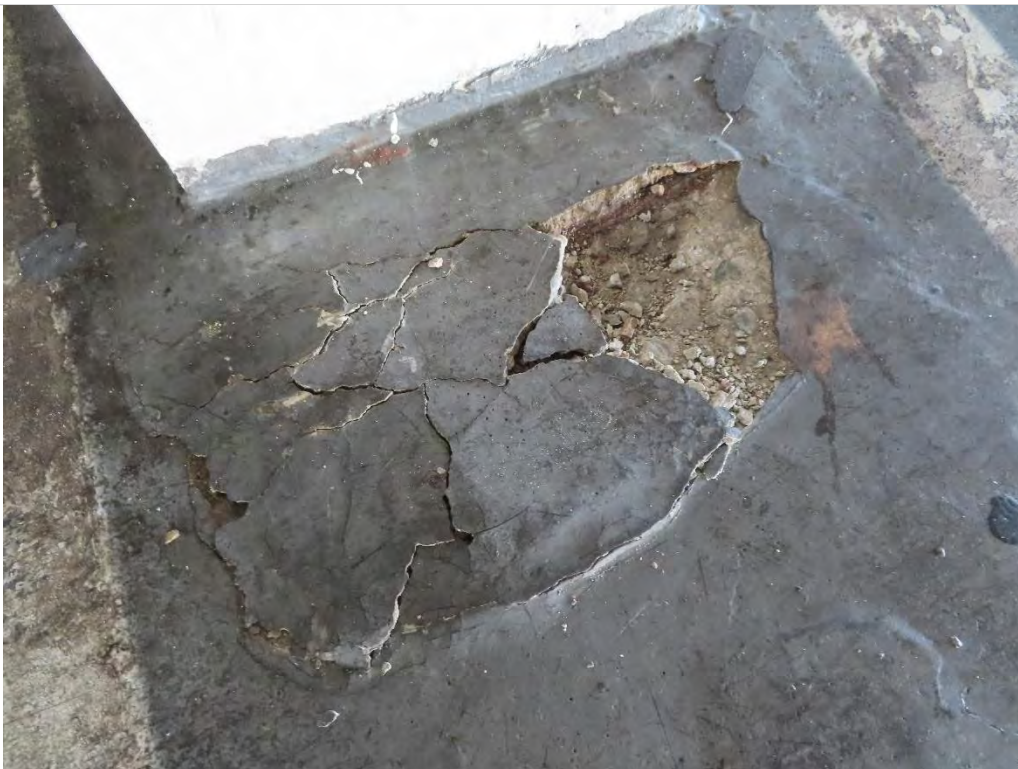
- Isolated concrete overlay deterioration with exposed reinforcement was observed on the Pier level (Photos 1.5 to 1.6).
- Typical Pier Level soffit slab deterioration and spalls with exposed and corroded reinforcement (Photos 1.7 and 1.8).

Photo 1.5- Concrete floor delamination, Pier Level (SH3-229)

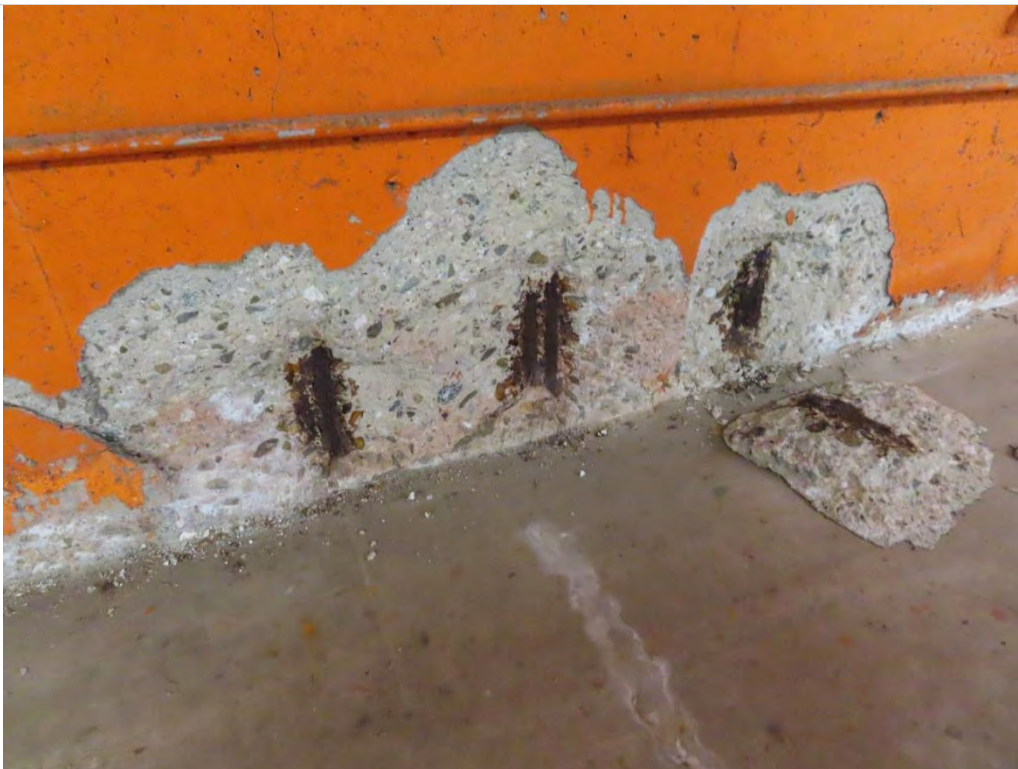
- Typical concrete wall delamination and spalling with exposed rebar on the Basement Level (Photos 1.17 and 1.18).
- Typical beam deterioration with exposed and corroded reinforcement was observed on the Basement Level (Photos 1.19 and 1.20).
- Typical wall cracks were also observed on the Basement Level (Photo 1.21).

Photo 1.17- Exposed rebar on wall, Basement Level (SH3-308)

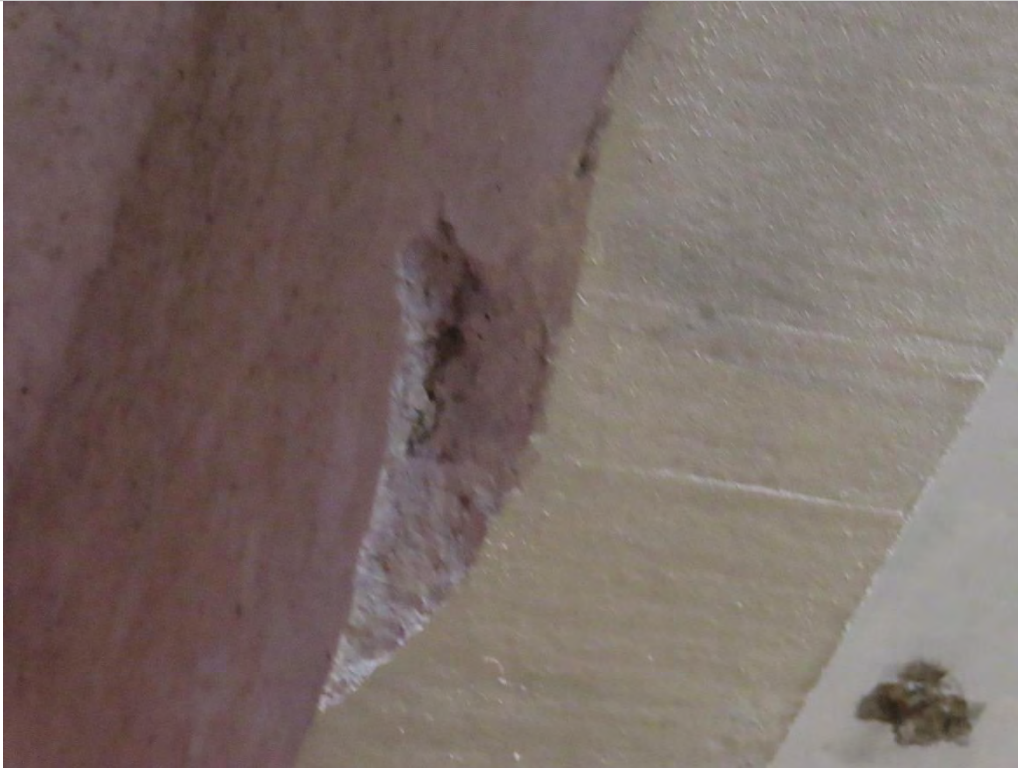
Photo 1.20- Concrete beam spall, Basement Level (SH3-271)

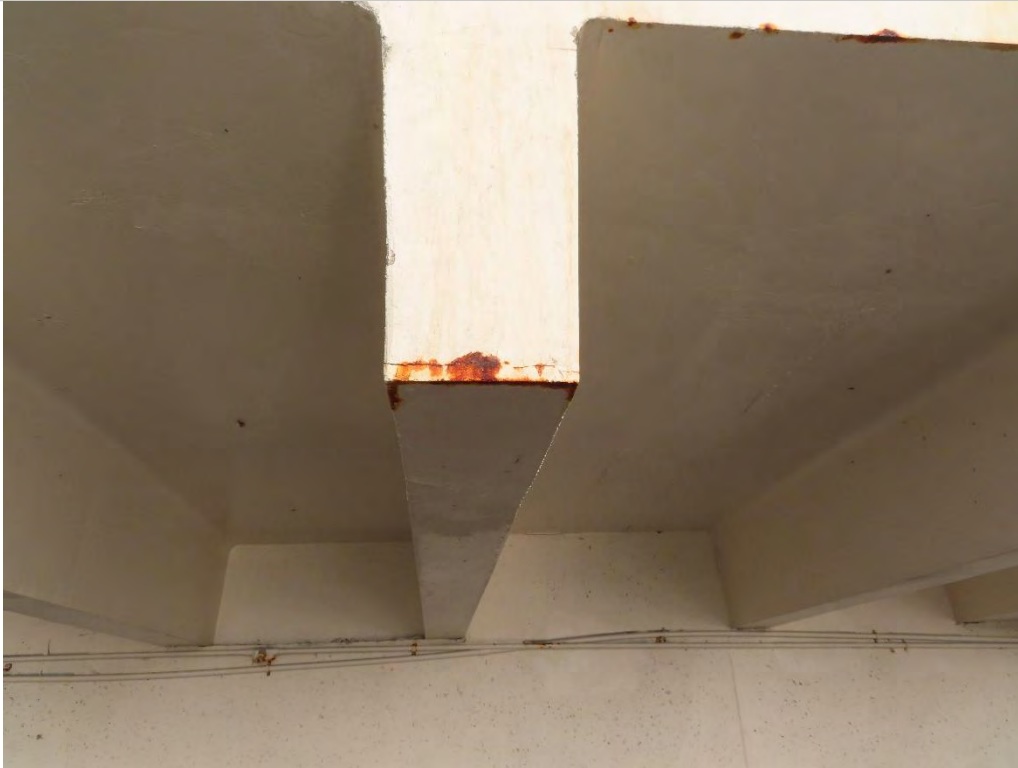
- Typical signs of rebar corrosion were observed east elevation of the parking structure (Photo 1.22).
- Typical spandrel beam deterioration with exposed and corroded reinforcement was observed on north and east elevations of the parking structure (Photo 1.23 to 1.25).

Photo 1.22 - Visual signs of rebar corrosion, Exterior - West elevation (SH2-343)

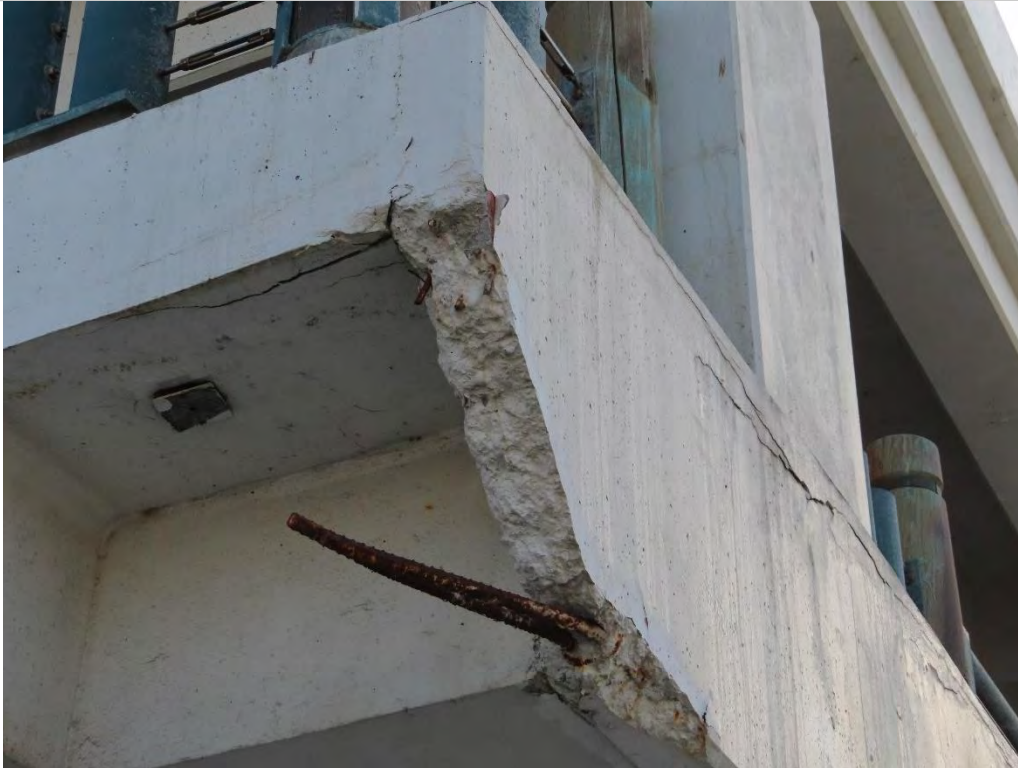
Photo 1.24- Concrete spandrel beam spall with exposed rebar, Exterior – North-east elevation (SH2-362)

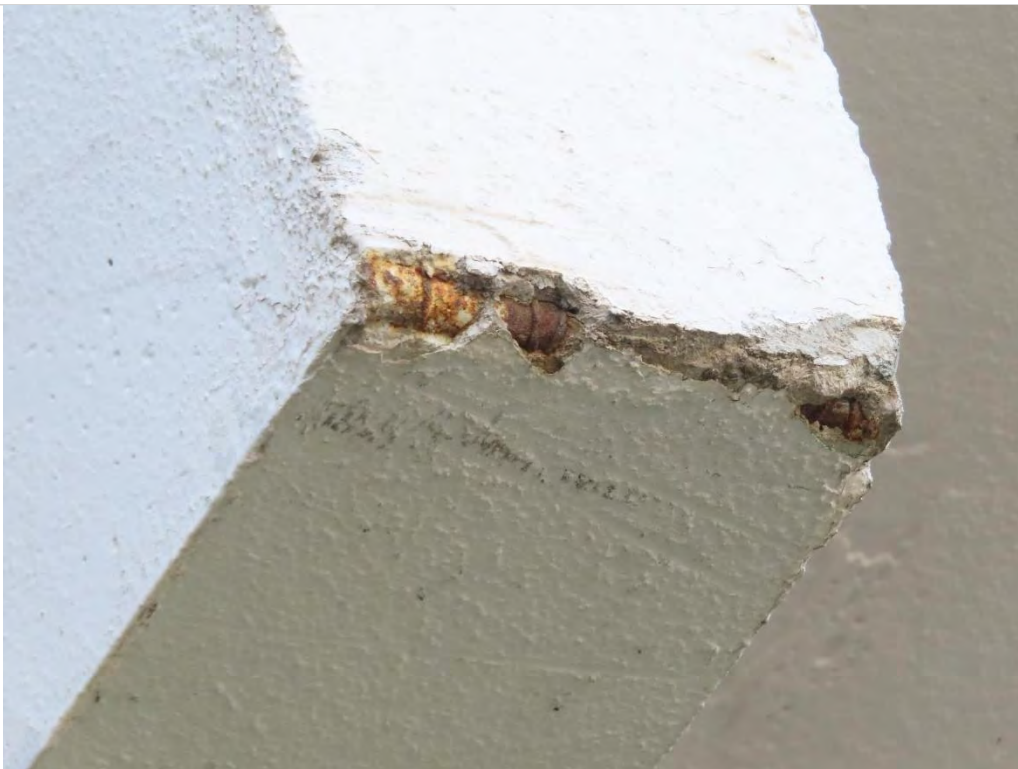
Photo 1.25- Concrete cantilever spandrel beam exposed rebar, Exterior – East elevation (SH2-372)

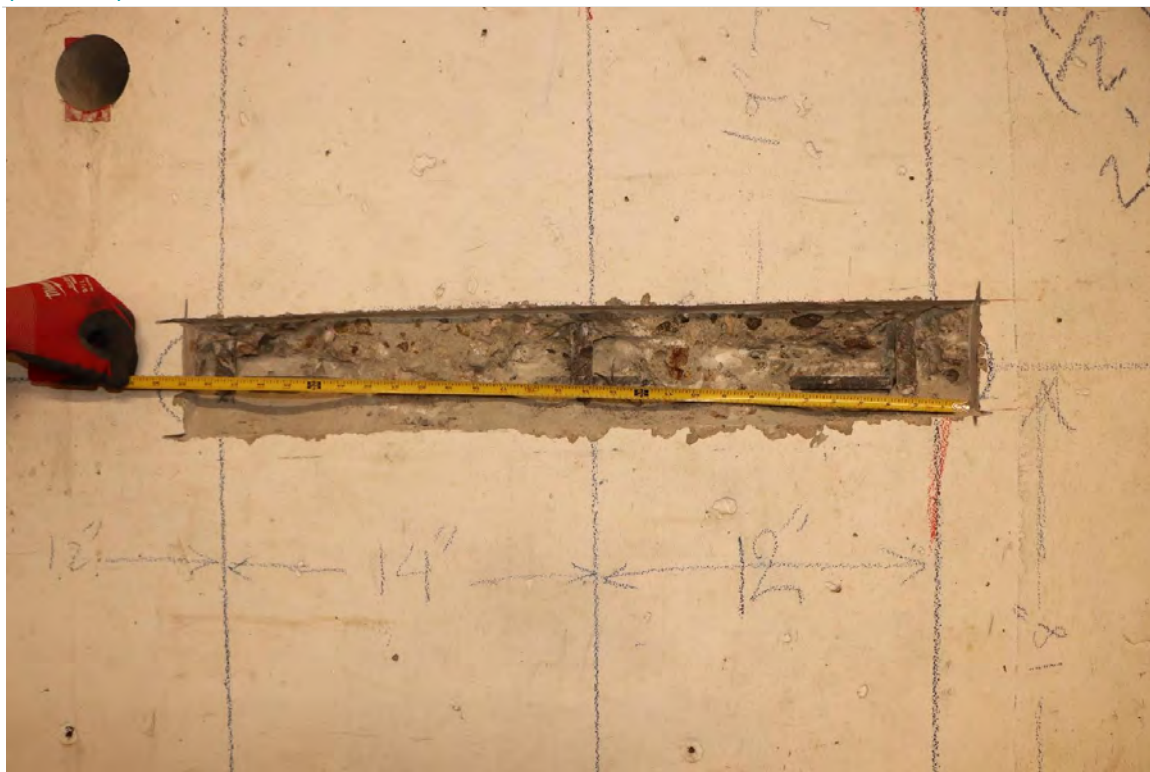
Photo 2.14— Vertical rebar placement at destructive location (DT3), South wall, 1962 Construction - Basement (BA2-409)

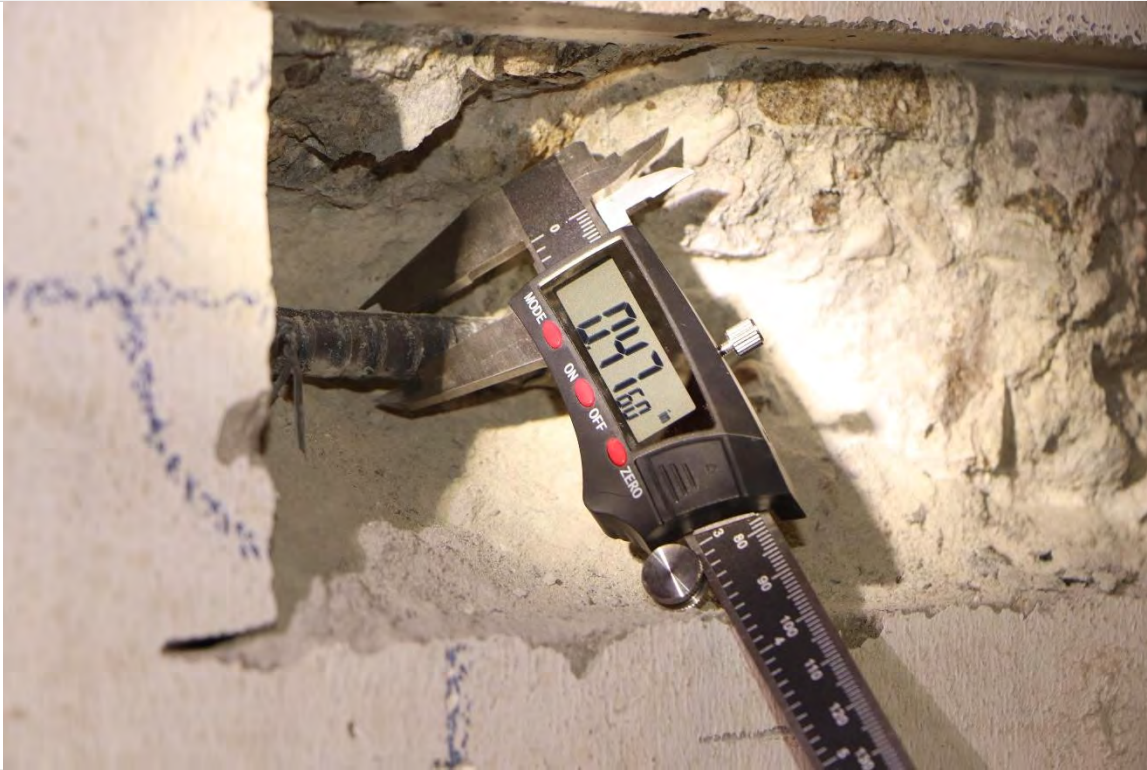
Photo 2.15— Horizontal #4 bar found at the wall destructive opening location DT3, South wall, 1962 Construction - Basement (BA2-344)

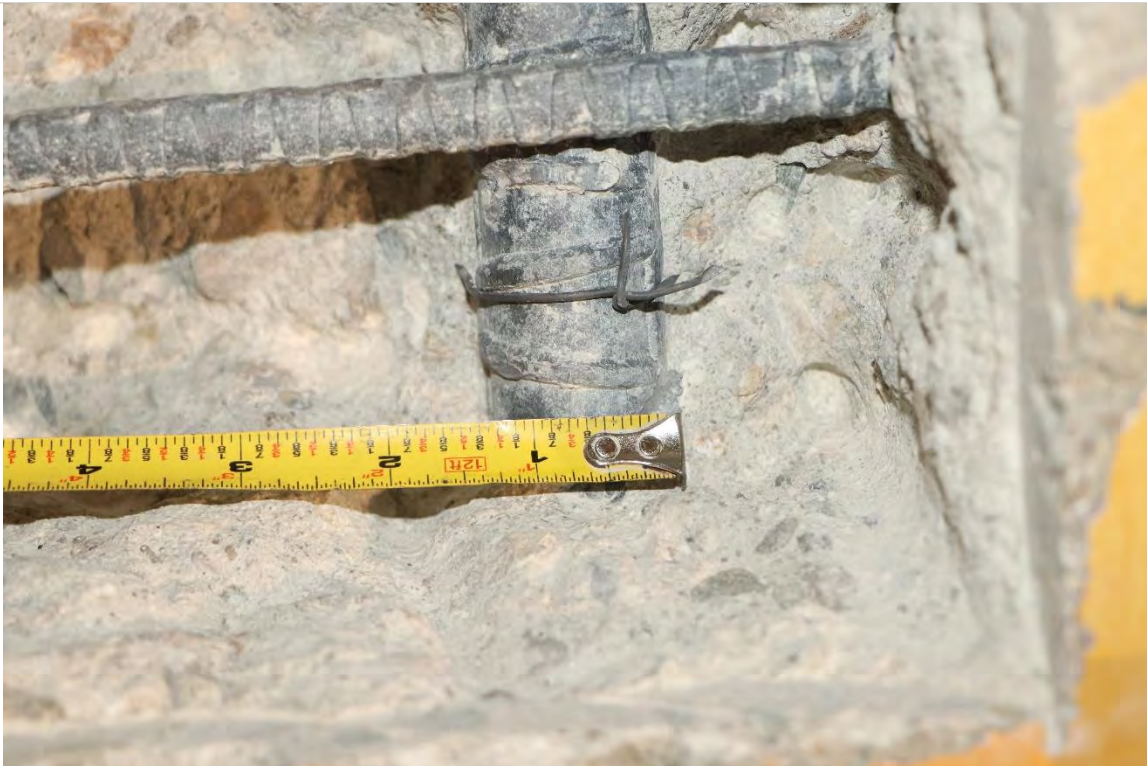
Photo 2.16— Vertical #10 bar found at wall jamb, destructive opening location DT4, Kitchen wall on gridline 3, 1962 Construction - Basement (BA2-580)

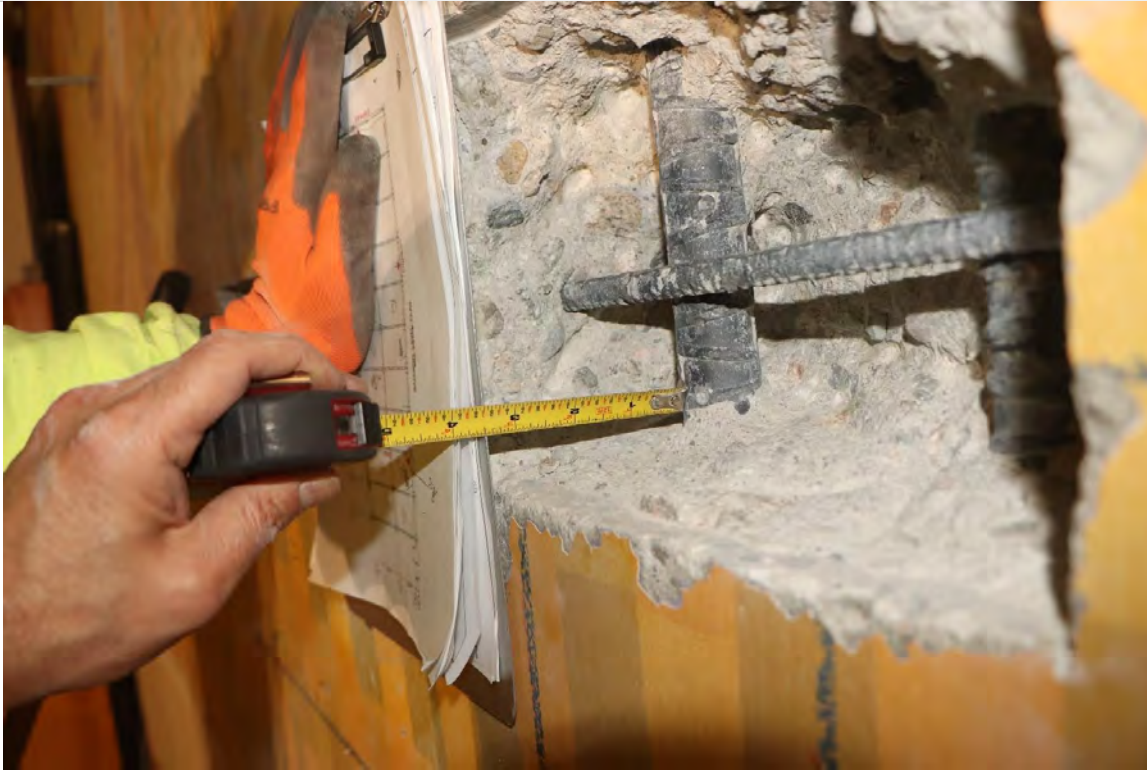
Photo 2.17— Vertical bar concrete cover measurement at wall jamb, destructive opening location DT4, Kitchen wall on gridline 3, 1962 Construction - Basement (BA2-594)

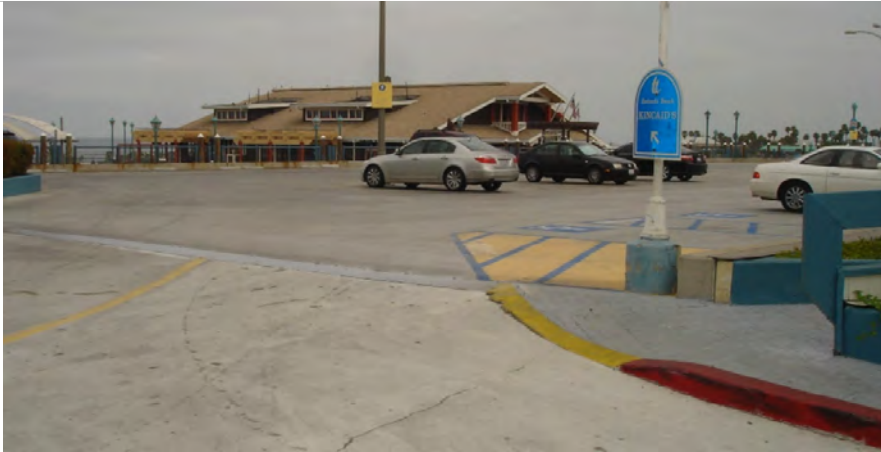
New 2 ½ inch thick overlay was added over the entire double tee system at the Village Level (See Photo 3.3) in 1992. It is our understanding that this modification was made to address higher diaphragm loads based on the requirements of UBC 1991. At Village Level, additional slab drag reinforcement was added near the shear wall along line 11. ASCE 41-17 diaphragm forces are significantly higher than the UBC 1991 diaphragm forces. Chord and drag collector elements shall be evaluated as force-controlled and they both will require retrofit in terms of addition of new chord and diaphragm steel at the Village and Pier Level.

Photo 3.3- 2 ½-inch-thick overlay of CIP topping slab – Village Level

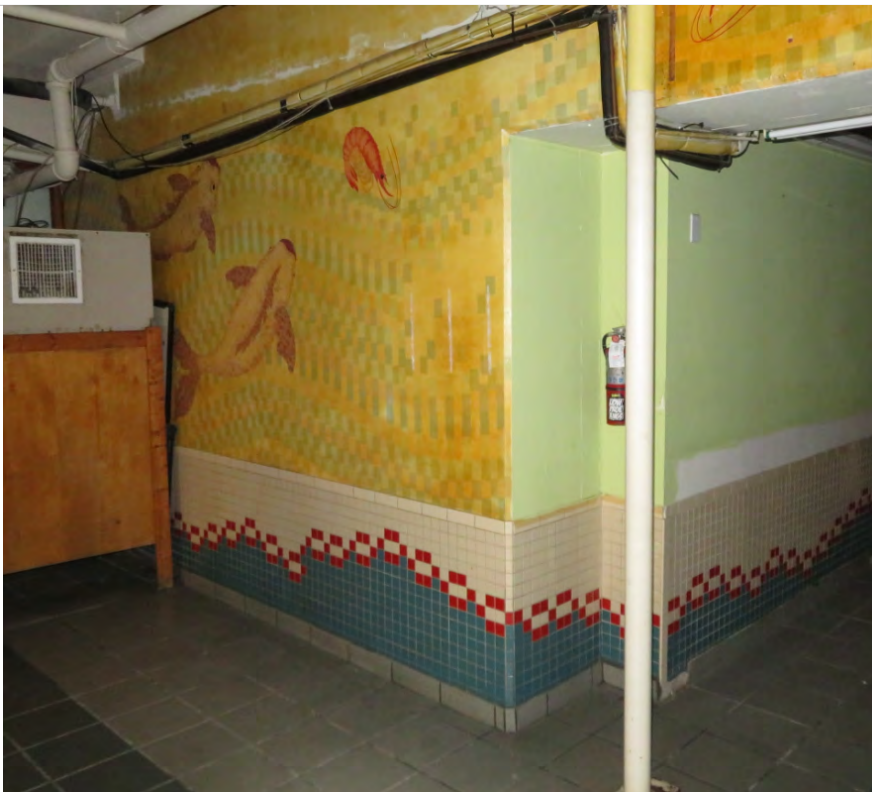
10. Thickening of existing shear walls is required at line 3 at the Basement level. Add horizontal reinforcement at Basement level shear walls along line 3 (see Photo 3.4) where existing shear walls reinforcement in horizontal direction doesn't meet the ASCE 41-17 and ACI 318-14 minimum wall requirement.

Photo 3.4- 24-inch-thick shear wall at line 3 and Y at Basement Level

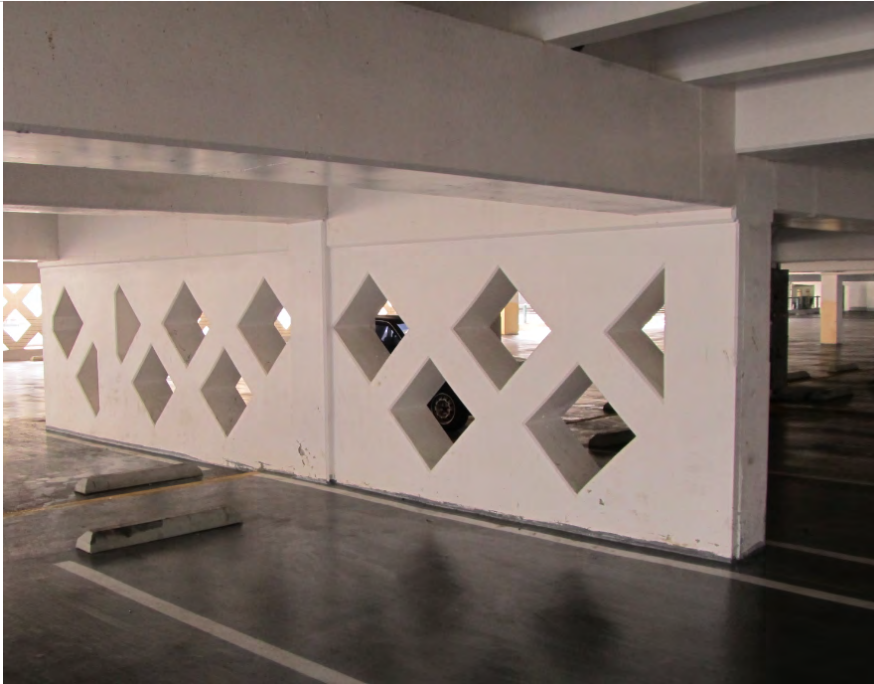
3. Addition of (24) new foundation drilled piers and wall footing at line 7 to support two new shear walls.
4. Strengthening of existing waffle shear wall at line 3 and line Y at the Pier Level as the diagonal braces of existing waffle shear wall are deficient in both axial compression and tension. This condition will improve once the new shear walls are going to be added at line 3 and at line 7 (See Photo 3.5).

Photo 3.5- 12-inch-thick waffle shear wall at line 3 and Y at Pier Level

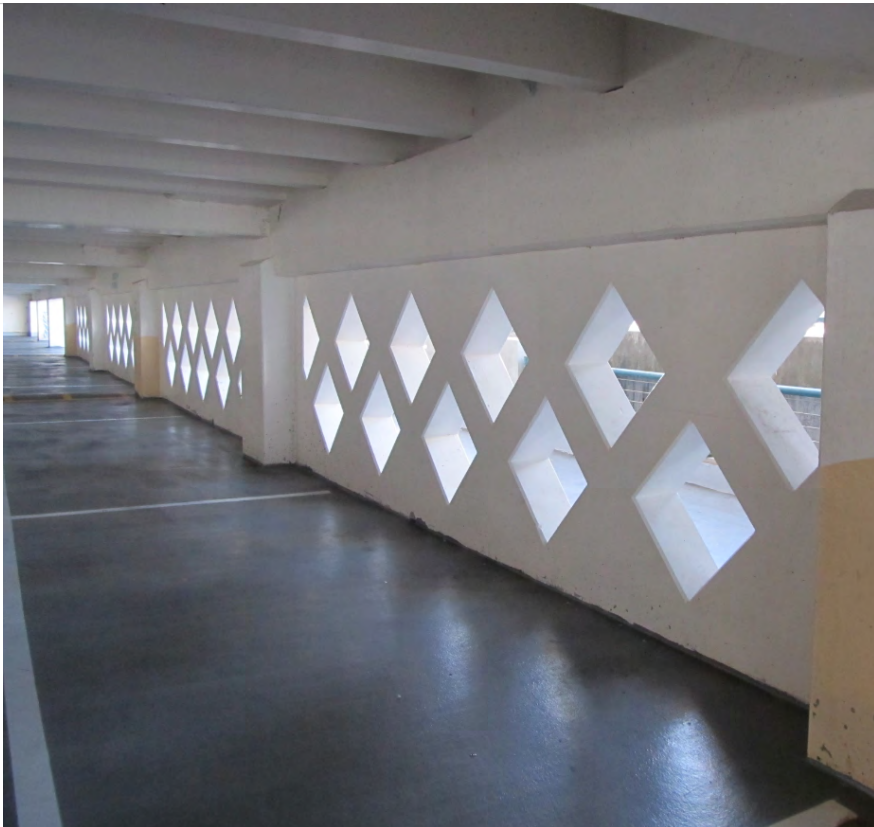
Photo 3.6- 12-inch-thick waffle shear wall along line X at Pier Level

12. Add new slab reinforcement at waffle shear walls at line X and Z.1 at Village Level (See Photo 3.6 and 3.7).
13. Strengthen CIP column at line 3 and Z at Pier Level (See Photo 3.9).

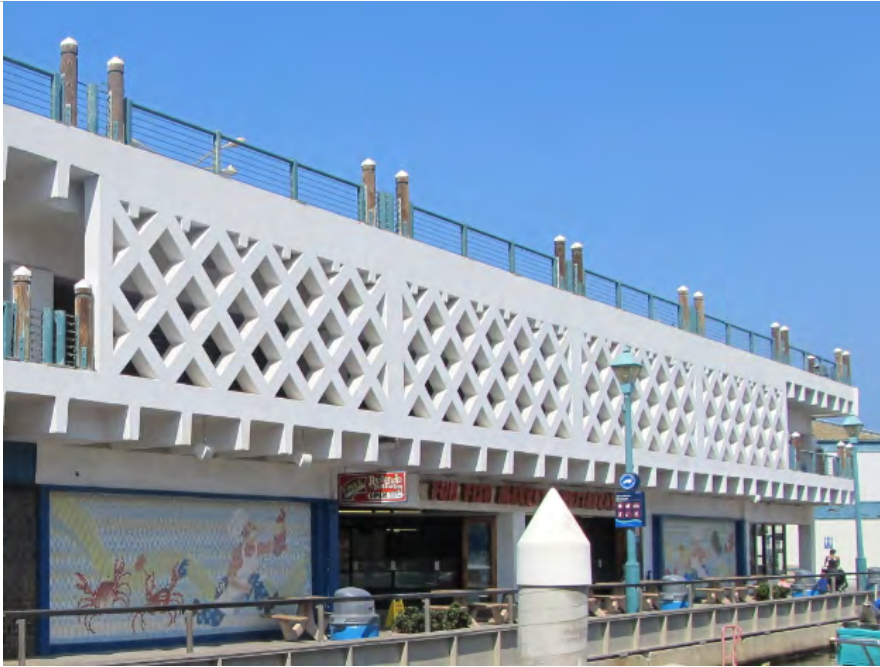
Photo 3.7- 12-inch-thick waffle shear wall at line Z.1 at Pier Level

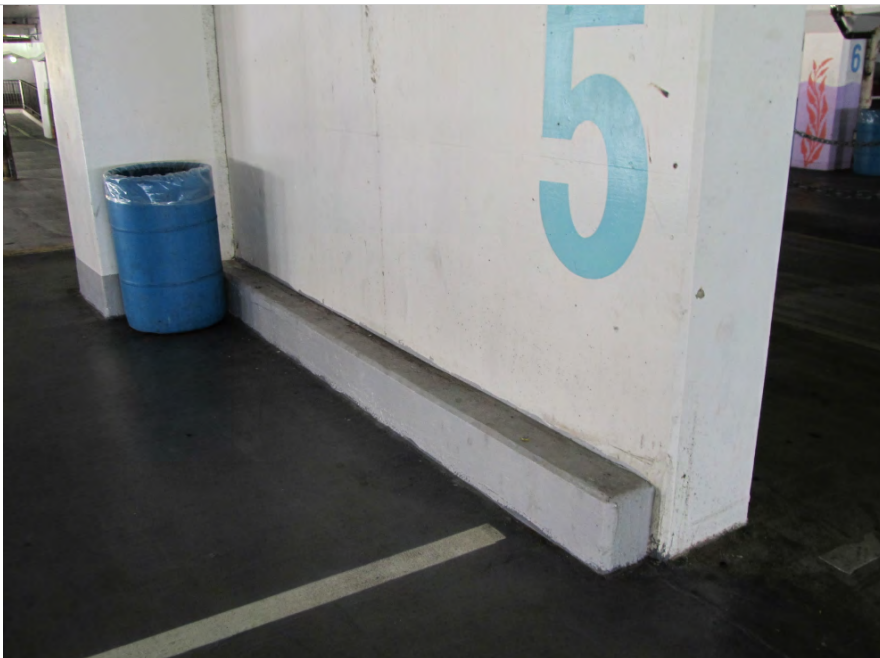
Photo 3.8- 10-inch-thick shear wall at line 11 and Y at the Pier Level

11. Add new slab reinforcement at shear walls oriented in the East-West direction at Village and Pier Level at line 3, 7, and 11 (See Photo 3.5, 3.8, and 3.13).

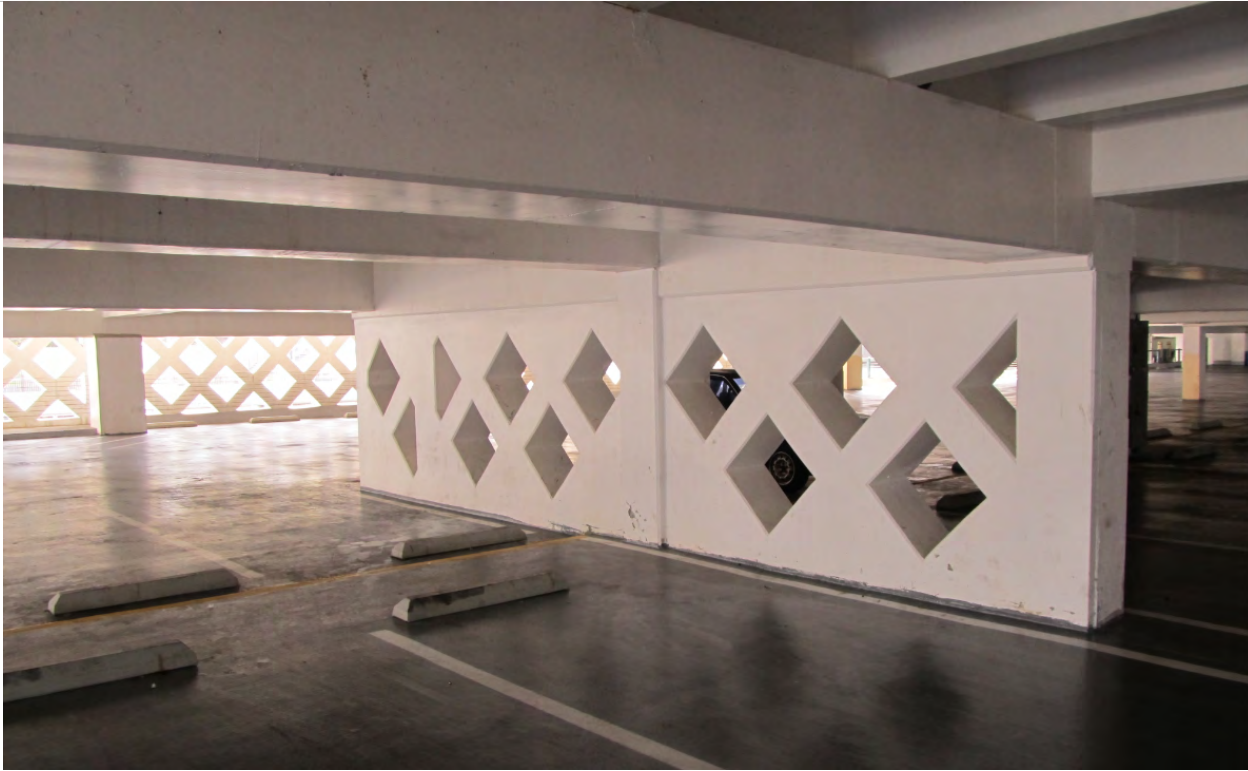
1. Add (1) new 21ft long concrete shear wall at line 3 near grid line Z at the Pier Level. The addition of new shear wall will eliminate the discontinuity of shear wall that currently exists as there is a 21ft long shear wall at the Basement Level that was built in 1962 and was part of the original design. The addition of new shear wall at line 3 near line Z will also reduce demand on line 3 existing shear wall at grid line Y at the Pier Level, which is currently showing signs of an overstressed condition in both flexure and shear (See Photo 3.4 and 3.9)

Photo 3.9- CIP columns at line 3 and Z at the Pier Level

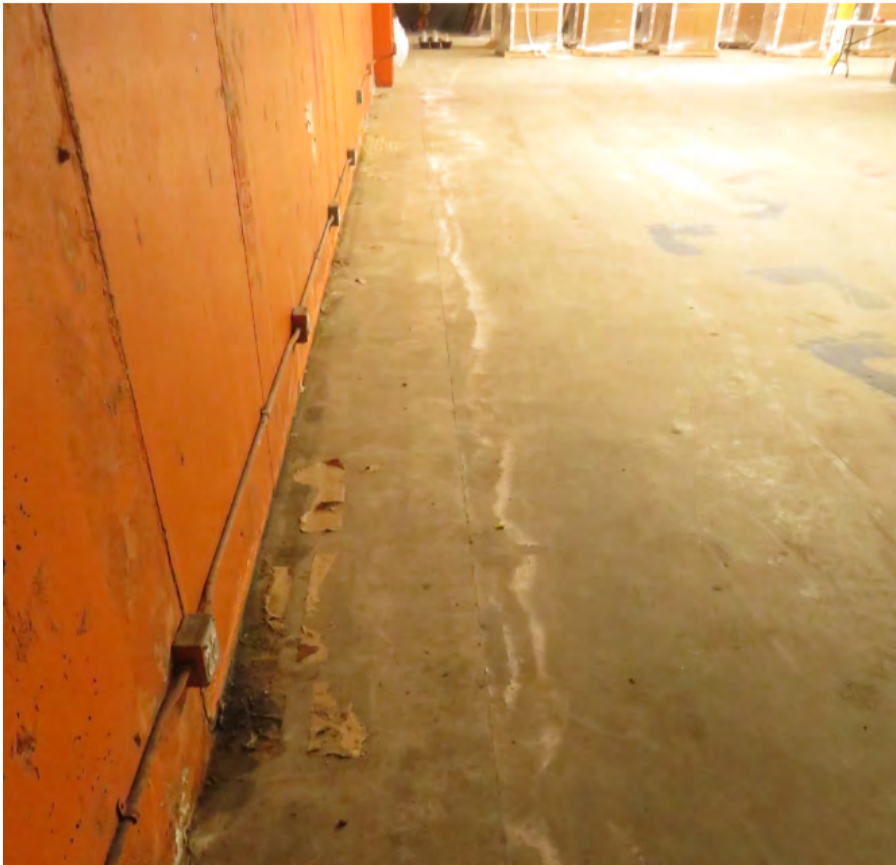
Photo 3.13- Shear wall along line 11 at Basement Level

8. Thickening of existing shear wall is required at line X at the Basement level from line 4 to 11 (See Photo 3.13)
9. Thickening of existing shear wall is required at line Z (basement level) from line (2 – 3) and (5 – 6) (See Photo 3.16).

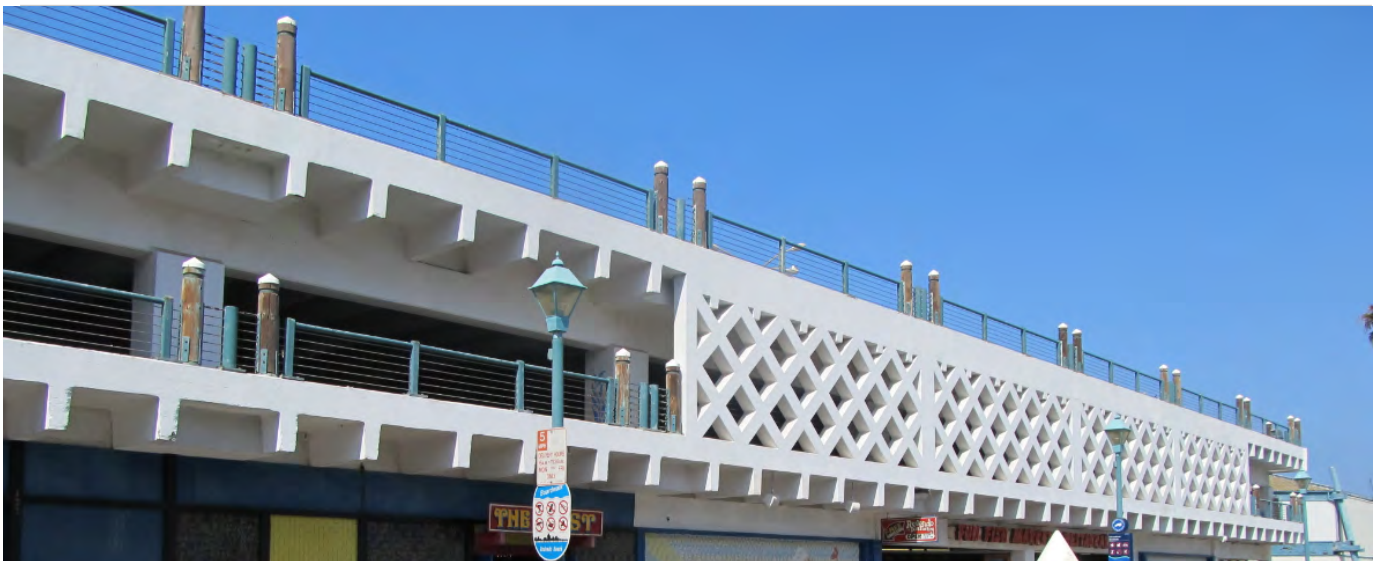
Photo 3.14- Truss chords at waffle shear wall at line Z.1 at the Village and Pier Level

5. Strengthening of existing top chord of the waffle shear wall at line Z.1 at the Village level. Addition of new chord reinforcement is required at the Village level (See Photo 3.14).

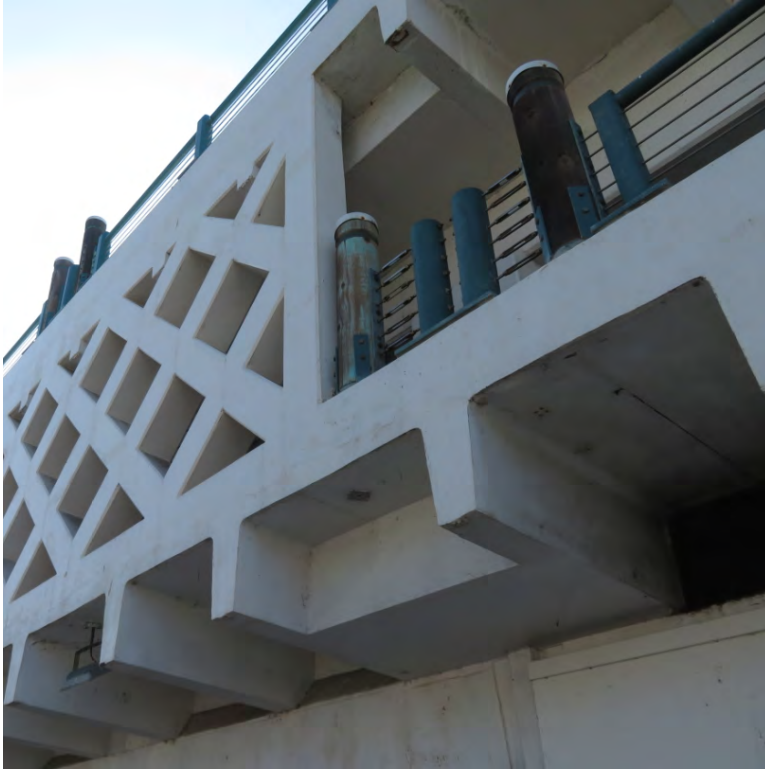
Photo 3.15- Precast double tee stems at waffle shear wall ends at line Z.1 at the Village and Pier Level

6. Strengthening of existing double tee stems at waffle shear wall ends at line Z.1 at the Village and Pier level (See Photo 3.15).
7. Strengthening of Shear walls ends to meet ASCE 41-17 confinement reinforcement. X (2-3) and (5-6) to meet requirement of ASCE 41-17 code force limit (See Photo 3.16).

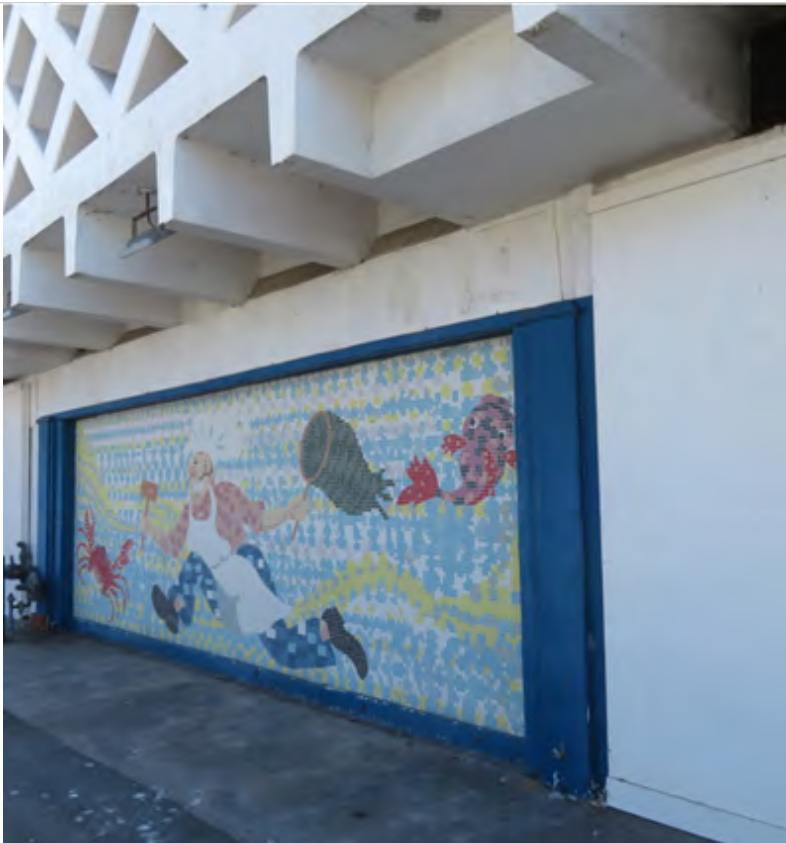
Photo 3.16- CIP Columns at shear wall ends at line Z at the Pier and Basement Level

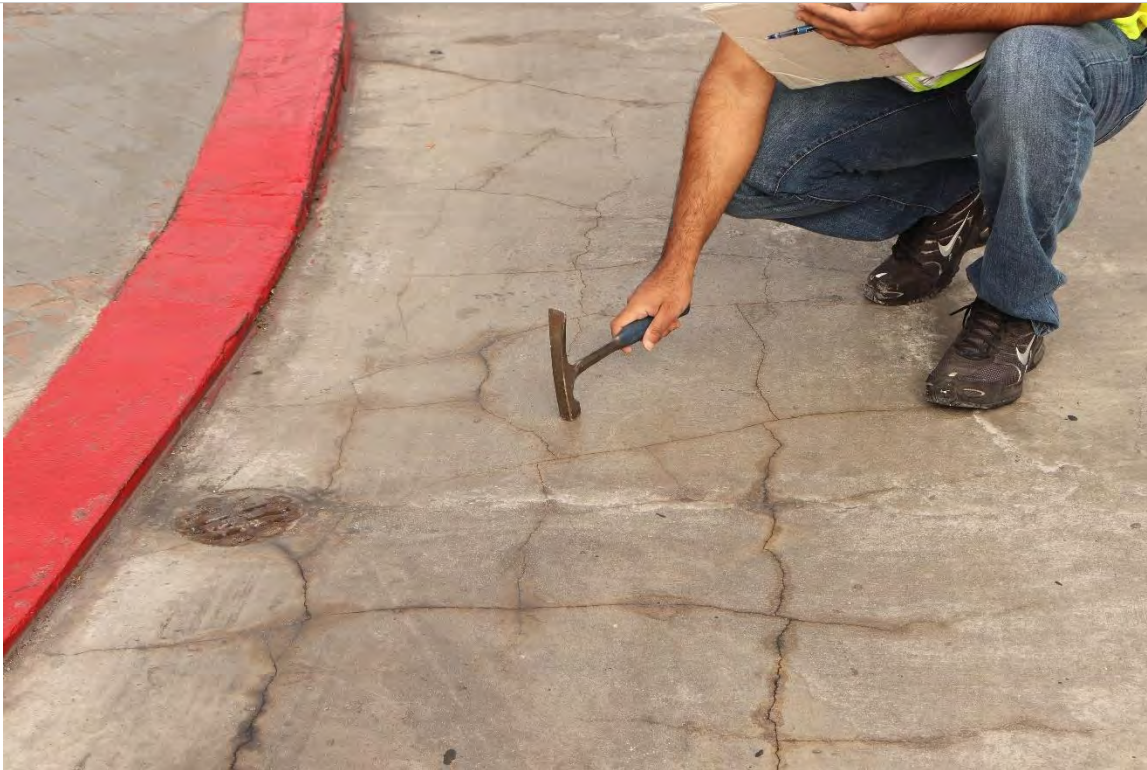
- Chain drags sounding of the Village level floor revealed isolated floor deterioration. Sounding the previous floor repairs indicated delamination which indicated that the repairs are not generally performing acceptably. Isolated floor cracks were also observed (Photo 1.1 to 1.5).

Photo 1.1- Concrete delamination, Village level (BA1-50)

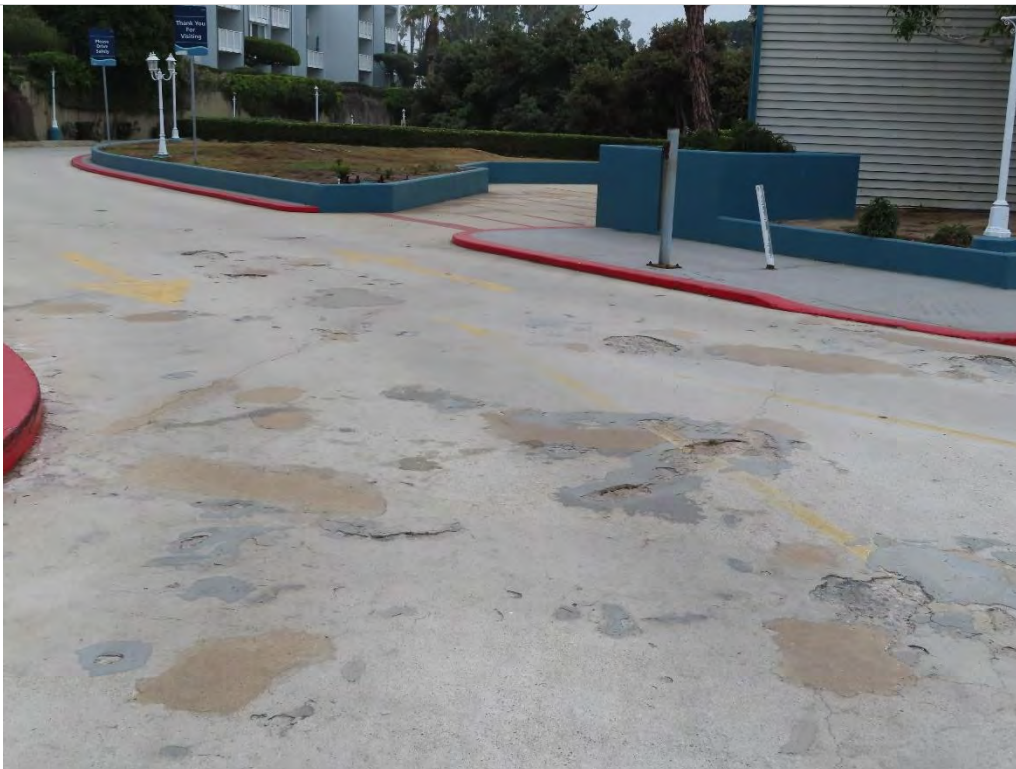
Photo 1.2- Concrete delamination, Village level (SH1-167)

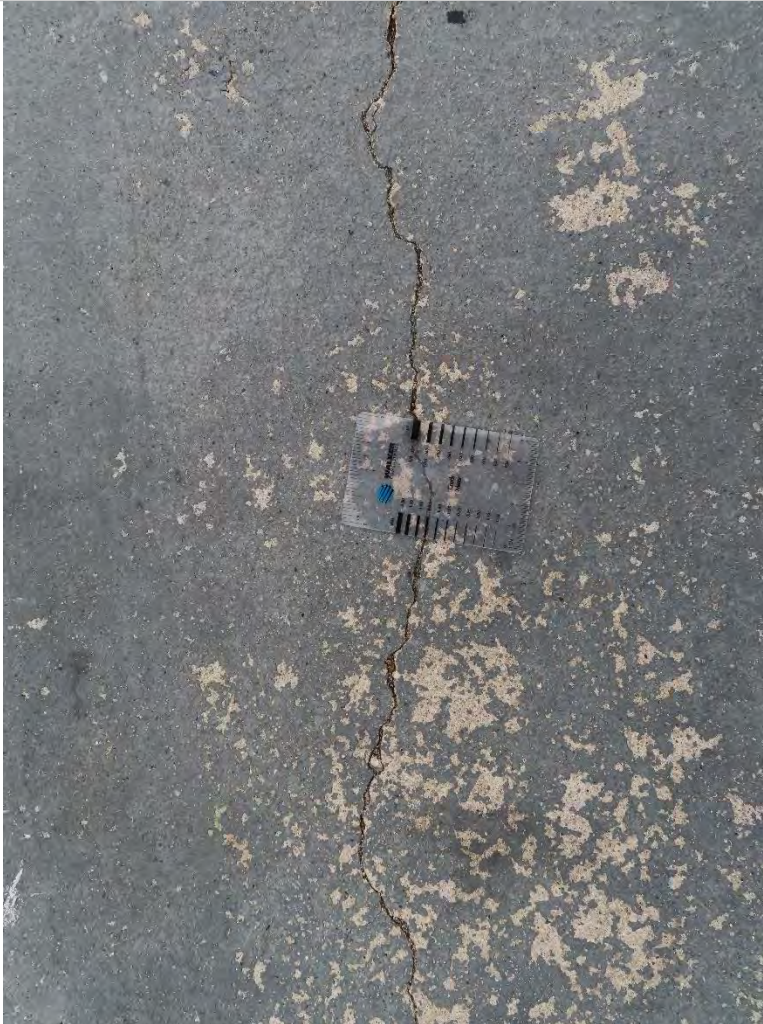
Photo 1.4- Cracks on concrete floor slab, Village level (SH1-165)

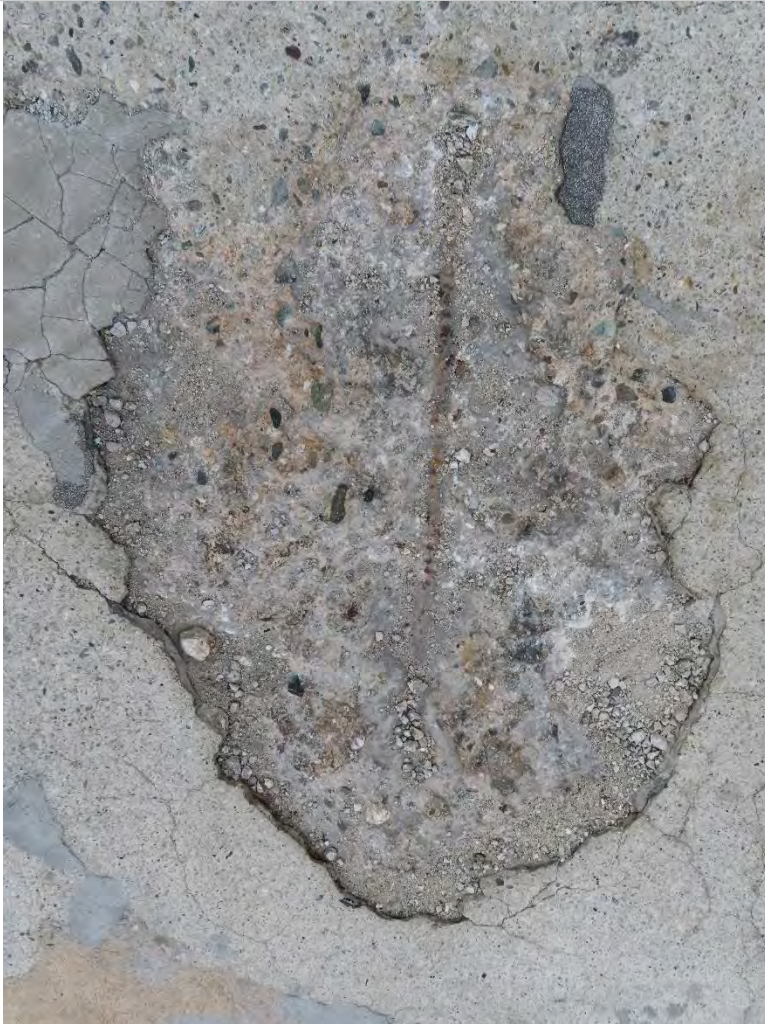
- Typical concrete topping deterioration with exposed and corroded reinforcement was observed primarily on the Village level along drive lanes (Photos 1.6 and 1.7).

Photo 1.6- Exposed rebar on floor, Village level (SH1-168)
