Re: 2021/22 Pier Parking Structures Condition Assessment

CITY OF REDONDO BEACH NORTH PIER PARKING STRUCTURE 2021-CONDITION ASSESSMENT

CITY OF REDONDO BEACH
Redondo Beach, CA

WALKER
CONSULTANTS

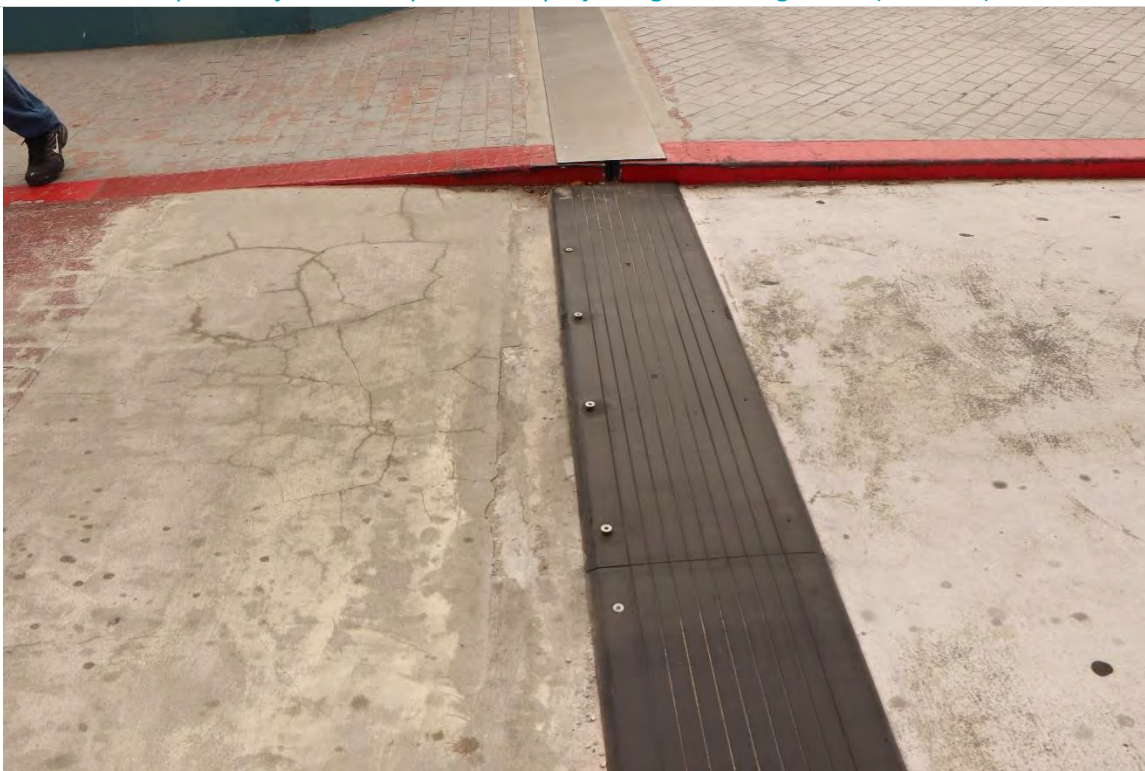
- Expansion joint cover plate bolts were seen projecting out, missing or loose (Photos 1.12 and 1.13).
- Typical deteriorated / spalled concrete planter walls (Photos 1.14).

Photo 1.12- Expansion joint cover plate bolts projecting out, Village level (BA1-139)

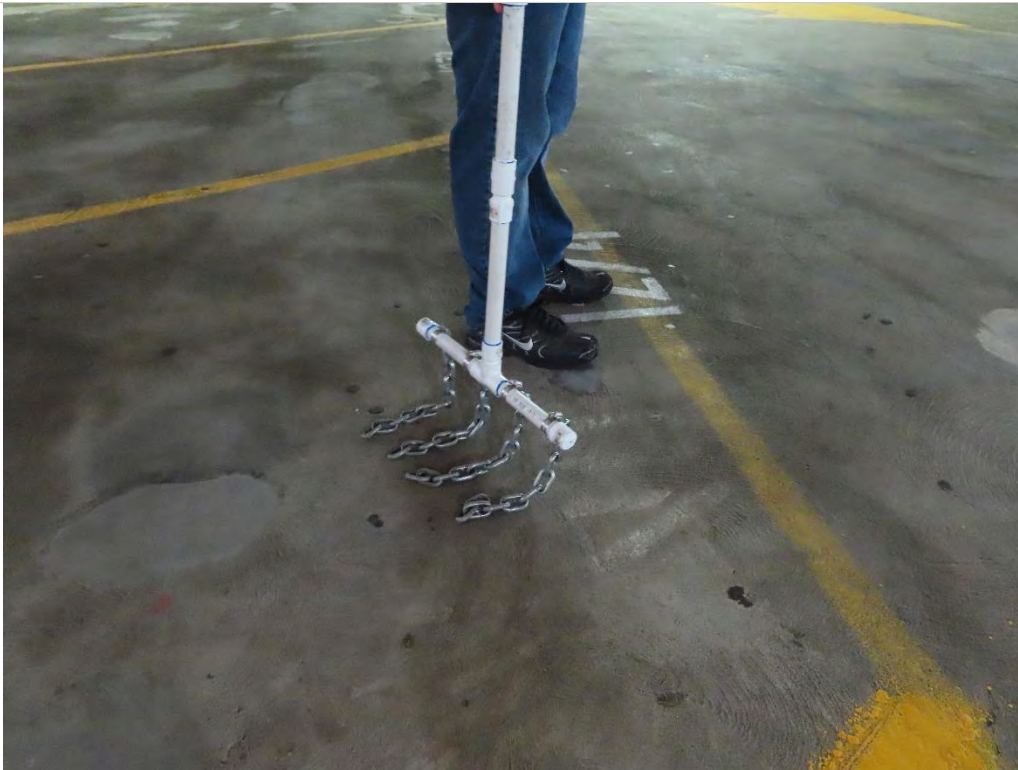
- Chain drags sounding of the Pier level floor revealed isolated floor deterioration. Sounding the previous floor repairs indicated delamination which indicated that the repairs are not generally performing acceptably. Isolated floor cracks were also observed (Photo 1.17 and 1.18).

Photo 1.17- Concrete delamination, Pier level (SH2-7)

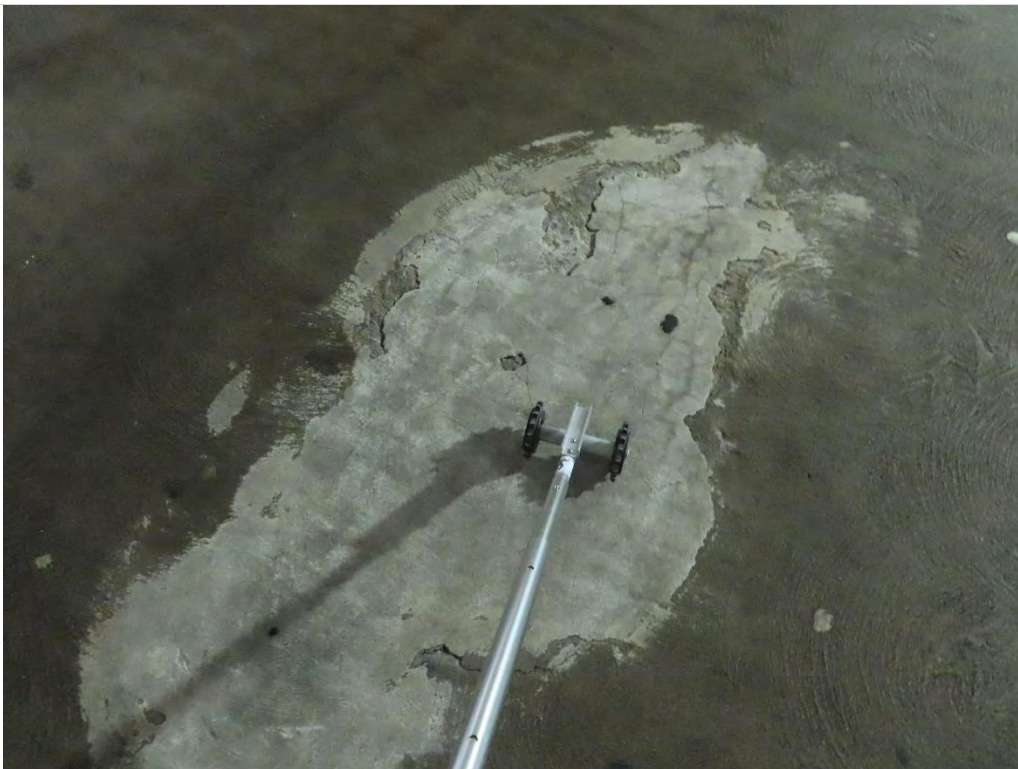
Photo 1.18- Concrete delamination, Pier level (SH2-21)

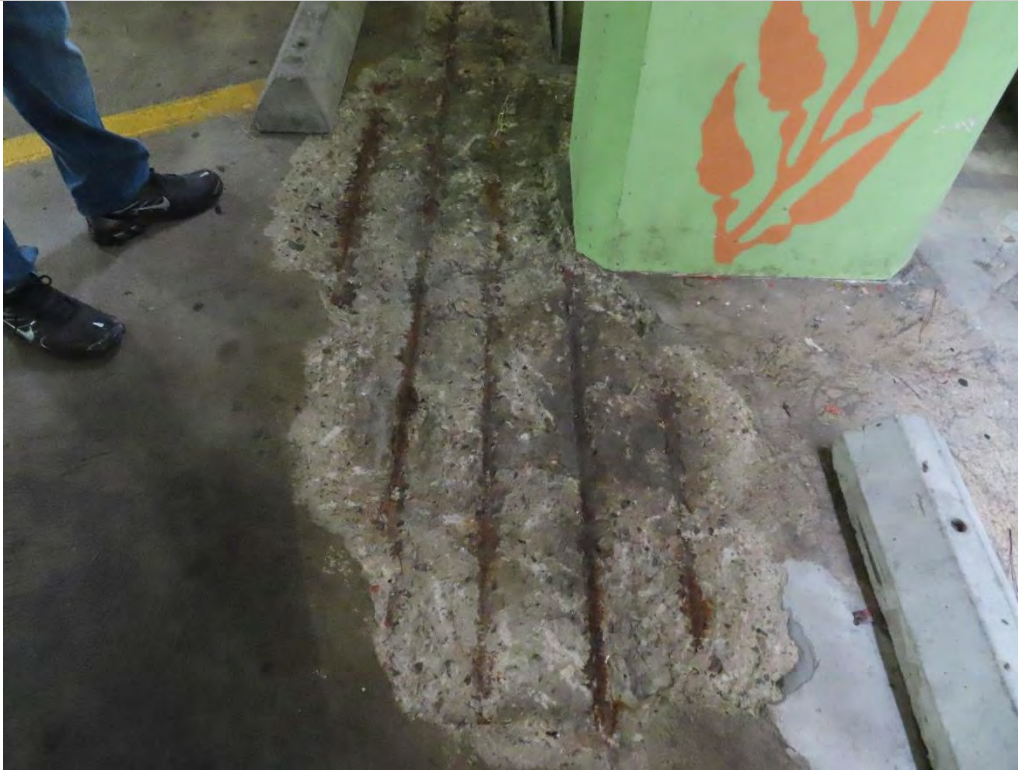
- Typical concrete slab deterioration with exposed and corroded reinforcement was observed primarily on Pier level on the northeastern side (Photos 1.19 to 1.21).

Photo 1.19- Exposed rebar on floor, Pier level (SH2-8)

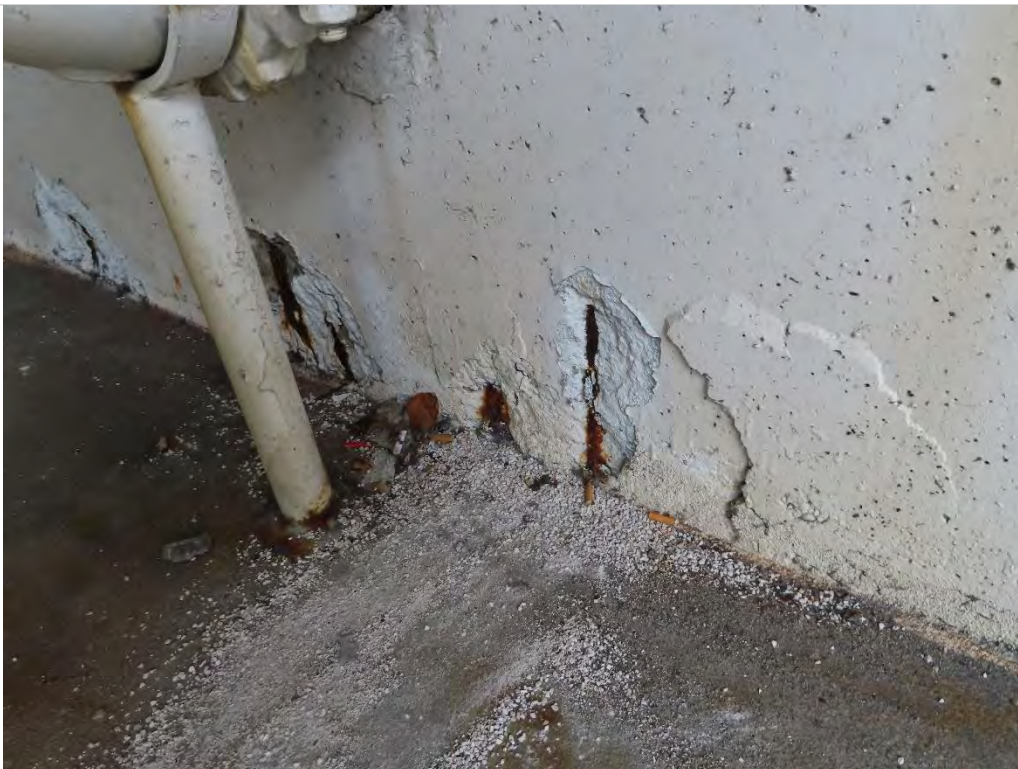
- Isolated slab edge deterioration and spalls with exposed and corroded reinforcement (Photos 1.22 and 1.23).
- Isolated concrete wall delamination and spalling with exposed rebars (Photos 1.24 and 1.25).

Photo 1.24- Exposed rebar on wall, Pier level (SH1-117)

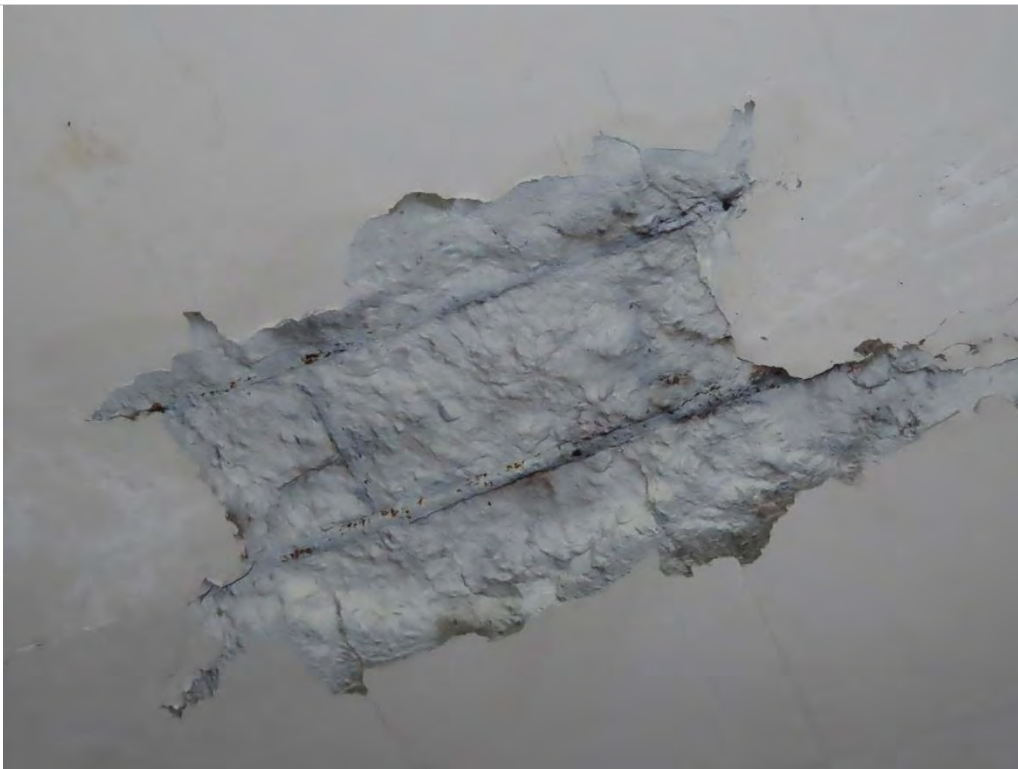
- Typical Pier level soffit slab deterioration and spalls with exposed and corroded reinforcement (Photos 1.26 to 1.28).
- Isolated beam deterioration with exposed and corroded reinforcement was observed primarily below the expansion joint (running north-south at south end of the garage) with other isolated locations (Photos 1.29 and 1.30).

Photo 1.26- Soffit slab deterioration and spalls with exposed reinforcement, Pier level (SH1-258)

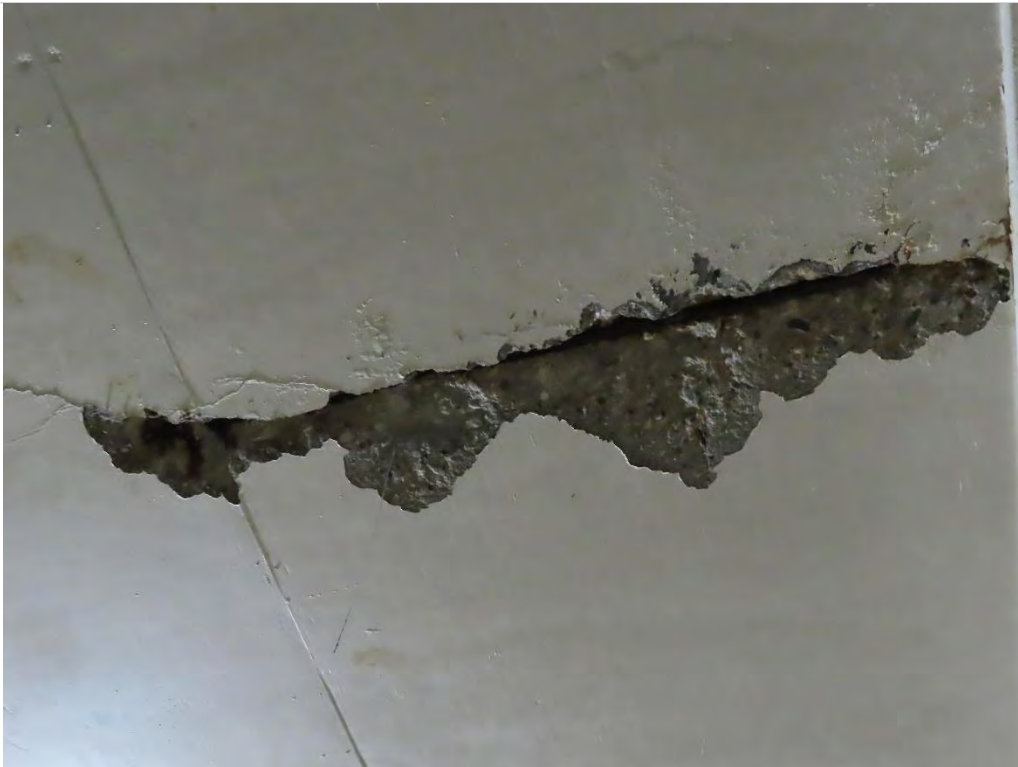
Photo 1.28- Soffit slab deterioration and spalls with exposed reinforcement, Pier level (SH1-249)

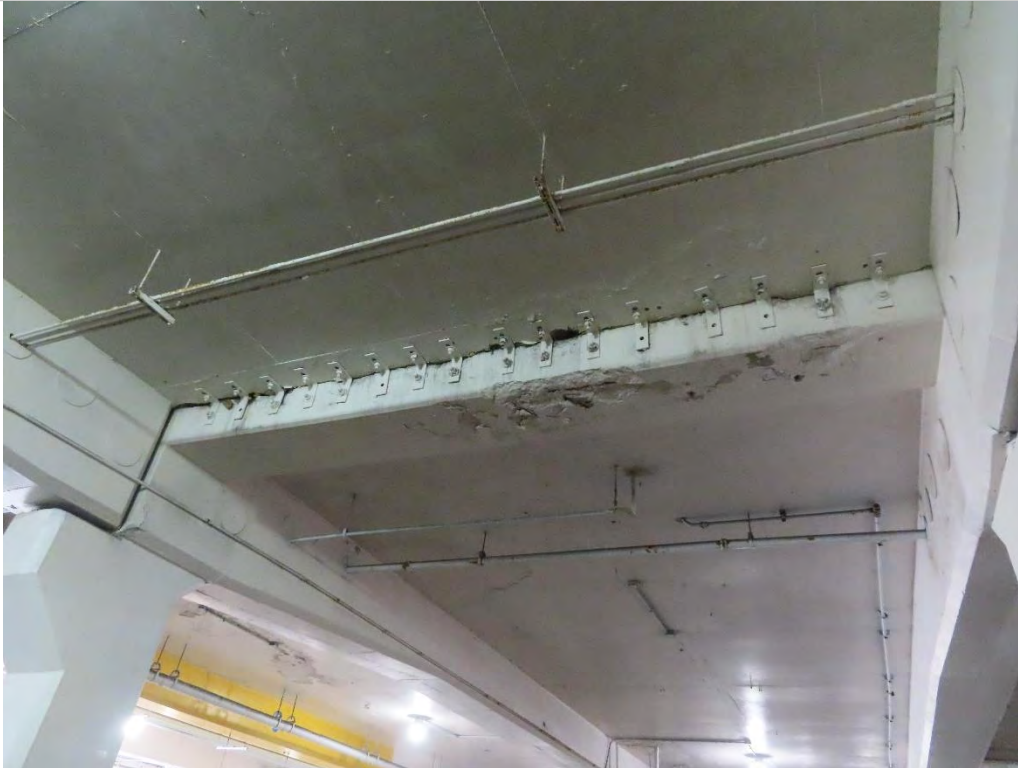
Photo 1.29- Concrete beam spalling below the expansion joint, Pier level (MM1-45)

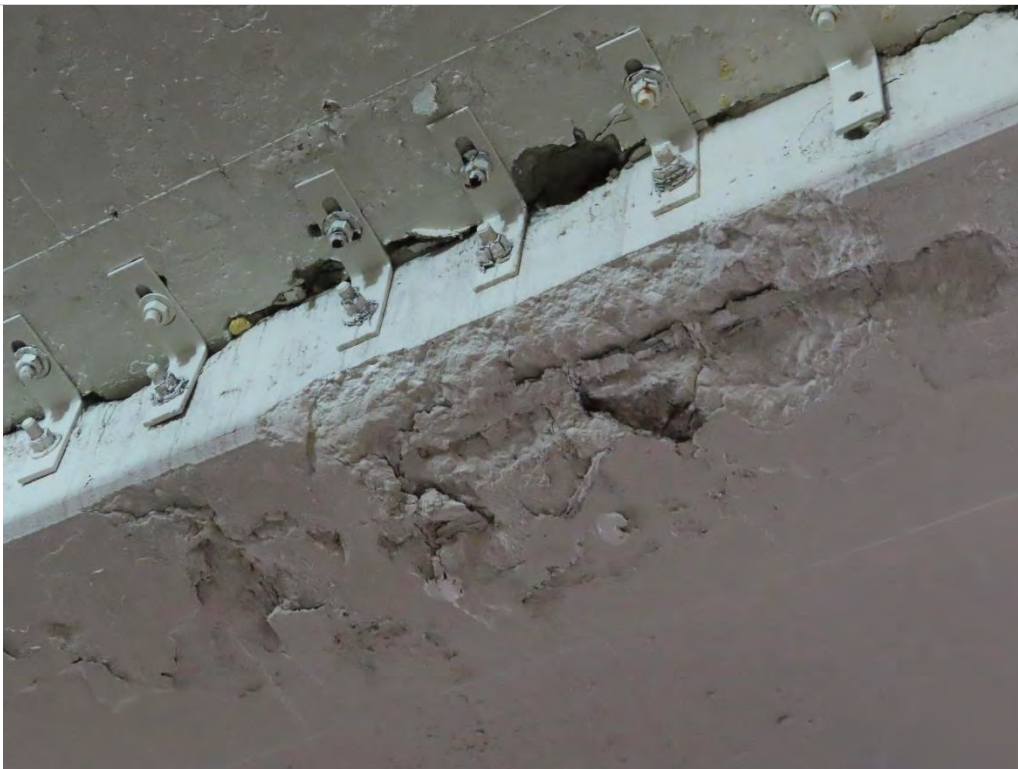
Photo 1.30- Concrete beam spalling below the expansion joint, Pier level (MM1-46)

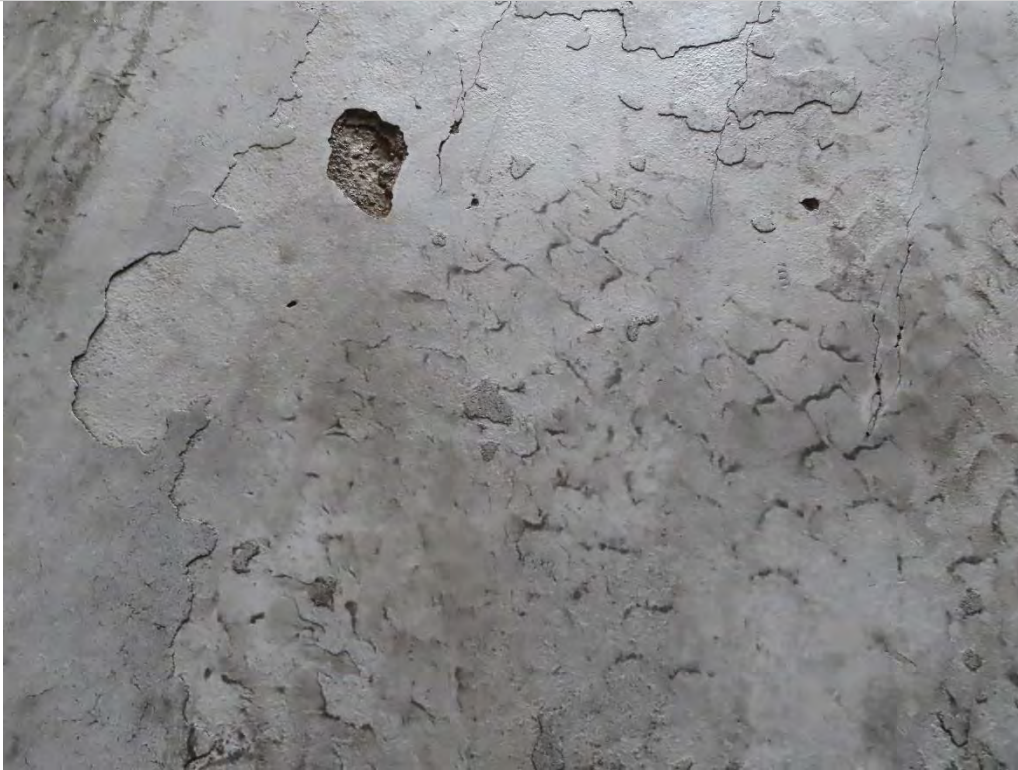
- Urethane traffic membrane was observed in poor to fair condition on the West side of the entire Pier level. Most of the high-traffic turning radii has worn surfaces with aggregate roll-out observed (Photos 1.31 and 1.32).

Photo 1.31- Compromised traffic membrane, Pier level (SH1-52)

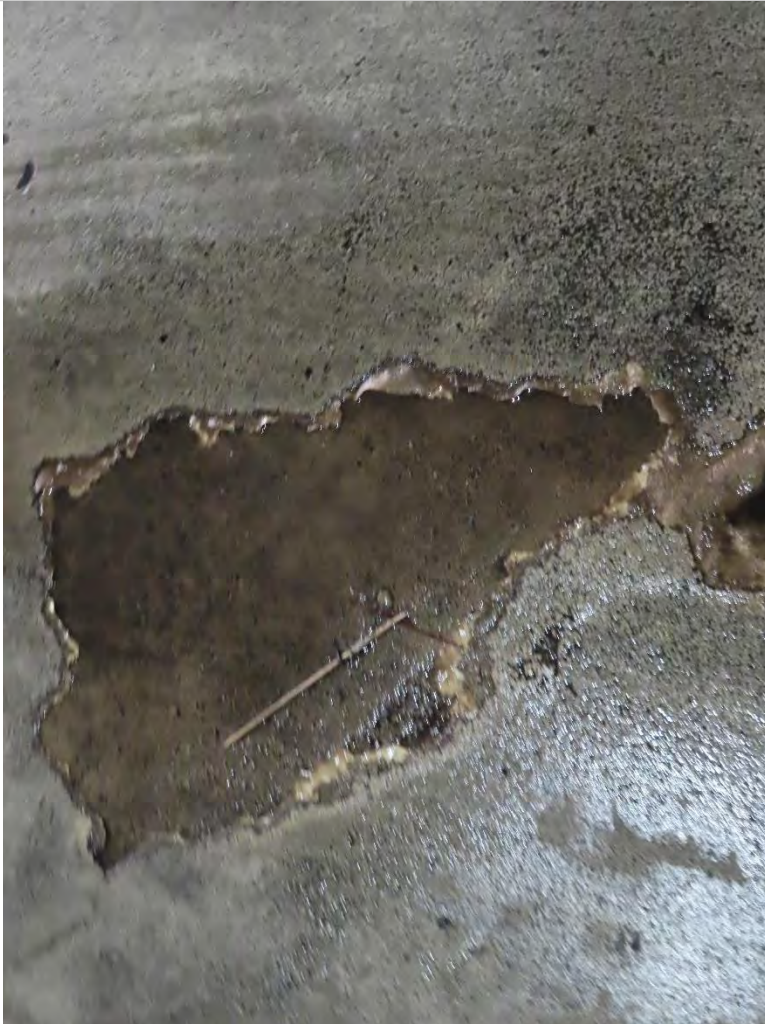
Photo 1.32- Compromised traffic membrane, Pier level (SH1-48)

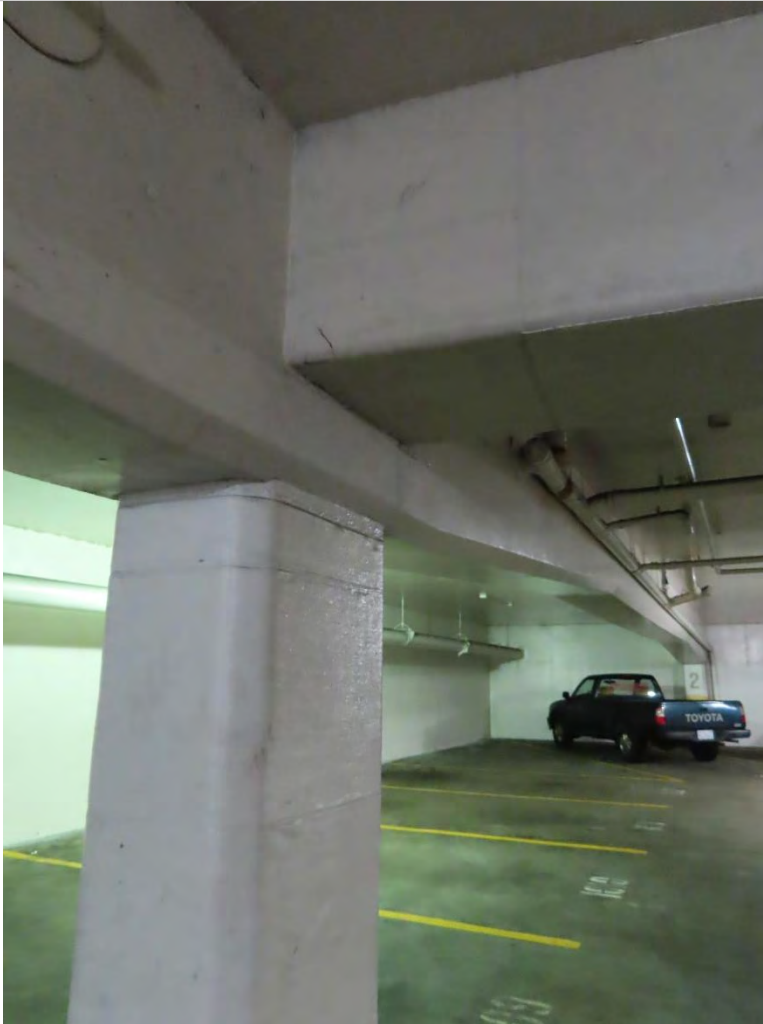
- The fiber reinforcing wraps with added concrete cover at select columns on the west elevations were observed. Also, some of the underside soffit surfaces of the Pier Level had received fiber reinforcing wrap (Photos 1.33).
- Underside drain piping was corroding (Photo 1.34 and 1.35).

Photo 1.33- Fiber reinforcing wraps with added concrete cover, Basin level (SH1-271)

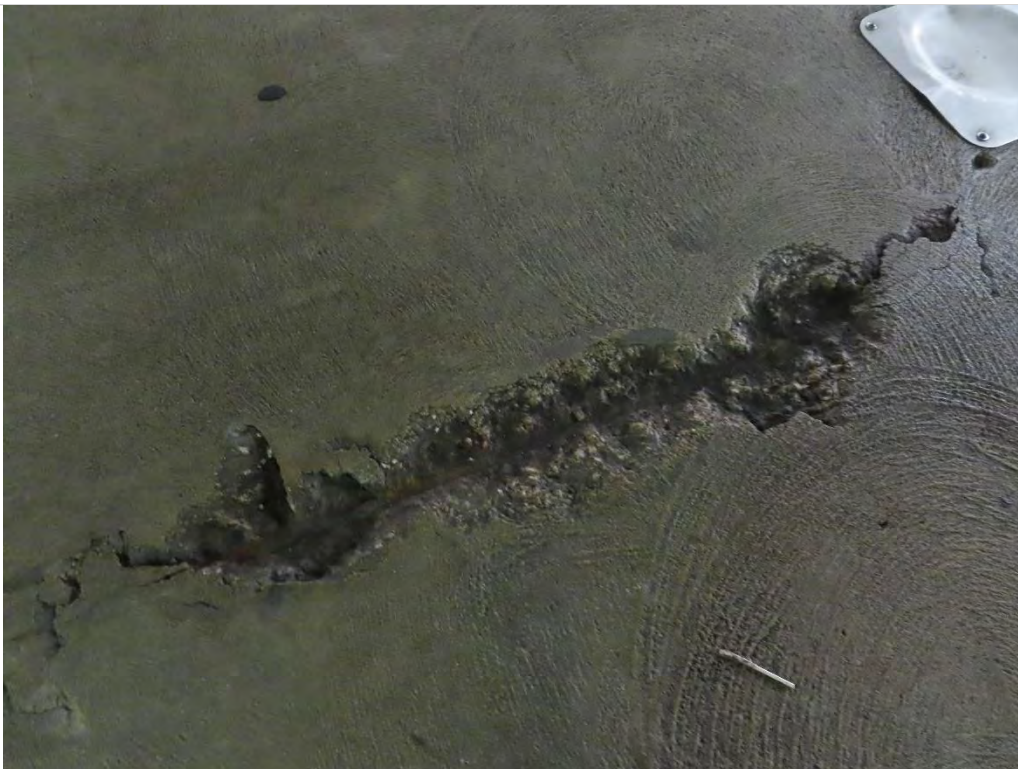
- Typical slab on grade spalls (Photo 1.36 and 1.37).
- Minor isolated concrete spalling was observed at the corners of the interior columns at a few locations on the basement and main parking levels (Photo 1.38).

Photo 1.36- Deteriorated slab on grade, Basin level (SH2-44)

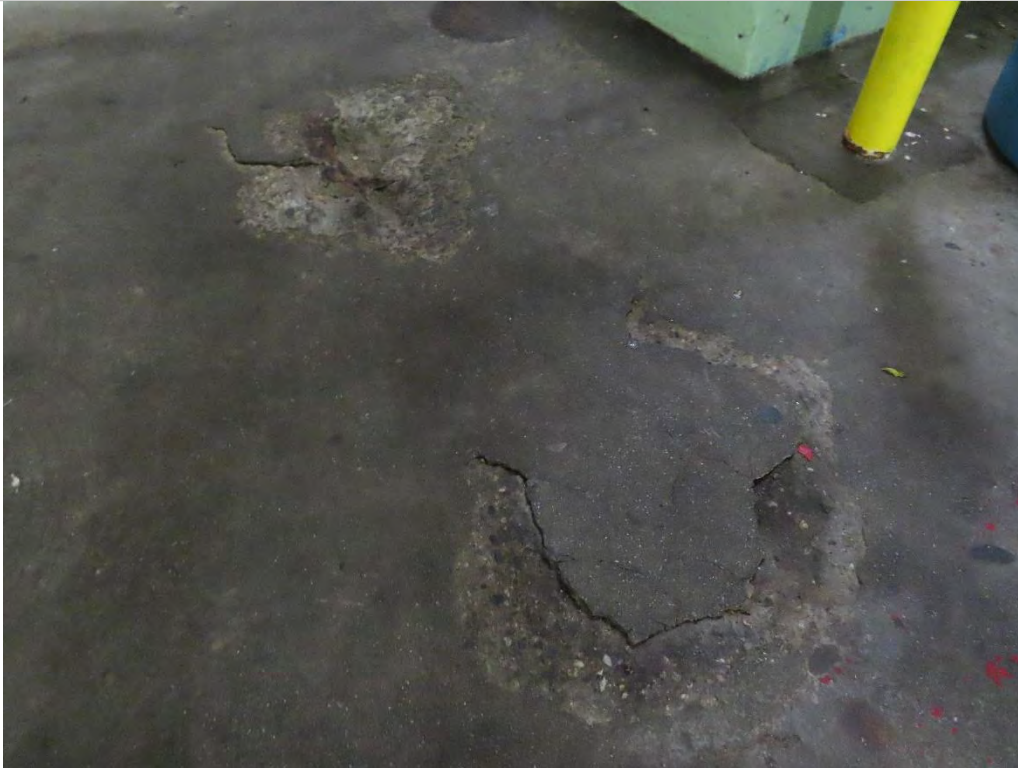
Photo 1.37- Deteriorated slab on grade, Basin level (SH2-48)

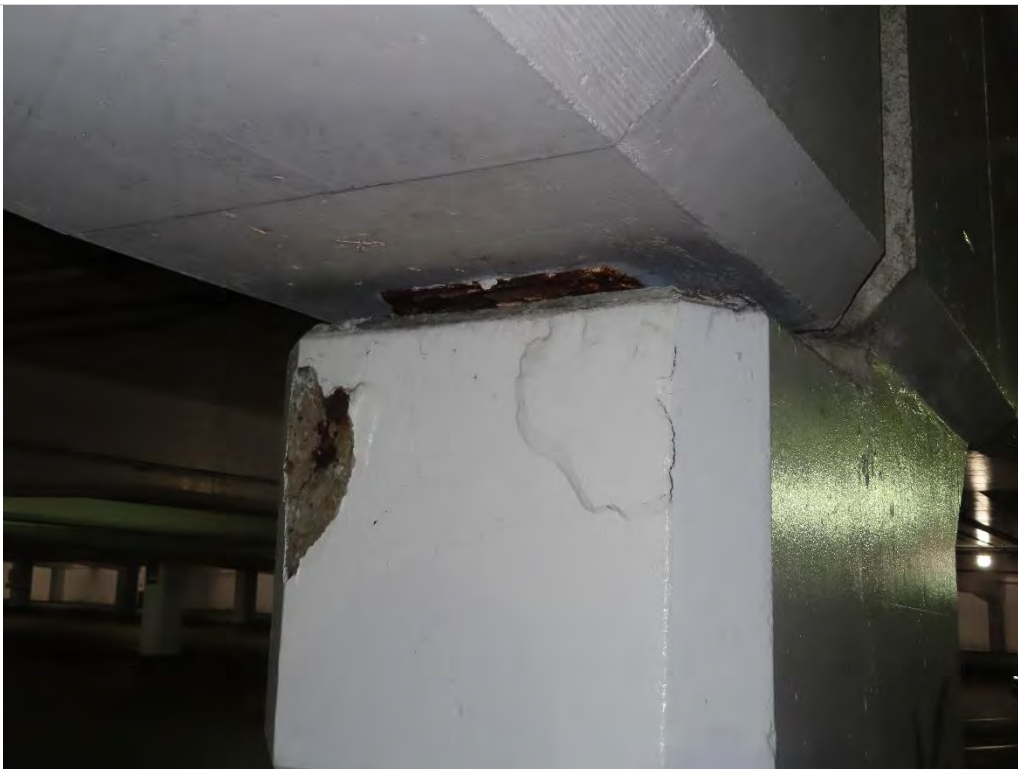
Photo 1.38- Isolated concrete column spalls, Basin level (SH1-241)

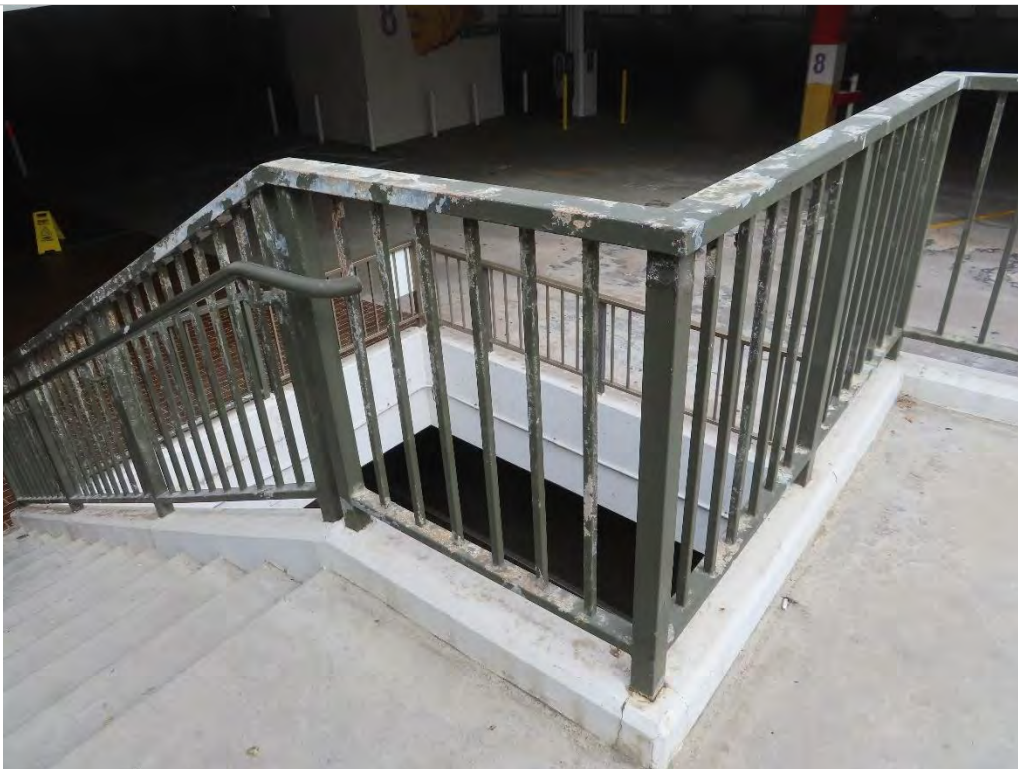
- Stair #2, 3, and 4:
 - Stair treads coating are peeled off (Photo 1.39 and 1.40).
- Stair #5:
 - Corrosion can be seen on all steel railing surfaces (Photo 1.41 and 1.42).

Photo 1.42- Corroded stair railing, (SH2-104)

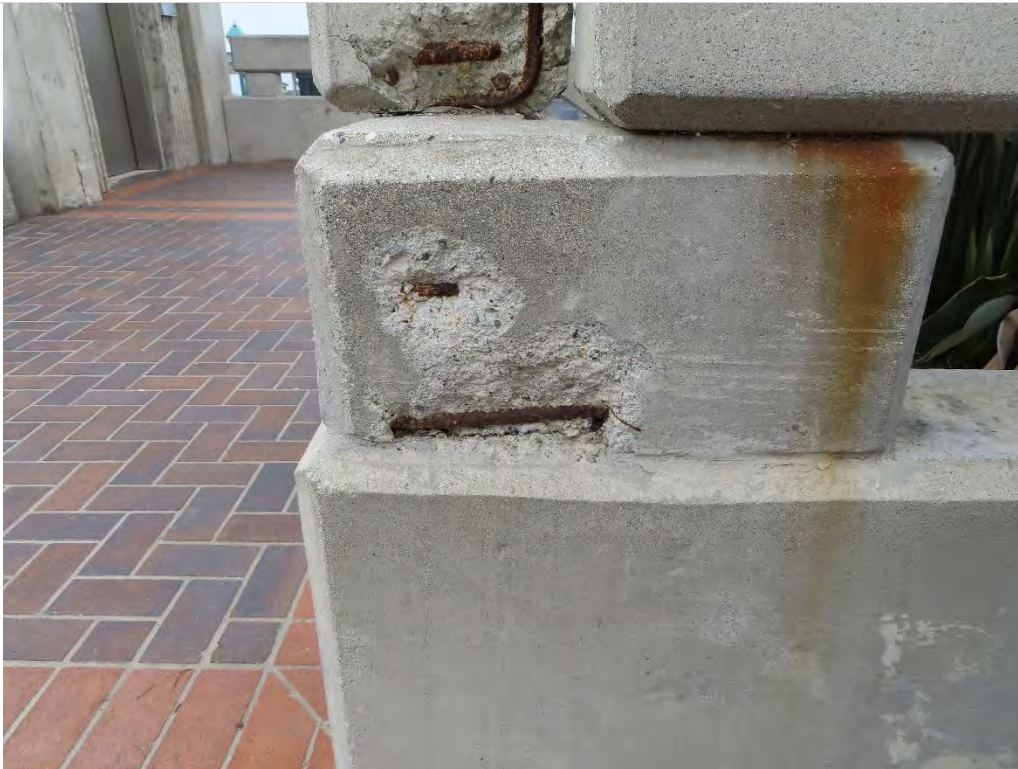
- Typical precast concrete spandrel deterioration with exposed and corroded reinforcement (Photo 2.1 and 2.2).
- Missing roof tiles above the stair tower were observed (Photo 2.3).
- Drains were plugged with leaves and minor amounts of trash (Photo 2.4).

Photo 2.2- Spalled precast concrete spandrel with exposed rebar, Plaza level (SH2-266)

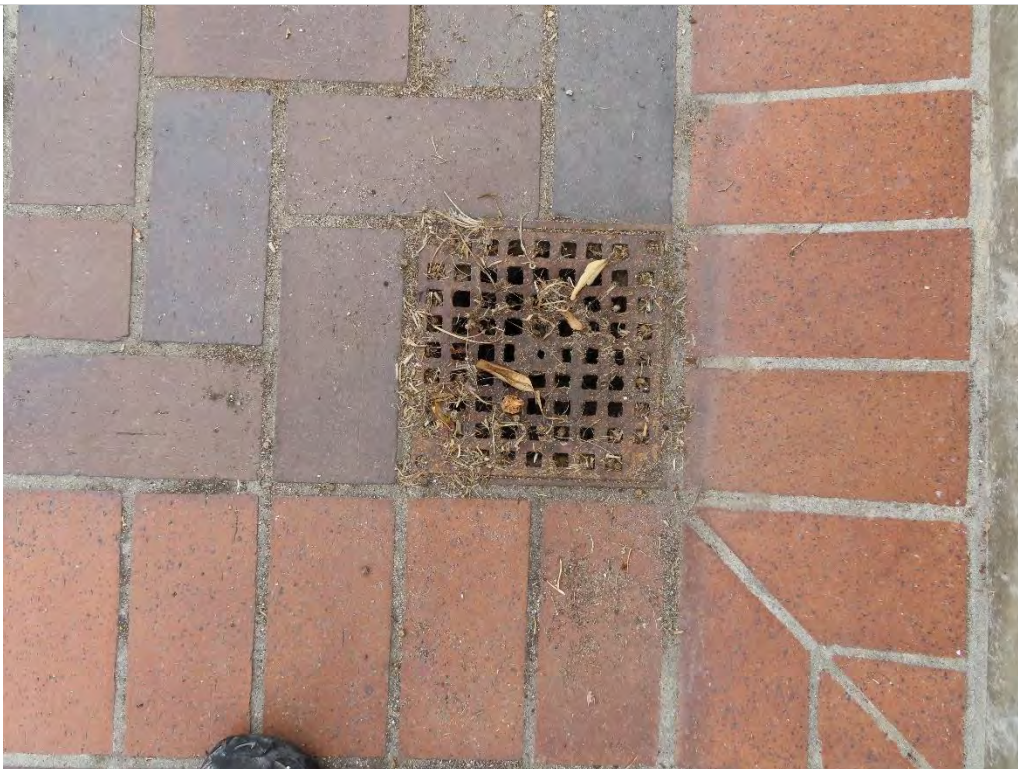
Photo 2.4- Clogged drains, Plaza level (SH2-267)

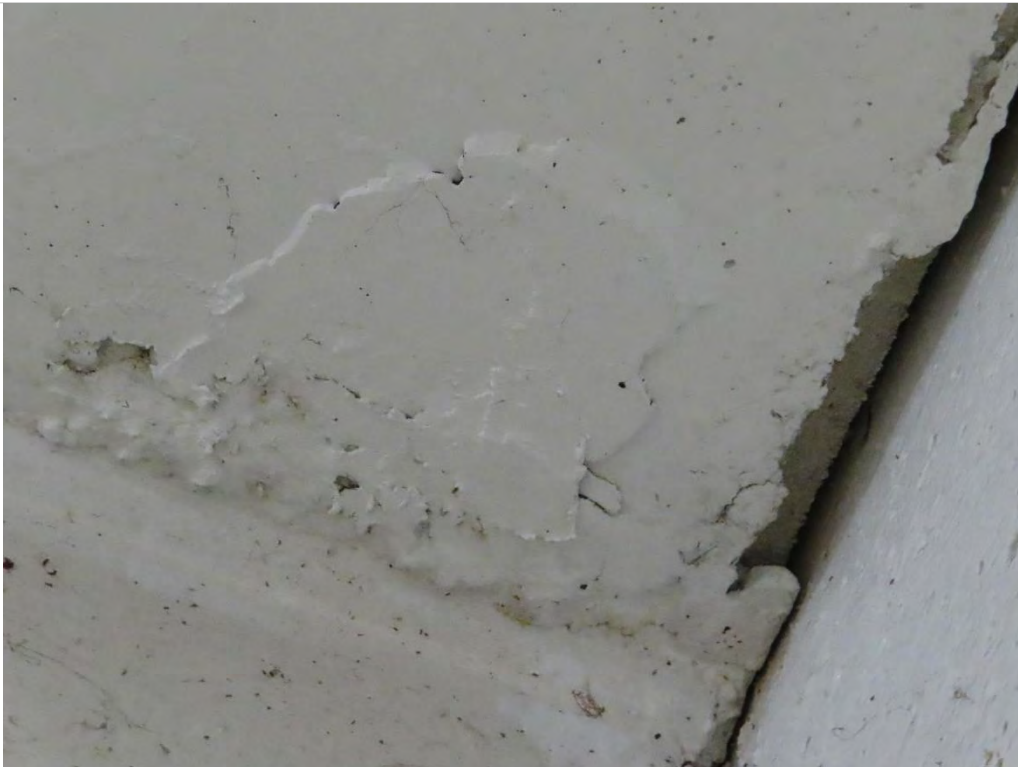
- Isolated delaminated concrete ceiling (Photo 2.10).
- Isolated delamination on the concrete walls exposing corroded reinforcement (Photo 2.11 and 2.12).
- Concrete stair deterioration was observed (Photo 2.13 and 2.14).
- Isolated damaged P/T rebar of a concrete beam (Photo 2.15).

Photo 2.10- Concrete spalling underside the slabs, Pier level (SH2-185)

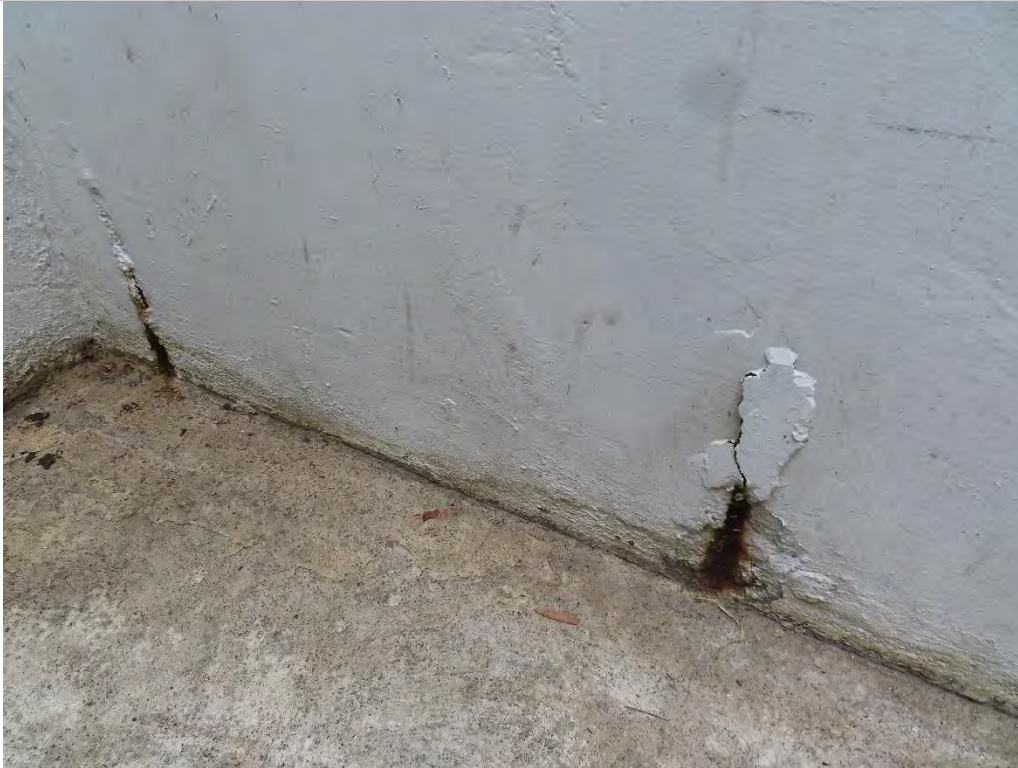
Photo 2.11- Exposed rebar on wall, Basin level (SH2-166)

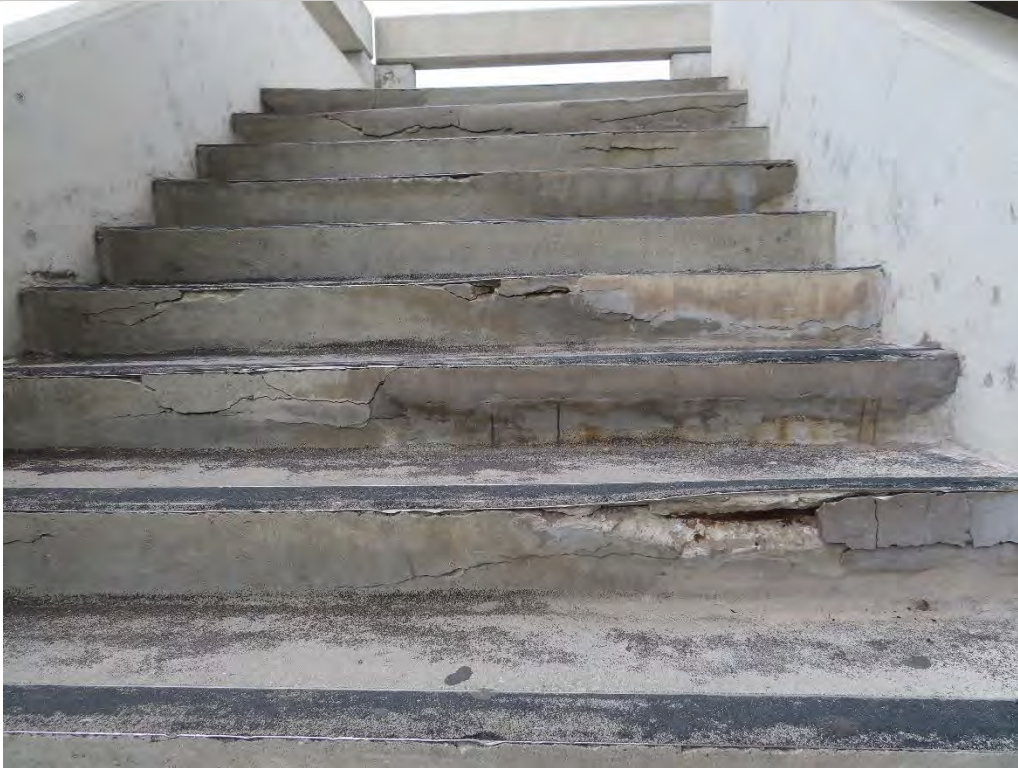
Photo 2.13- Damaged concrete stair treads and risers, (SH2-206)

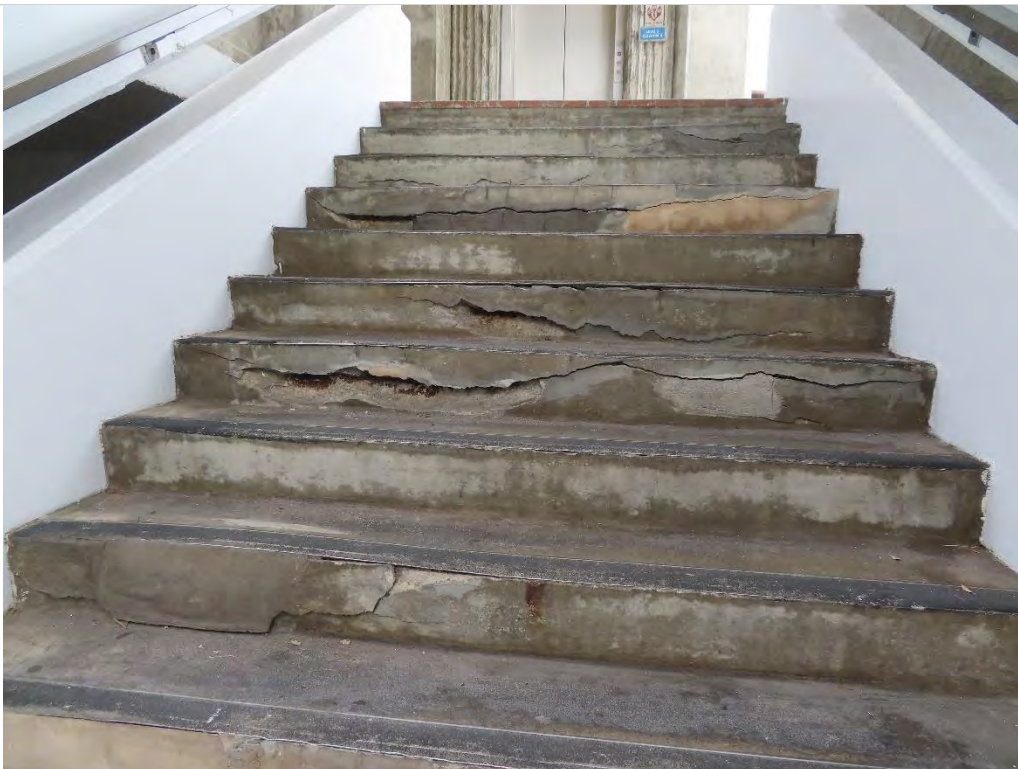
Photo 2.14- Damaged concrete stair treads and risers, (SH2-209)

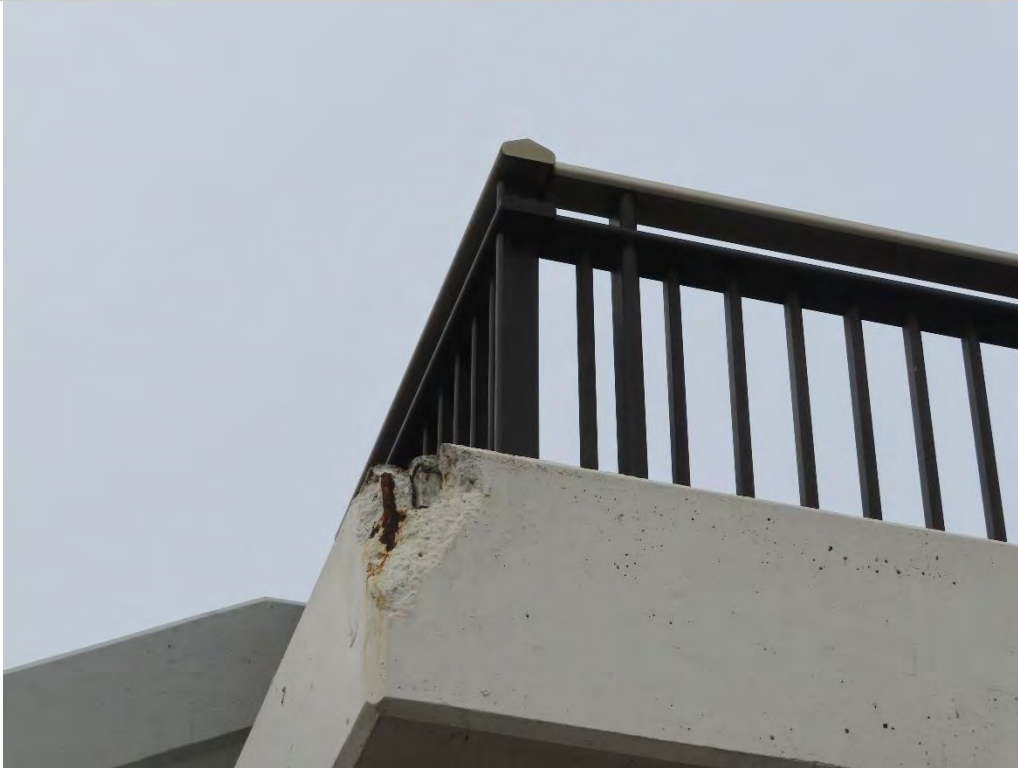
- Slab edge spalling and exposed rebar was observed mainly at the southwest end of South Pier parking garage. (Photo 3.1).
- Isolated concrete curb delamination was observed at the south end of South Pier parking garage (Photo 3.2).
- Isolated concrete wall delamination with exposed corroded rebar was observed on the south end of the South Pier parking garage (Photo 3.3).

Photo 3.1- Exposed and corroded rebar, Exterior - South elevation (SH2-252)

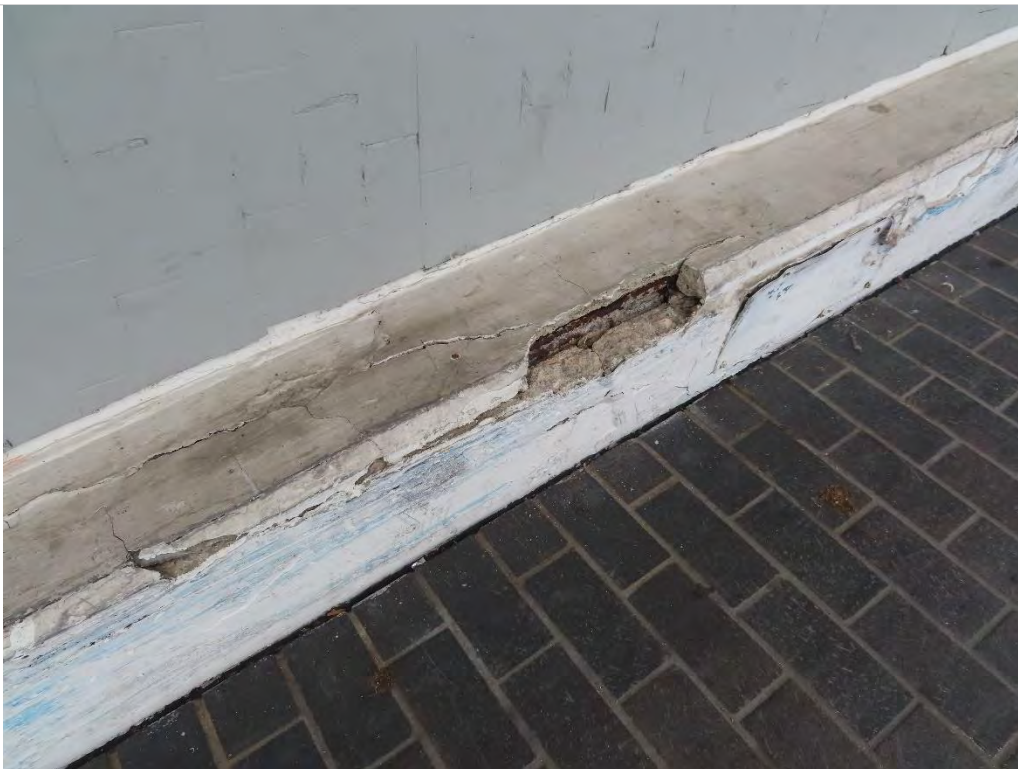
Photo 3.2- Exposed and corroded rebar, Exterior - South elevation (SH2-257)

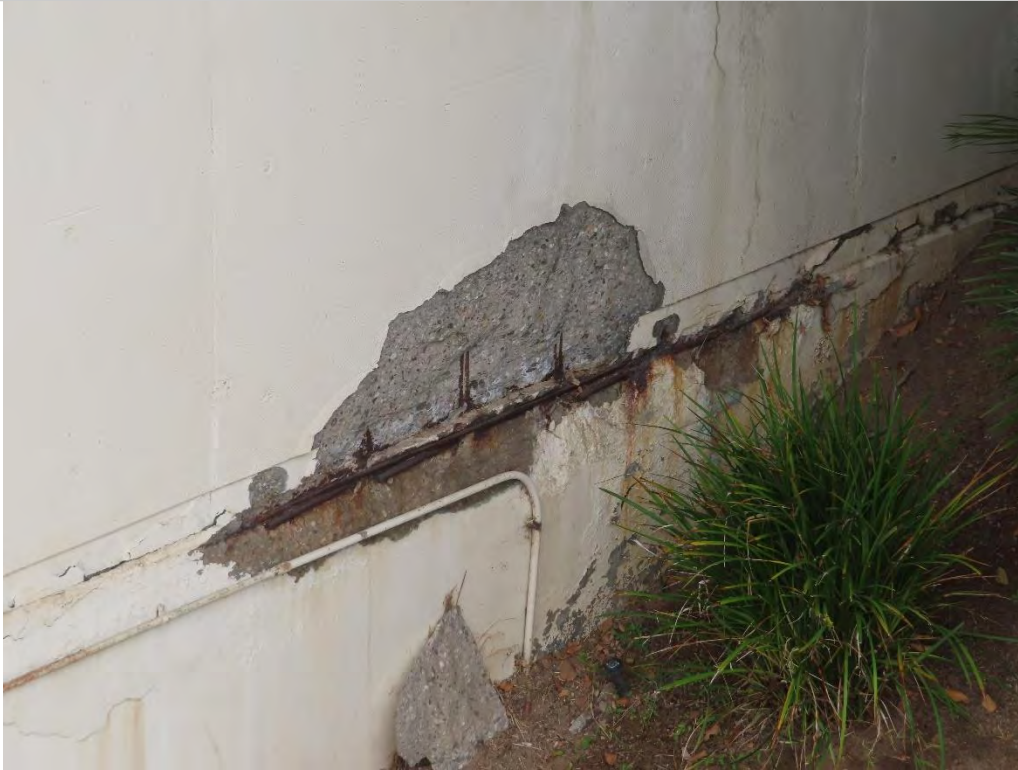
Photo 3.3- Concrete delamination, Exterior - South elevation (SH2-262)
