MEMORANDUM

Re: 2021/22 Pier Parking Structures Condition Assessment

**CITY OF REDONDO BEACH
NORTH PIER PARKING
STRUCTURE
2021-CONDITION ASSESSMENT**
CITY OF REDONDO BEACH
Redondo Beach, CA

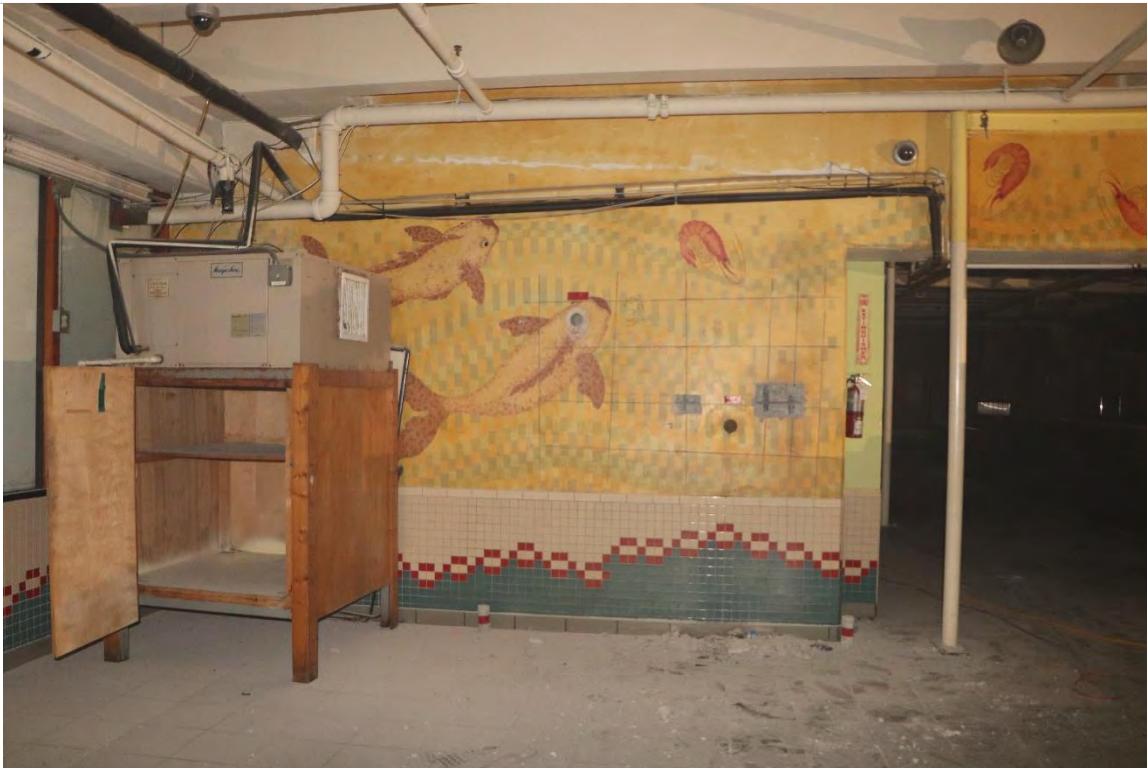
Photo 2.11—Destructive wall location (DT4), Kitchen wall on gridline 3, 1962 Construction - Basement (BA2-568)

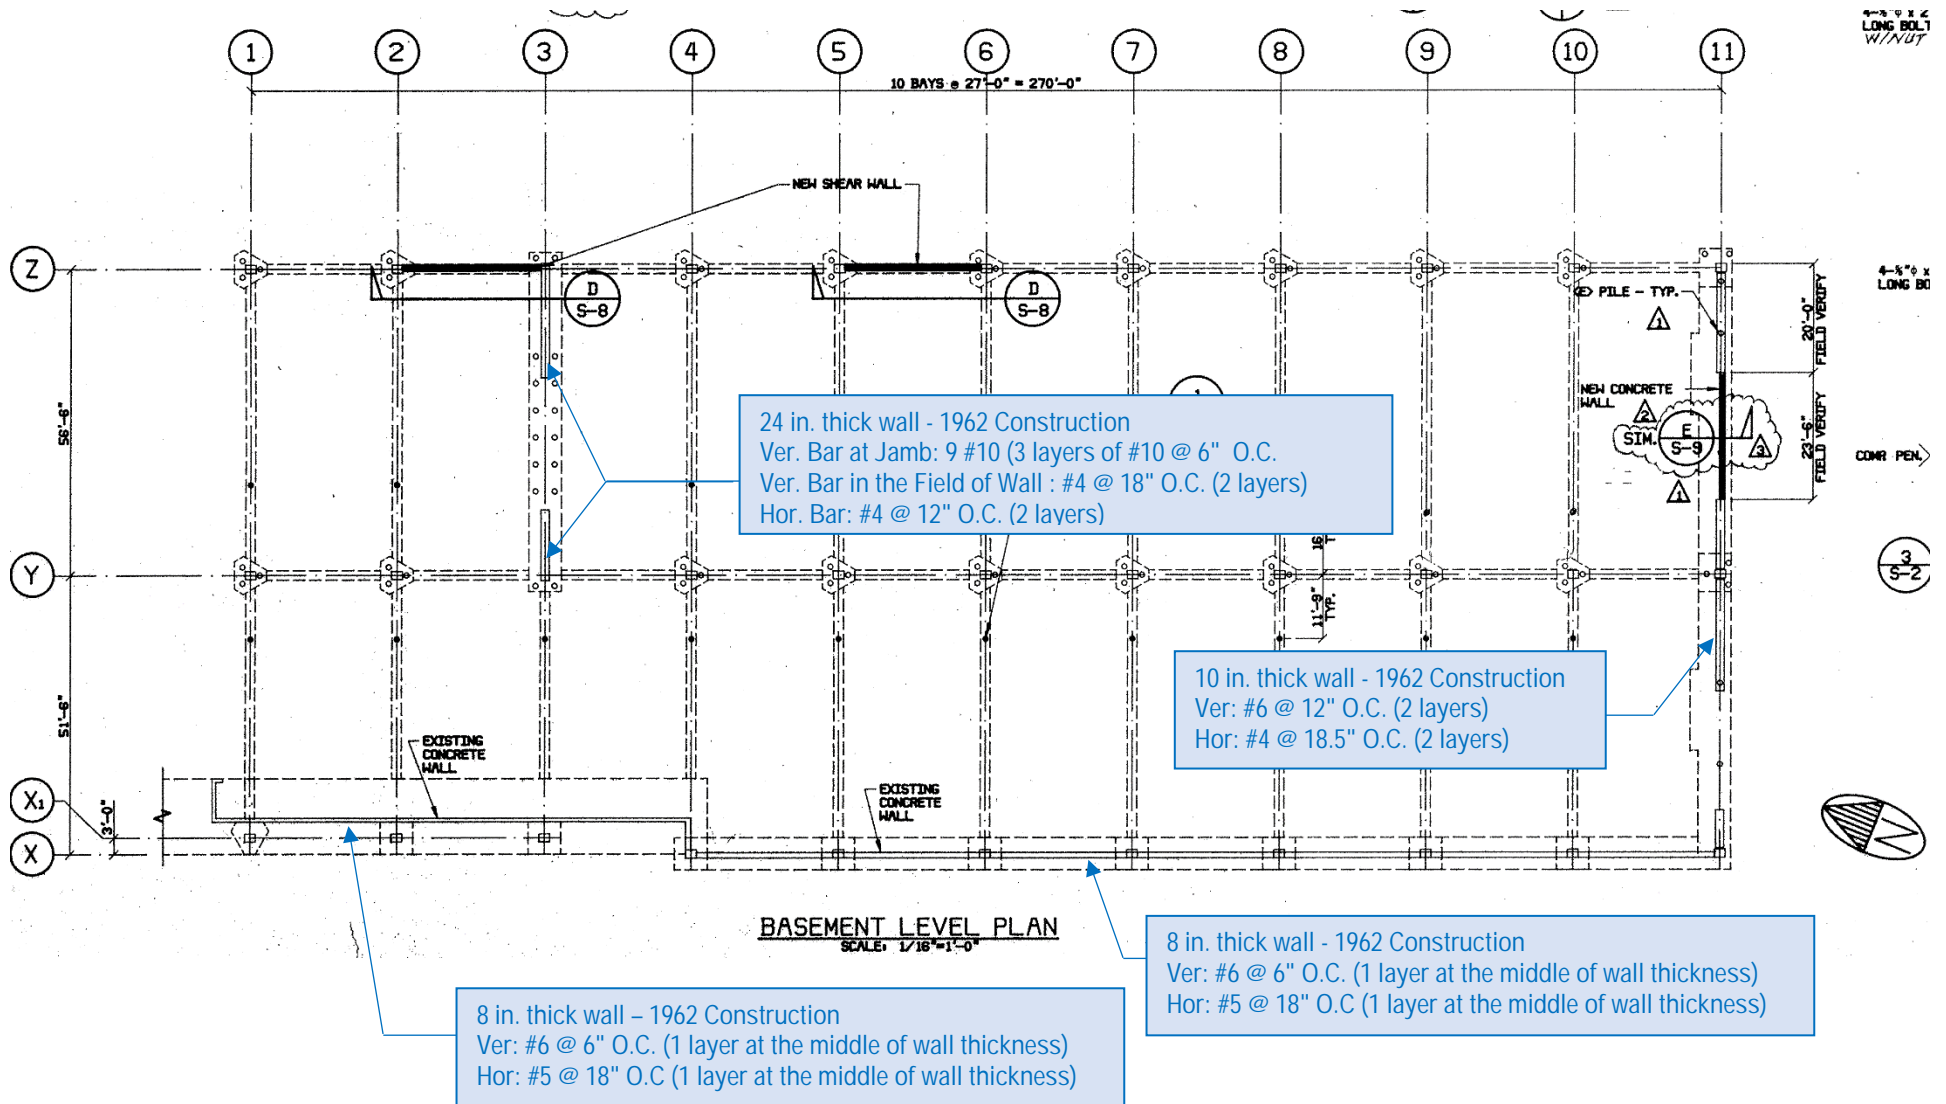
Figure 2.3 Steel reinforcement found at wall destructive openings – Basement Level

We also performed destructive testing to expose the steel reinforcement in the concrete walls for measuring bar sizes and spacings. Overall, we exposed steel reinforcement at 8 locations on the walls of which 5 were on the original concrete walls in the Basement. We also exposed 3 locations on the second floor retrofit waffle walls to check the presence of confinement steel in the wall diagonal members. Locations of destructive openings are shown in Figures 2.1 and 2.2. Steel reinforcement sizes and spacings measured during testing are shown in Table 2 and Figures 2.3 and 2.4. During our investigation of the wall opening, we did not observe any significant sign of rusting and deterioration on the exposed bars. Wall steel reinforcement were generally in good condition. We

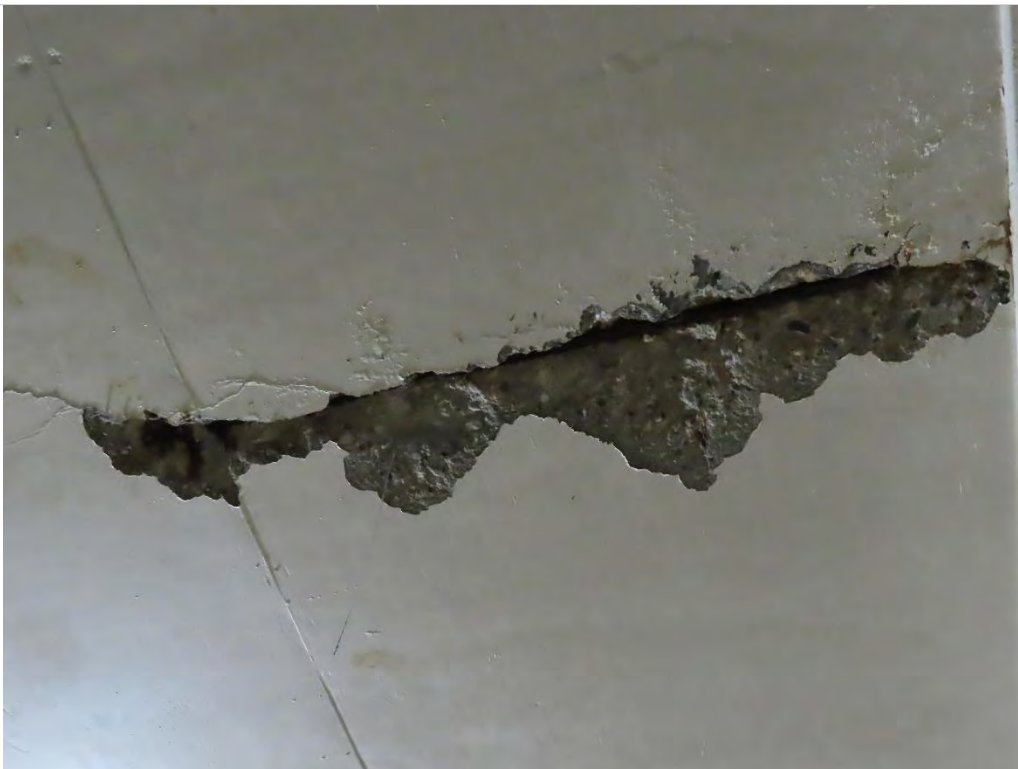
- Typical Pier level soffit slab deterioration and spalls with exposed and corroded reinforcement (Photos 1.26 to 1.28).
- Isolated beam deterioration with exposed and corroded reinforcement was observed primarily below the expansion joint (running north-south at south end of the garage) with other isolated locations (Photos 1.29 and 1.30).

Photo 1.28- Soffit slab deterioration and spalls with exposed reinforcement, Pier level (SH1-249)
