| Project Name | Aviation Park Soccer Field ASTM F1936 Gmax Impact Evaluation | | |
| Client Info | AFE SPORTS 2683 Lime Ave, Signal Hill, CA 90755 | Site Info | 1935 Manhattan Beach Blvd, Redondo Beach, CA 90278 |
| Report Date | 09/10/2021 | Test Date | 09/09/2021 |

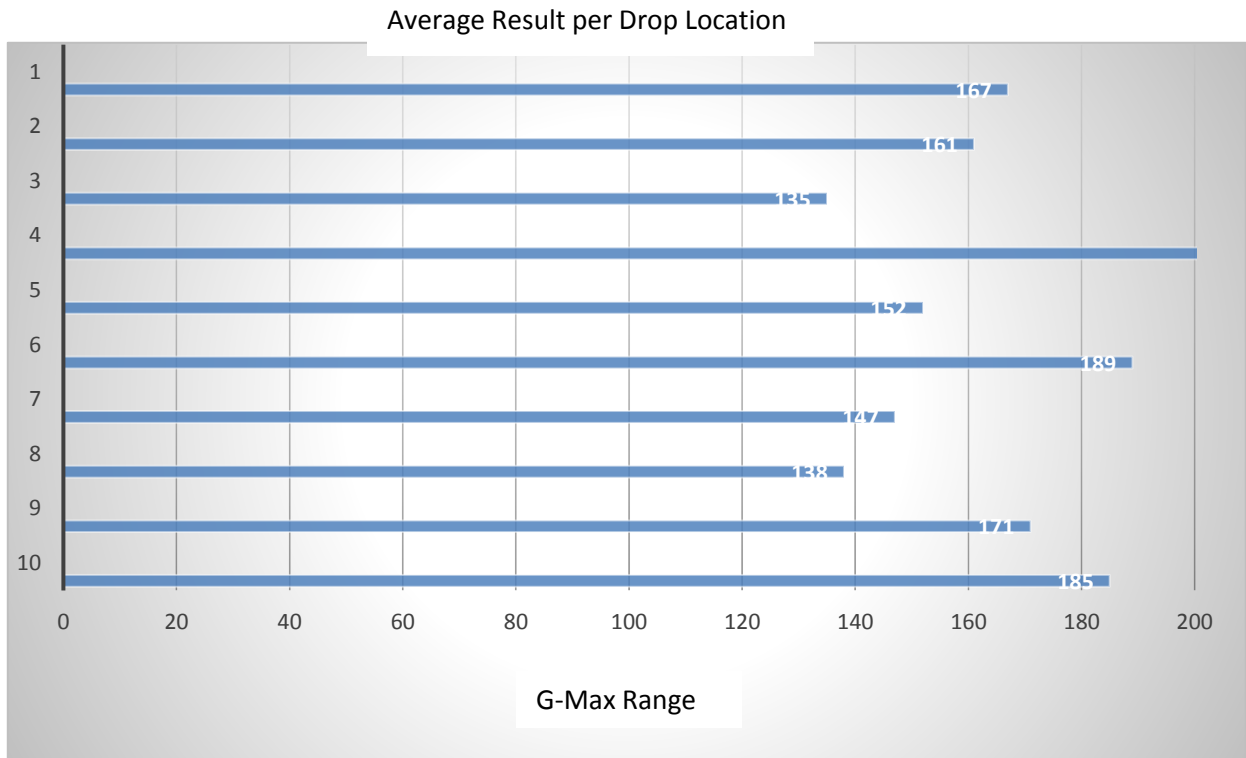
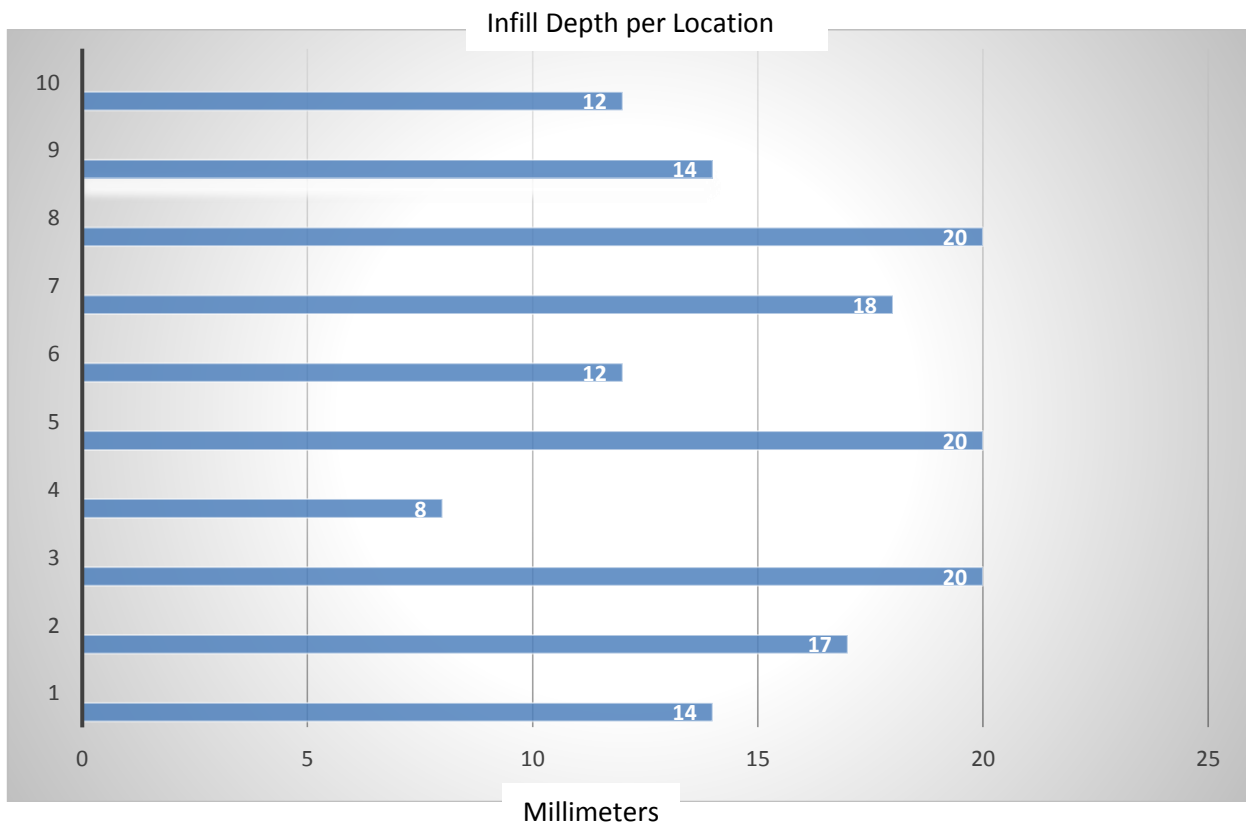
1. There are locations in the goal mouths of the small sided soccer that are exposing the underlayment and destroying the integrity of the product below. These areas fall outside of our testing locations per ASTM requirements but would fail or come close to failing for safety. These locations need to be repaired immediately.

5. There is a tremendous amount of loose yarn all over the surface and around the site. With the site containment becoming a growing concern for field owners in respect to the impact it has on the storm water runoff and carrying plastic to the ocean overtime. This being an older field the lead levels of the yarn maybe exceeding the 50 – 100 PPM that most design and Municipality Owners require the yarns to comply with when purchasing new fields today. The lead and other chemicals in the yarn were not of high concern at the time this field was installed at its estimated date of 2007. The growing concern of the PFAS materials (plastic and rubber) leading to the ocean and storm water system in relation to this field, I would suggest that the field and site be cleaned of the yarn and excess rubber on the surface to ensure a better containment of the plastic fibers and rubber leaving the site. My concern would be with rubber removal to only happen around the site, as removing any surface rubber from this field will only increase the hardness at this point in time of the field's life.

6. The underlayment of the field from our experience due to the age of the field and product material makeup will need to be replaced with the turf system. The material may not survive the removal process and the uplifting to regrade the base then re-installation. The Owner should be prepared to install a new underlayment when the replacement time occurs.

7. The field estimated installation date is 2007. The age would be close to 14 years old. From our observations in testing fields and building fields in California this product has seen its time and I would suggest that replacement of the surface be completed sooner than later at this time.
