APPLICATION FOR CERTIFICATE OF APPROPRIATENESS

**124 N. Catalina Avenue**

124 N. Catalina Avenue (1946/1950)

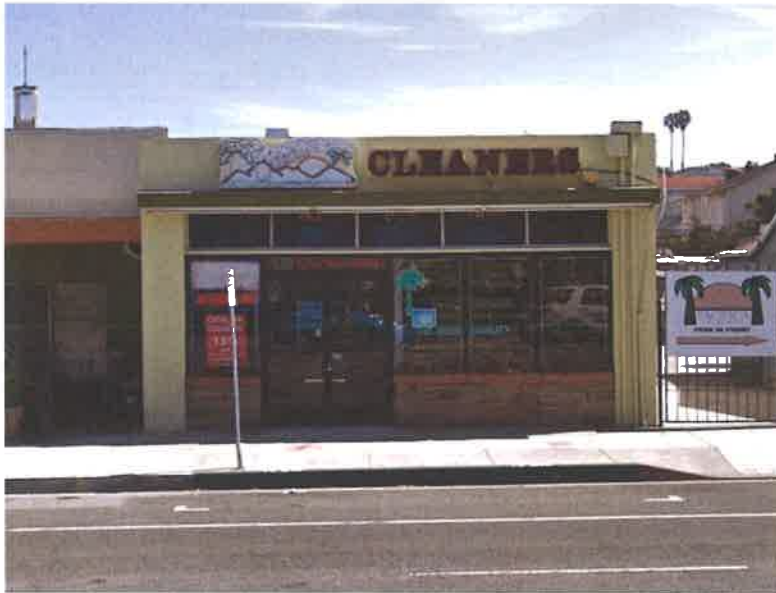
The front façade retains the original configuration of the storefront opening including the horizontal mullion that separates the upper transom windows although the window sash and storefront has been changed to dark finished aluminum. There is a decorative pattern of masonry at the bulkhead that may be original. Existing signage is not original. The building extends back into the parcel with space for laundry equipment. That area is generally unadorned on the exterior and the massing offsets along the south elevation separating the significant front part of the building from the less meaningful rear structure.

The façade is generally in satisfactory condition. There have been unattractive modifications to the front façade mostly from exposed electrical service and outdoor lighting applied to the building that impacts the historic quality of the building. The horizontal wood mullion separating the transom windows should be refurbished.

The current storefront and glazing could be replaced while maintaining the full opening and the expression of the transom windows. The horizontal element that separates the upper transom windows needs rehabilitation to maintain.

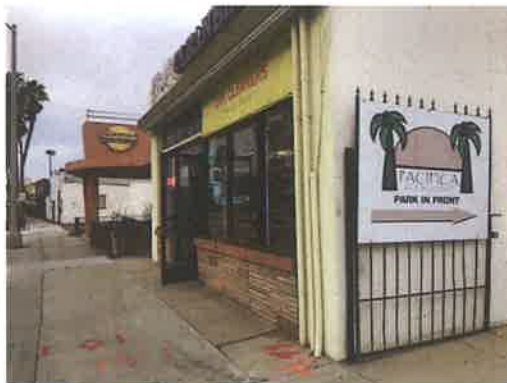
Electrical service and exterior lighting should be reconfigured

Electrical service elements applied over the south end of the front façade should be removed and relocated. Exterior lighting should be compatible with building.

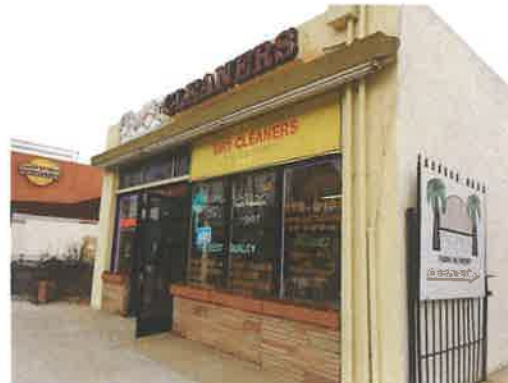
Masonry bulkhead may be original.  
Refurbish mullion at transom windows

Further investigation is needed for the storefront bulkhead. The bulkhead may not be original based on wall construction behind the stone veneer. It is unknown whether the current door opening is original.

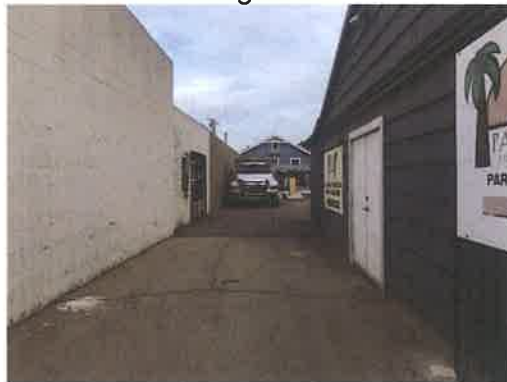
Long south elevation is not significant  
and can be modified as needed

The rear portion of the building is not a historic feature and can be altered or removed without impact the resource. Additional openings will be provided on the south elevation to provide more daylight and connection to the exterior for new uses. These openings will be differentiated from the front façade.
